# National Transportation Safety Board

## Marine Accident Brief

**Accident No.:** DCA-09-CM-001

**Vessel:** U.S. commercial fishing vessel *Katmai*, official number 918779, overall length 92.2 feet, registered length 73.3 feet, beam 26 feet, 148 gross register tons, 101 net tons, built 1987

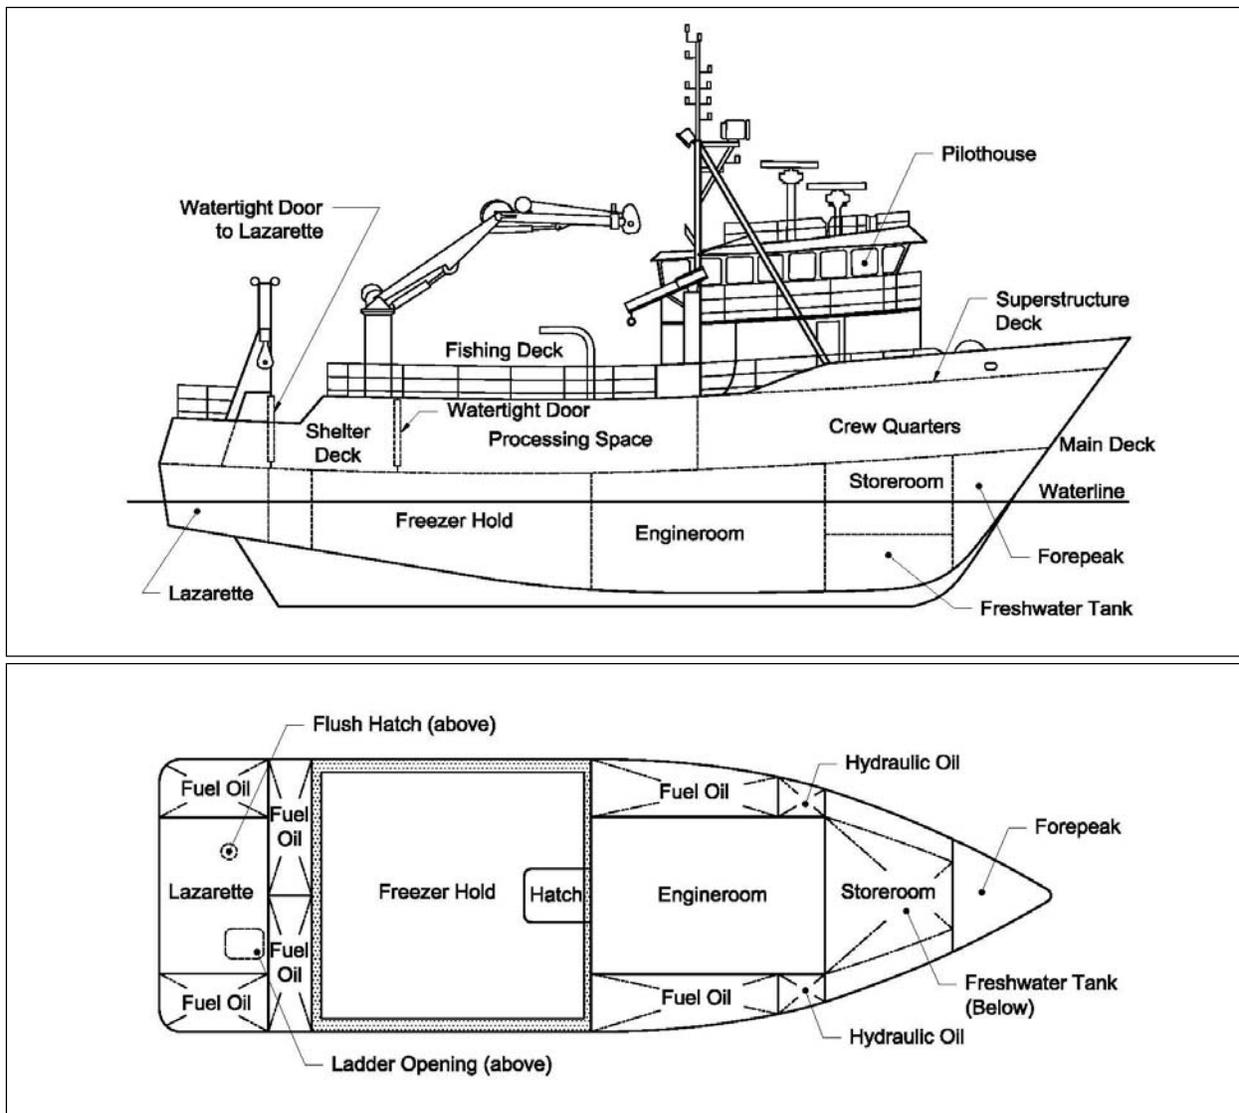
noted that the watertight door to the space was open and that the space had flooded.<sup>13</sup> According to the master, the engineer closed the watertight door, reported the flooded lazarette to the master, and then went to the engine room to start the bilge pump to dewater the lazarette. At 2329, the master sent a second e-mail to the *Blue Ballard*, reporting that the *Katmai*'s lazarette was flooded. The engineer started the bilge pump and reported to the master that the water level in the lazarette was dropping. Meanwhile, one of the deckhands stated that several inches of water had accumulated in the processing space on the main deck.

The main deck was divided into crew quarters, an enclosed fish-processing space, and a shelter deck. The fish-processing space held equipment such as plate freezers, chiller tank, sinks, conveyors, sorting machine, air-conditioning system, and refrigerator/freezer. A tube directed fish from the fishing deck into the processing space.<sup>27</sup> Manually operated watertight doors allowed access forward to the crew accommodation area and galley and aft to the shelter deck. The shelter deck contained equipment and fishing gear. A watertight door on the shelter deck led to the lazarette, which was accessible by ladder.

in bags that each contained 45 pounds of finished product, and stacked in the hold. The lazarette contained two hydraulic rams that positioned the rudders. The space also contained two refrigeration compressors and two hydraulic steering pumps as well as a portable dewatering pump.

**Figure 3.** Profile and internal spaces of *Katmai* (top) and layout below main deck (bottom). Drawing based on illustration in vessel’s 1996 stability report, recent vessel photographs, and testimony before marine board.

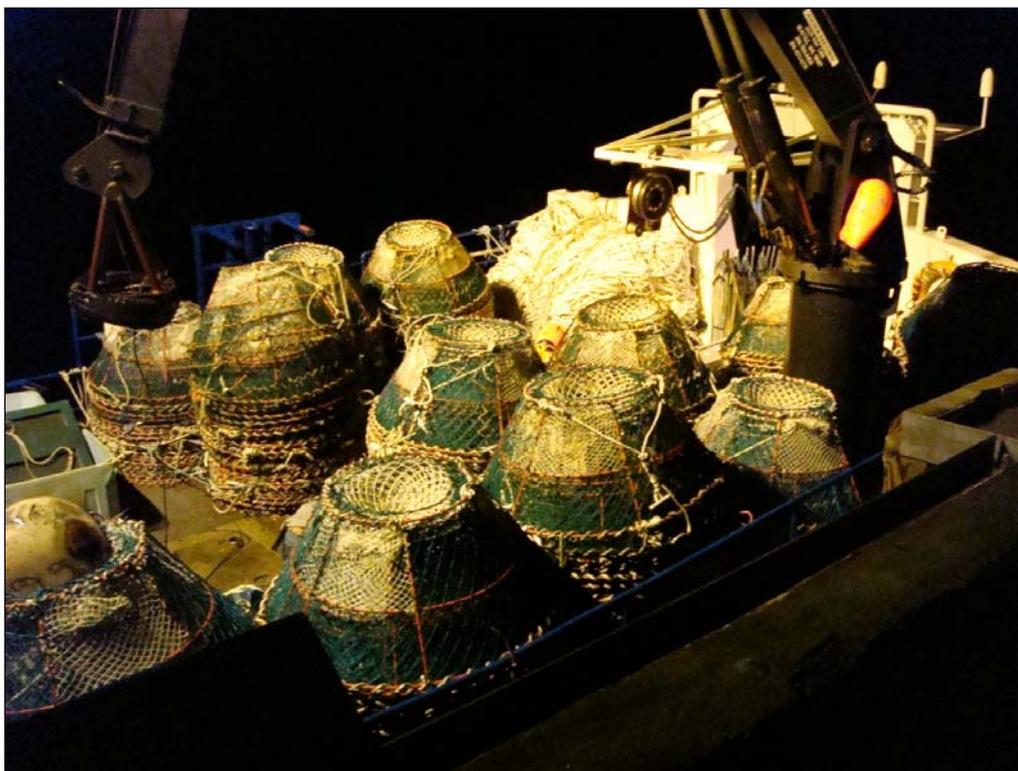
**Figure 4.** Cod pots on *Katmai*'s fishing deck, looking aft (Katmai Fisheries, Inc., photograph).
