# National Transportation Safety Board

## Marine Accident Brief

### Capsizing of Towing Vessel *Megan McB*

<b>Accident no.</b>	DCA13LM027
<b>Vessel name</b>	<i>Megan McB</i>
<b>Accident type</b>	Capsizing
<b>Location</b>	Lock and Dam 7, Mississippi River mile marker 702.5, near La Crescent, Minnesota
<b>Date</b>	July 3, 2013
<b>Time</b>	0558 central daylight time (coordinated universal time – 5 hours)
<b>Injuries</b>	One fatality
<b>Damage</b>	\$500,000
<b>Environmental damage</b>	50 gallons of diesel fuel discharged into the water
<b>Weather</b>	Winds at 3 knots from the south, air temperature 86°F, water temperature 81°F
<b>Waterway information</b>	Mississippi River, Lock and Dam 7, water flow rate of 88,900 cubic feet/second

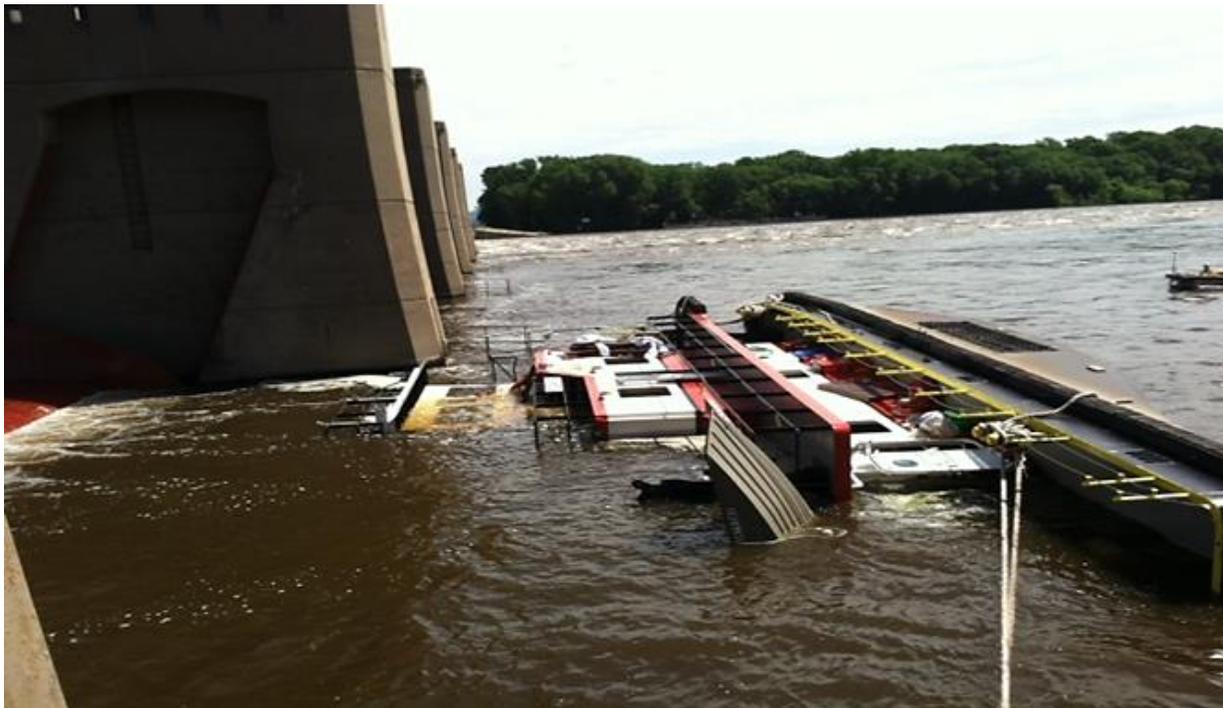
The *Megan McB* lying on its port side south of gate no. 1 of Lock and Dam 7 on the Mississippi River. The photo looks northeast across the river. (Photo by the United States Coast Guard)

The river current swept the *Megan McB* into gate no. 1 of the dam. The top of the vessel's starboard-side superstructure made contact with the catwalk atop the dam, causing the vessel's hull to be pushed out from underneath the superstructure, while the superstructure remained pinned against the catwalk. As a result, the *Megan McB* capsized onto its port side and came to rest just south of gate no. 1, where concrete baffle blocks held the vessel in place. The pilot and first mate were able to escape through the wheelhouse windows, which the strong current had broken, but the deckhand was missing. The pilot on board the *Bill Berry* notified the assistant lock operator, who launched a rescue boat onto which the pilot and the first mate were retrieved about 8 minutes later. The search continued for the missing deckhand. About 1300 that afternoon, divers located the deckhand's body on the second deck of the *Megan McB*'s superstructure.

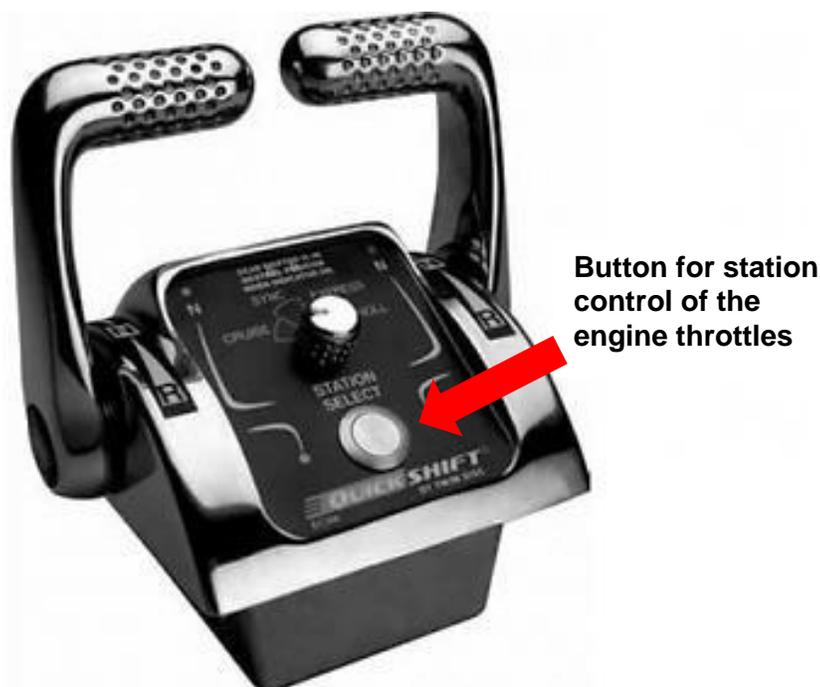
The electronic control head for the *Megan McB*'s engine control throttles. (Photo by Twin Disc Inc.)

Nine minutes later, about 0555, the pilot prepared to maneuver the *Megan McB* into the main lock. He radioed for the crew to let go the mooring line. The deckhand proceeded to the bow and removed the line from the mooring pin on the pier. The pilot then attempted to engage the engines by moving both throttles forward on the electronic control head; however, because he had not pressed the station select button, the engines did not respond. The pilot told investigators that he did not know that he had to press this button to control the engines; he had received no instruction in using the electronic control head.

Brennan Marine did not have a process for instructing first-time *Megan McB* pilots about the vessel's electronic engine control throttles, even though the need to press the station select button for engine control was unique to the *Megan McB*. Similarly to the accident pilot, the pilot originally scheduled to work the 1800–0600 shift on July 2 and 3 also did not know how to operate the electronic control head when he first piloted the *Megan McB*. He told investigators that he too did not have engine control the first time he got under way with the vessel, but that, in his case, the mate who had served on board the *Megan McB* during the delivery transit from the shipyard came to his aid and alerted him about pressing the station select button.

The National Transportation Safety Board determines that the probable cause of the capsizing of towing vessel *Megan McB* was the replacement pilot's unfamiliarity with the vessel's electronic engine control throttles, which resulted in his inability to avoid gate no. 1 of Lock and Dam 7. Contributing to the capsizing was Brennan Marine's lack of effective procedures to ensure that the *Megan McB* was operated by a replacement pilot familiar with the electronic engine control throttles, which were unique to this one vessel in the company fleet.

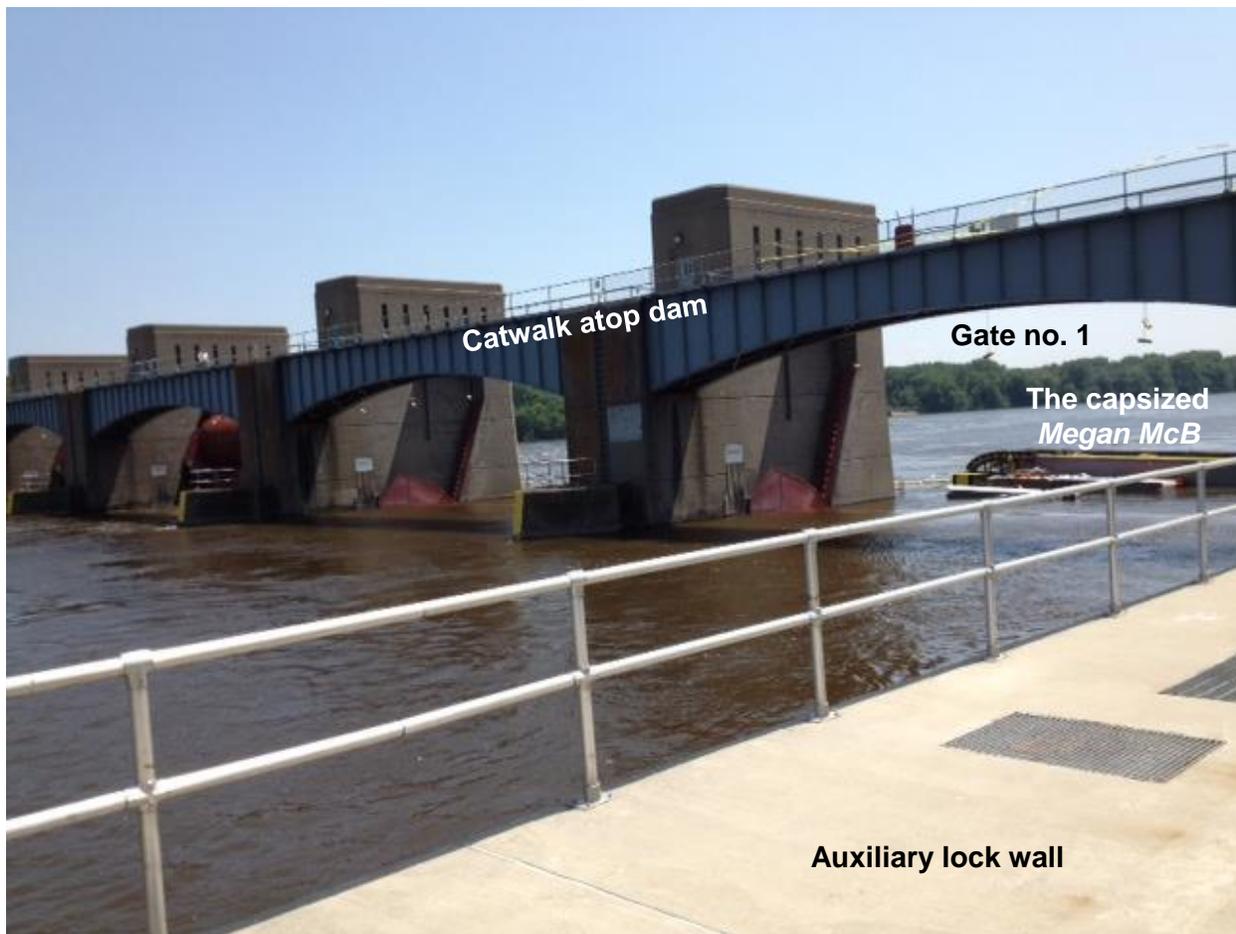
Lock and Dam 7, looking east across the river from atop the auxiliary lock wall. The *Megan McB* lies just past gate no. 1. In this photo, the gates are in their fully closed position to reduce water flow. However, at the time of the capsizing, the gates were fully open. (Photo by the Coast Guard)

On July 16, 2013, salvage efforts were concluded when Brennan Marine removed the *Megan McB* from the dam. The vessel had not sustained hull damage; however, flooding damage of interior spaces and equipment was estimated at \$500,000. As of the date of this report, the *Megan McB* remains out of service at the Brennan Marine facility.
