National Transportation Safety Board

Marine Accident Brief

Capsizing and Sinking of the Fishing Vessel *Christopher's Joy*

| Accident no. | DCA14LM020 |

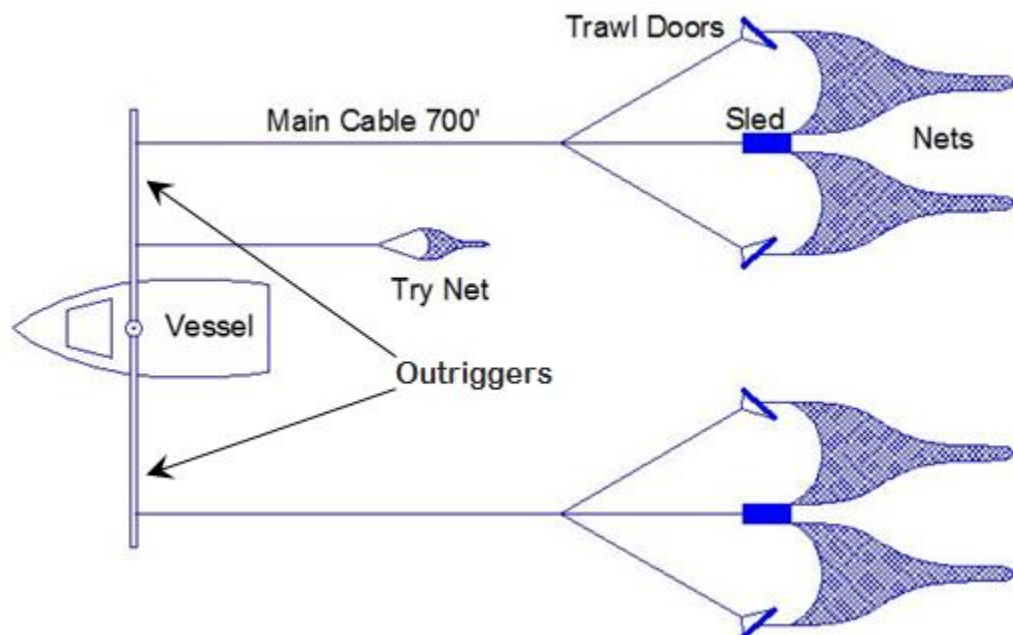
Configuration of *Christopher's Joy* trawl nets.

According to the master, he had about 700 feet of steel cable tow wire paid out from each outrigger towing block to each trawl on the seafloor. The master indicated that he felt the angle of outriggers on the *Christopher's Joy* was higher than normal, at about 25 degrees above the horizon. Vessels on which he had previously worked had the outriggers set about 15 degrees off the horizon. Because the tension of the trawl lines is transferred to the vessel through the towing points on the outriggers, the higher angle raises the towing point and therefore the effective center of gravity of the attached trawl weight. This weight moved higher reduces the vessel's stability. Weighted, wing-shaped stabilizers with lifting surfaces, sometimes referred to as "birds," can be deployed into the water from the tip of each outrigger when in the down position to dampen the roll of the vessel while under way. These stabilizers do not improve the stability of the vessel; rather, they serve only to slow the rolling motion when the vessel is making speed through the water. The master told investigators that during this particular trawl he felt it was unnecessary to have the outrigger stabilizers in the water.

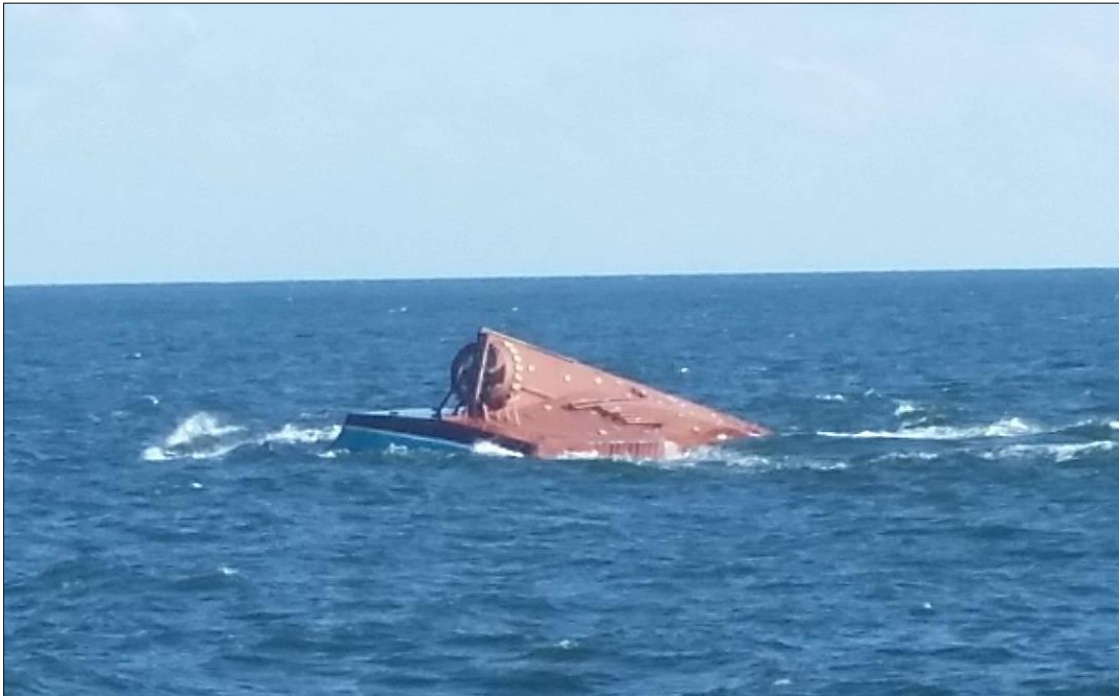
**Stern of *Christopher's Joy* after the two surviving crewmembers were rescued.
(Photo by crewmembers on board the supply boat *Miss Anna*)**
