Allision of Crane Barge, Pushed by Towing Vessel  
*Cory Michael*, with the Florida Avenue Bridge  
New Orleans, Louisiana  
August 13, 2014

**Marine Accident Report**  
NTSB/MAR-15/02  
PB2015-105662

**National  
Transportation  
Safety Board**

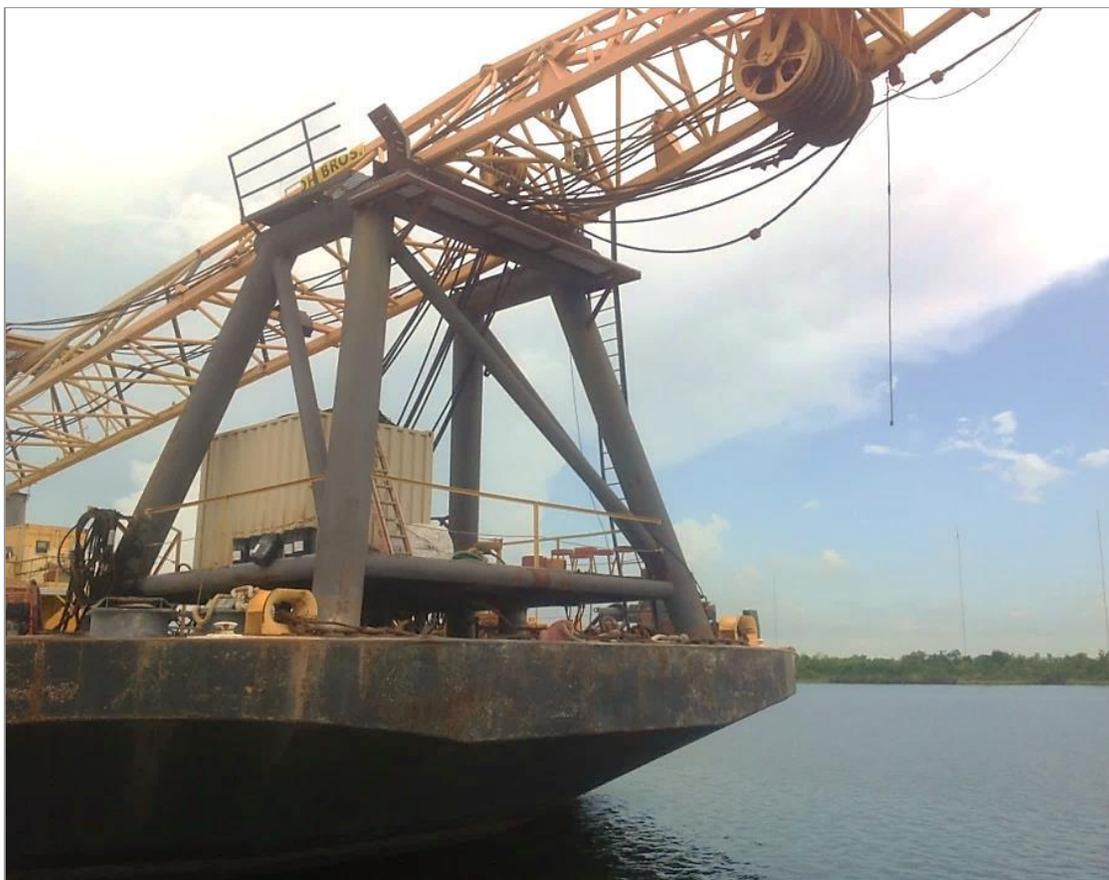
The Boh Bros. foreman and other personnel secured the crane on the barge to prevent lateral (side-to-side) movement and locked the boom into the stowed position using a mechanical safety retaining mechanism inside the boom hoist gear case to prevent downward motion. The tip of the boom extended about 14–16 feet beyond the barge's bow, and the boom was at a 14-degree angle of elevation off the barge's deck. At this angle, the boom was elevated above the cradle permanently mounted on the barge's bow. The cradle is a four-legged tower system, which, when in use, provides the boom's frame with a solid resting point, relieving tension from the wire cables and associated block-and-tackle used to raise and lower the boom (figure 3). In addition, when in use, the cradle prevents lateral movement of the boom. However, for the accident transit, the boom was suspended above the cradle and not supported by it.

**Figure 3.** Postaccident photo of the cradle on barge *BBCCI 901.012*. In this photo, the crane boom is resting in and supported by the cradle. However, during the accident transit, the boom was suspended unsupported above the cradle, relying instead on the crane's own mechanisms for support.

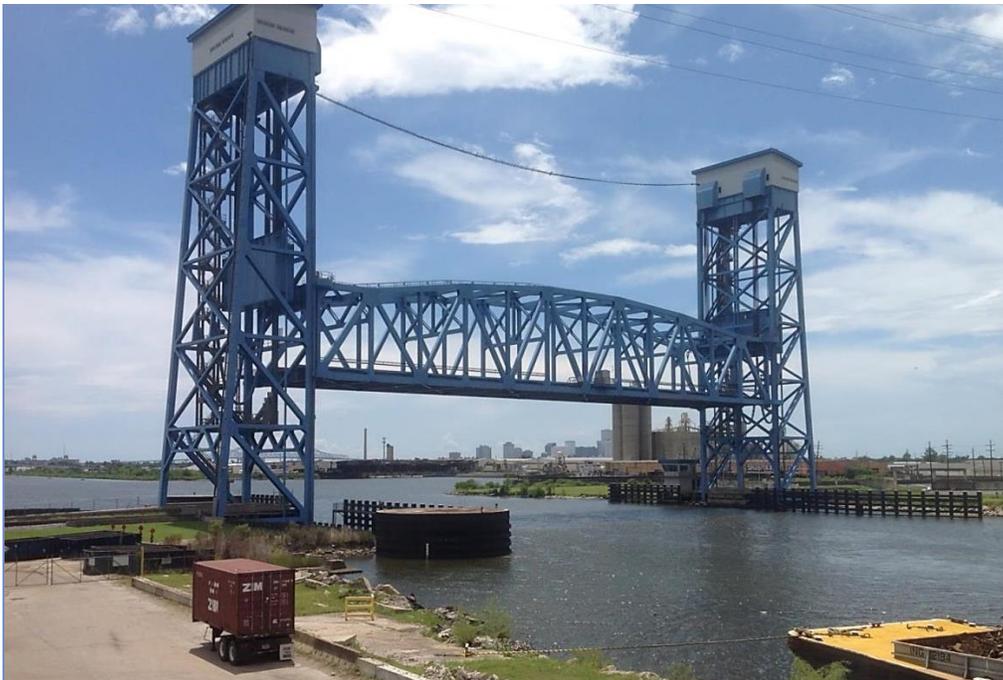
**Figure 4.** Postaccident photo of the Florida Avenue Bridge, seen from the northeast looking toward the southwest.

As of the date of this report, the alignment problem with the Florida Avenue Bridge has been repaired and the lift span can now be raised to its fullest extent (156 feet).

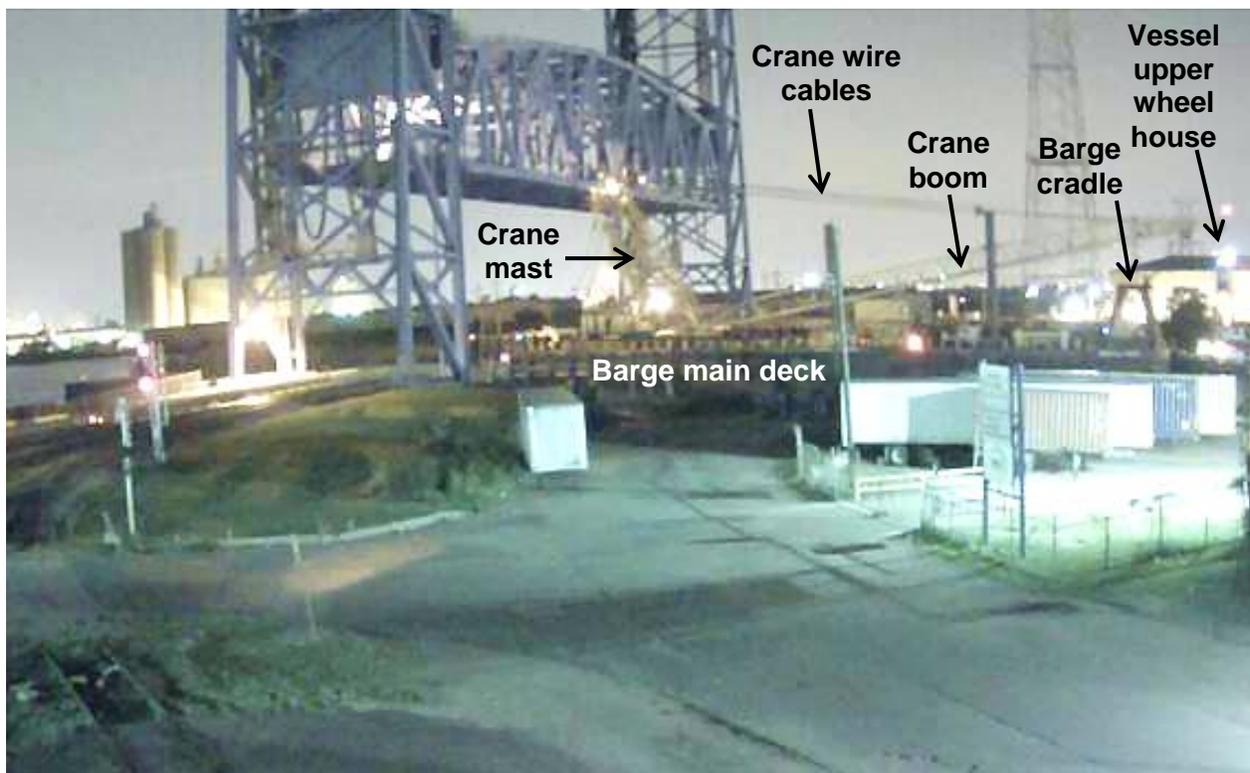
As the stern of the barge passed under the bridge's lift span, the crane mast struck the steel framing of the lift span (figure 5).

**Figure 5.** Still image, captured from security video footage, of the moment just before the crane mast struck the lift span of the Florida Avenue Bridge, about 2355. The impact initiated a series of failures on the crane, including release of tension on the wire cables between the crane mast and boom, which allowed the boom to drop onto the *Cory Michael's* upper wheelhouse.

The impact caused a series of failures on the crane that resulted in 322,000 pounds of the crane's counterweight falling into the waterway and the crane boom dropping onto the *Cory Michael's* upper wheelhouse. The overhead and supporting structural framing of the upper

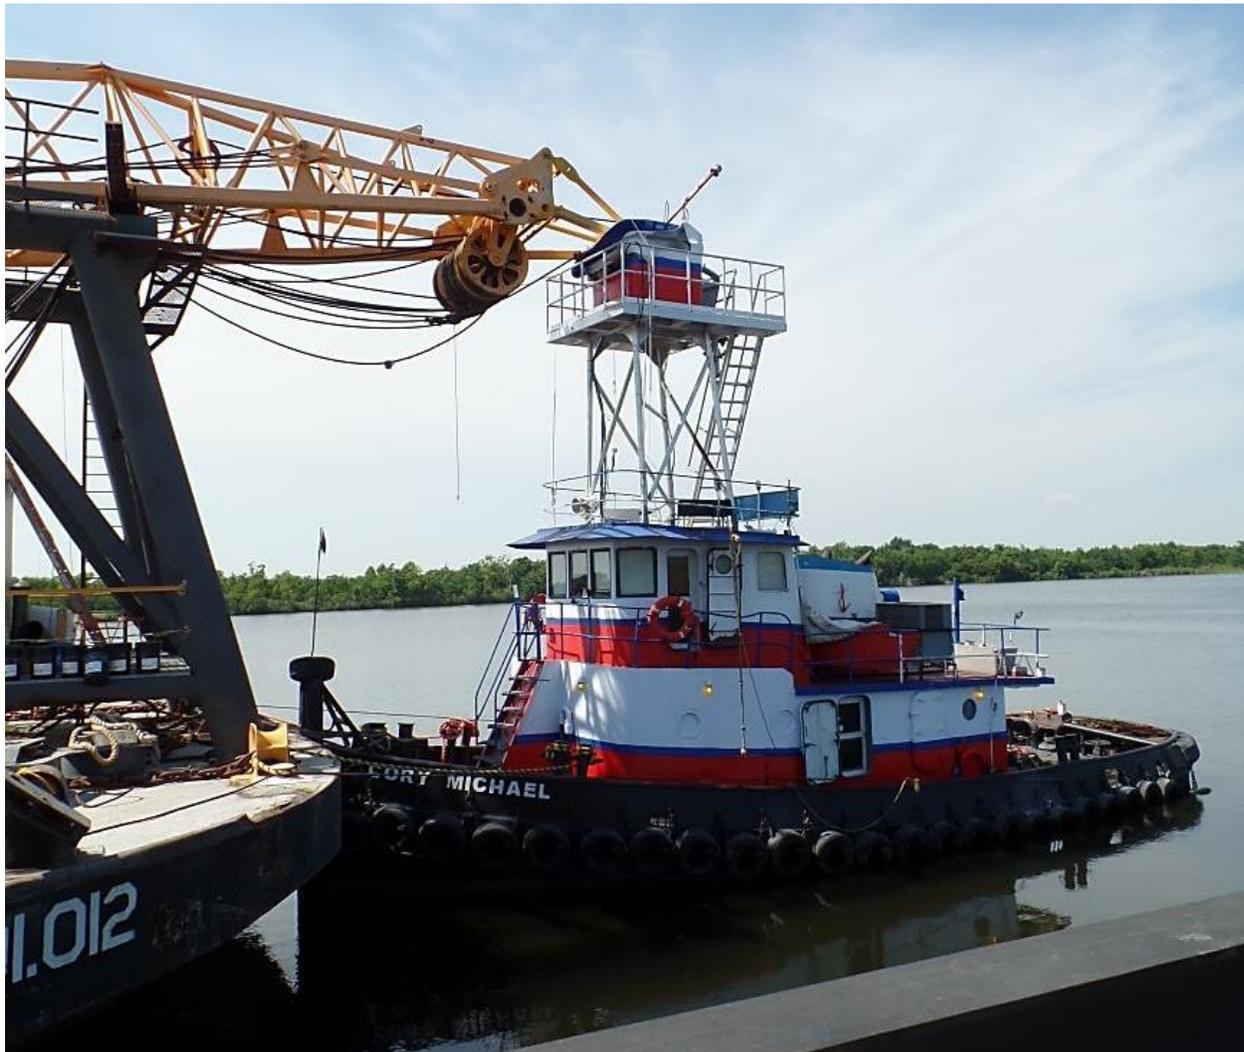
wheelhouse collapsed from the impact, fatally injuring the captain. The barge cradle stopped the crane boom from dropping further onto the vessel (figure 6).

**Figure 6.** Postaccident photo of the crane boom on top of the *Cory Michael's* collapsed upper wheelhouse.

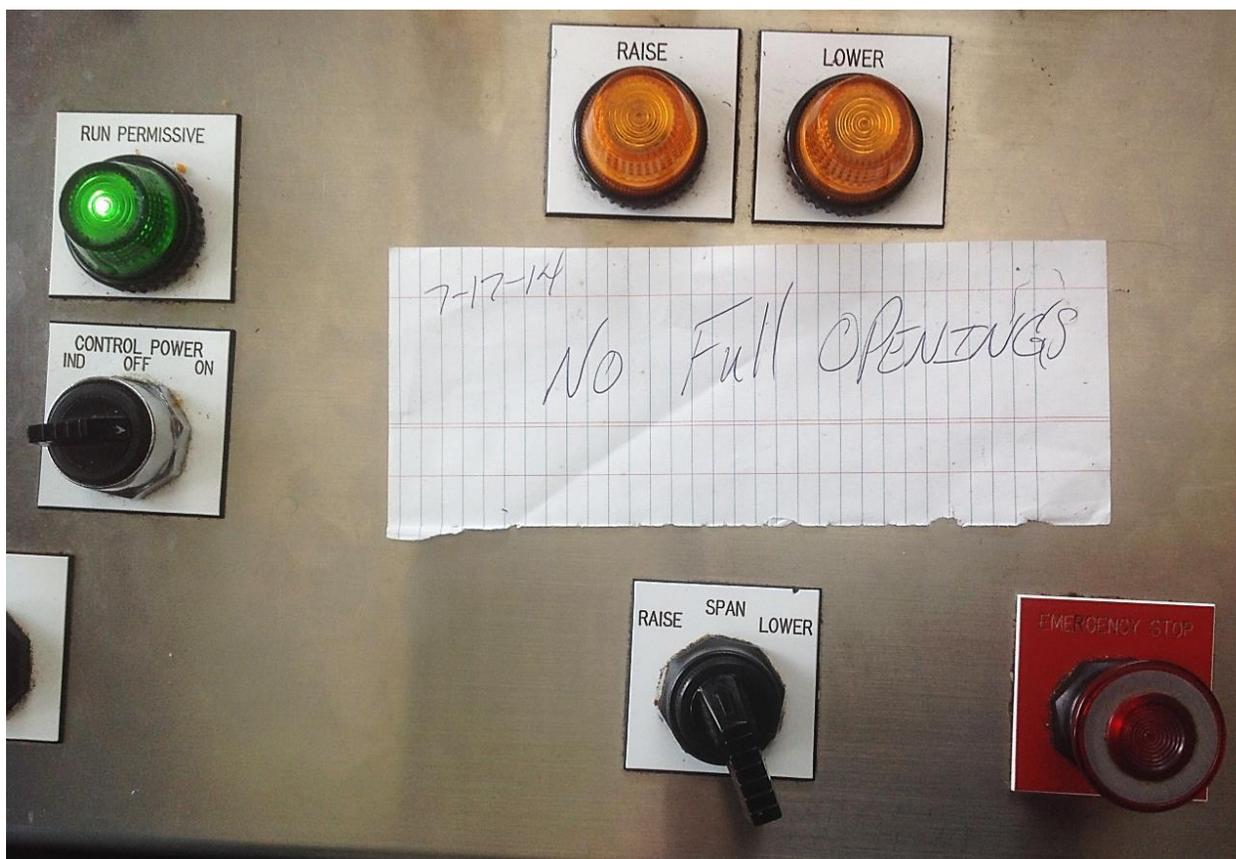
As time went by, the Florida Avenue Bridge operators developed a practice of obtaining and accepting a specific height request from vessel operators. They would then raise the lift span an additional 15–20 feet beyond that height as a margin of safety. This practice was not written; Port of New Orleans staff had orally conveyed it to the bridge operators. When investigators examined the bridge control station, they found a recent handwritten note reminding bridge operators not to raise the lift span to its fullest extent (figure 7). As a result, the green light on the lift span did not illuminate post-Katrina, including on the day of the accident.

**Figure 7.** Photo of handwritten note, posted in the Florida Avenue Bridge’s control station, instructing bridge operators not to raise the lift span to its fullest extent.

After the accident, the Port of New Orleans instituted several measures designed to improve the training of bridge operators and mitigate the risk of similar incidents:
