National Transportation Safety Board

Marine Accident Brief

Capsizing and Sinking of Fishing Vessel *Destination*

Accident no.	DCA17FM006
Vessel name	<i>Destination</i>
Accident type	Capsizing and sinking
Location	Bering Sea, 2.6 miles northwest of St. George Island, Alaska 56°39' N, 169°49.8' W
Date	February 11, 2017
Time	0610 Alaska standard time (coordinated universal time – 9 hours)
Injuries	6 fatalities
Property damage	\$2.5 million est.
Environmental damage	Oil sheen
Weather	Visibility 9 miles, light snow, cloudy skies, winds northeast at 23 knots with gusts up to 34 knots, seas northeast at 13 feet, surface current south at 0.78 knots, air temperature 18°F, water temperature 37°F, morning twilight 0915, sunrise 0955
Waterway information	The Bering Sea covers 885,000 square miles in the north Pacific Ocean, bordered by the following areas: Russia (Siberia), Bering Strait, mainland Alaska, Alaska Peninsula, and Aleutian Islands. The average depth of the sea is approximately 5,000 feet. The area around St. George and St. Paul Islands (Pribilof Islands) is much shallower, measuring 180–300 feet deep.

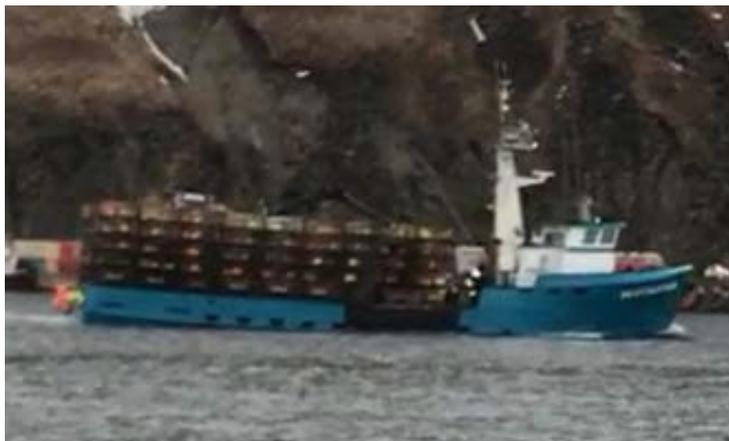
A screenshot from video of the *Destination* as it arrived in Dutch Harbor carrying 200 crab pots on February 9, two days before the accident. (Video courtesy of *April Lane* crewmember)

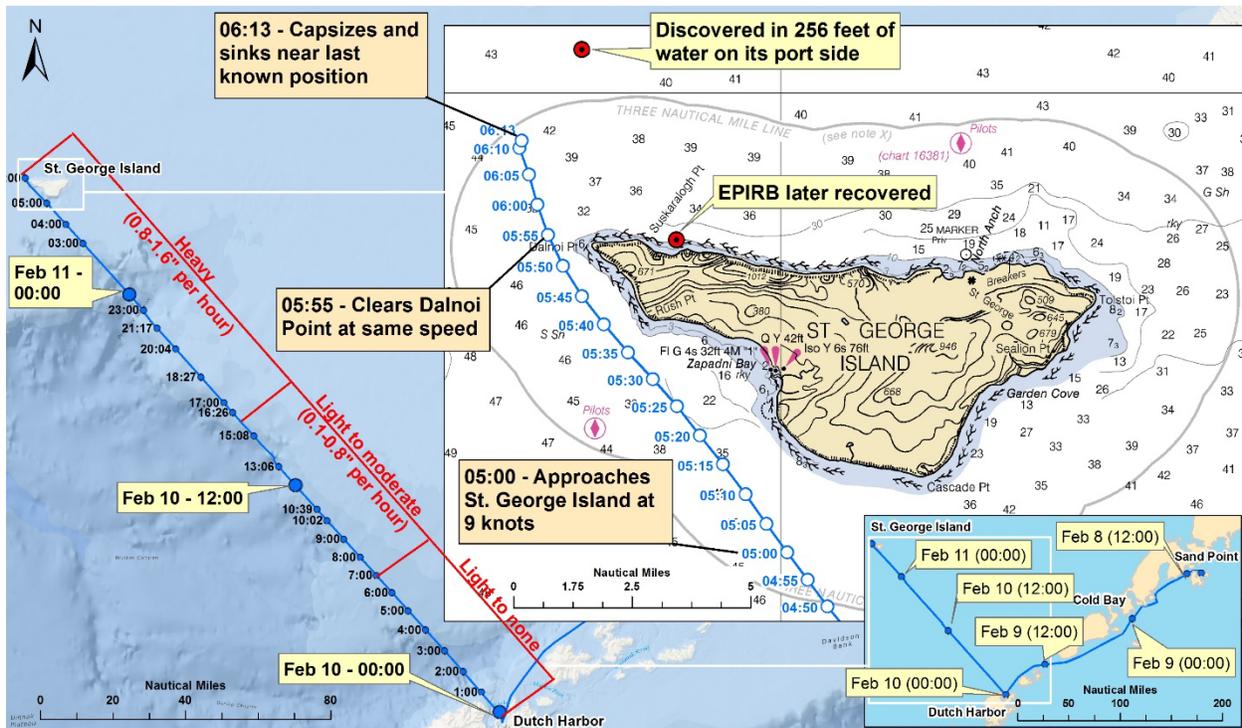
AI5 trackline of the *Destination* leading up to the site of the sinking on February 11. From left to right: (1) estimated rates of icing along the voyage from Dutch Harbor to St. George Island; (2) last 83 minutes of the transit west of St. George Island, where the EPIRB was later recovered nearby; and (3) positions and corresponding times for the vessel's passage from Sand Point through Cold Bay and Dutch Harbor to ultimately St. George Island near where the vessel was discovered in 256 feet of water (42 fathoms). (National Oceanic and Atmospheric Administration [NOAA] chart 16381)

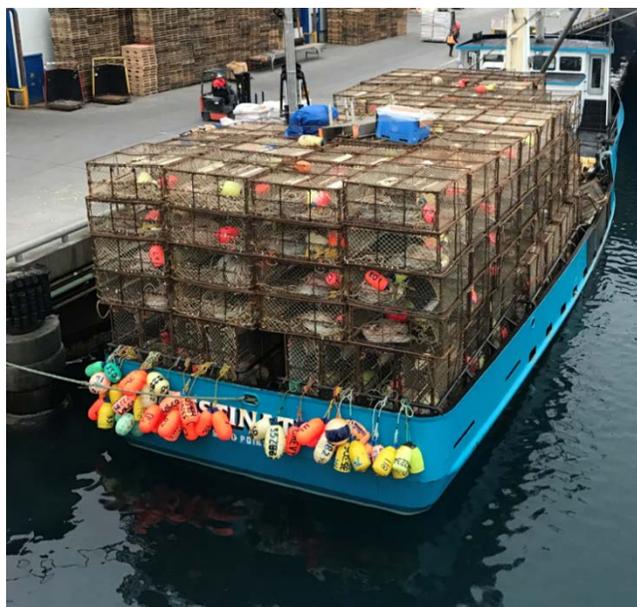
Although the *Destination* could carry a maximum of 224 pots per its stability instructions booklet, former crewmembers said that the captain nearly always carried 200 pots. The pots were stacked in five tiers: those in the first tier were stored on their sides, which left space for a 3-foot-wide-by-7-foot-high tunnel down the centerline of the vessel; the other pots in the four tiers were stacked horizontally, four across and approximately seven lengthwise. The tunnel allowed the crew access to the following: the manhole covers for wet-well fish hold nos. 1, 2, and 3 located on the centerline; the steering room, through a watertight door from fish hold no. 3; and the mooring cleats on deck at the stern. Two former crewmembers said that fish hold nos. 1 and 2 were typically full, “pressed” with seawater, and that hold no. 3 was empty and uncovered. “We always left the hatch off,” one of them added, in reference to the manhole for hold no. 3. The *Destination*’s stability instructions booklet that investigators reviewed required that the no. 3 hold be empty for the departure condition that most resembled the vessel’s actual departure condition on the accident voyage and advised that “precautions shall be taken to ensure that the tank is completely empty.”

Crab pots that the *Destination* was carrying during its stopover at Dutch Harbor. (Photo courtesy of *Ocean Rover* crewmember)

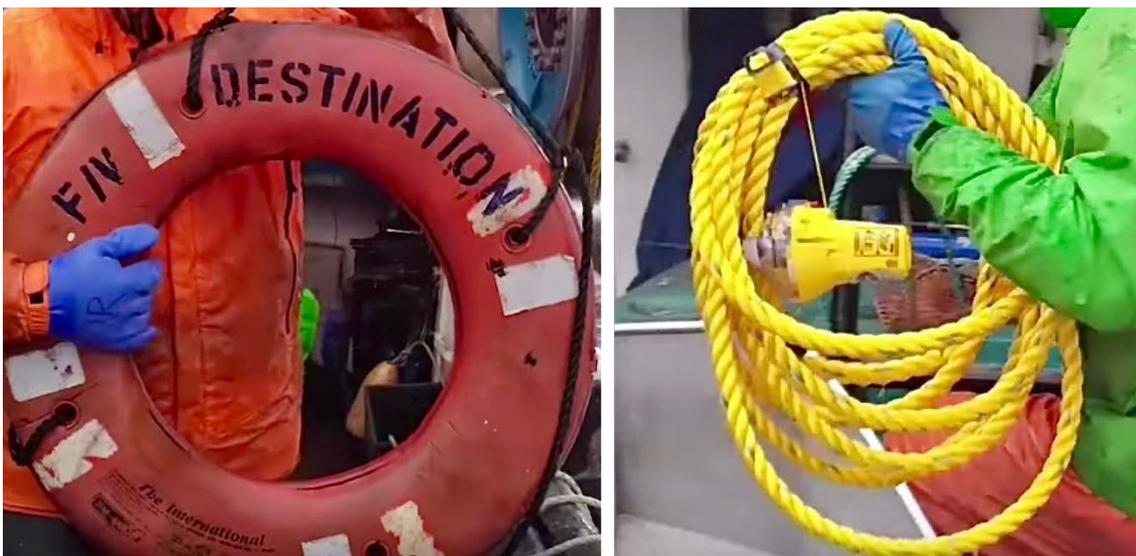
Screenshots from video captured by the *Silver Spray* crew of items recovered from the *Destination*: a life ring (at left), along with a line and the vessel’s EPIRB (at right).

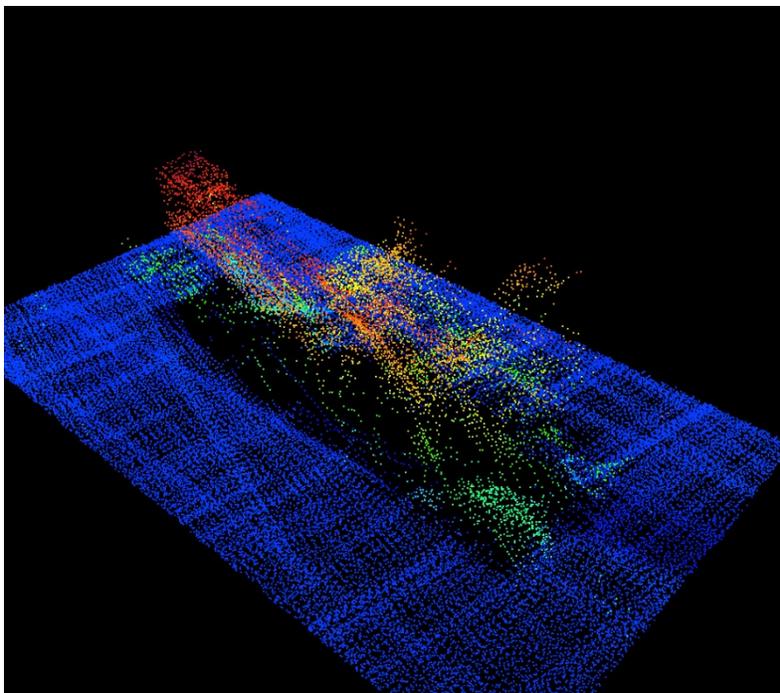
On July 25, the Coast Guard cutter *Healy* deployed a remotely operated vehicle (ROV) to examine the target that NOAA located. The *Destination* was able to be identified but strong subsurface currents prevented the Coast Guard from maneuvering the ROV closer to the vessel for a detailed examination of its hull.

Side-scan sonar image of the *Destination* on its port side. (Image courtesy of NOAA)

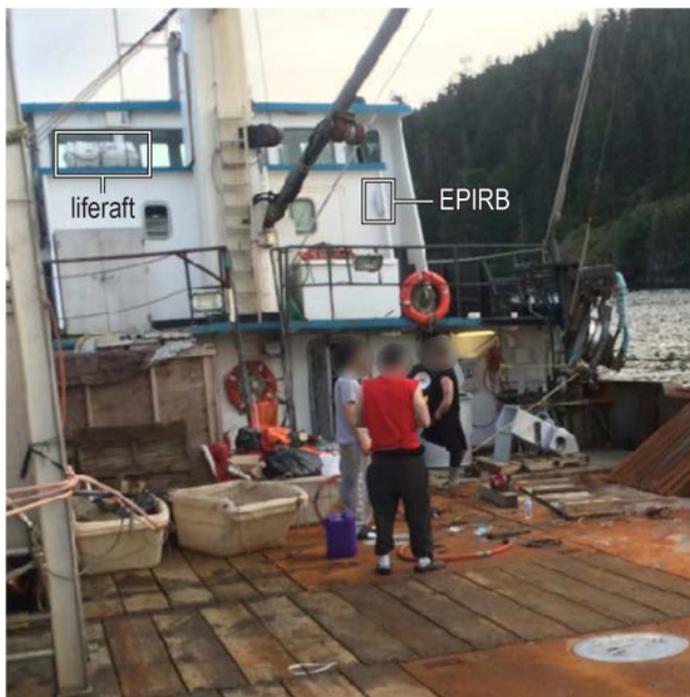
An undated photo of the *Destination* taken by a former crewmember reveals the locations of the liferaft (at left) and EPIRB (at right) that were on board the vessel aft of the wheelhouse.

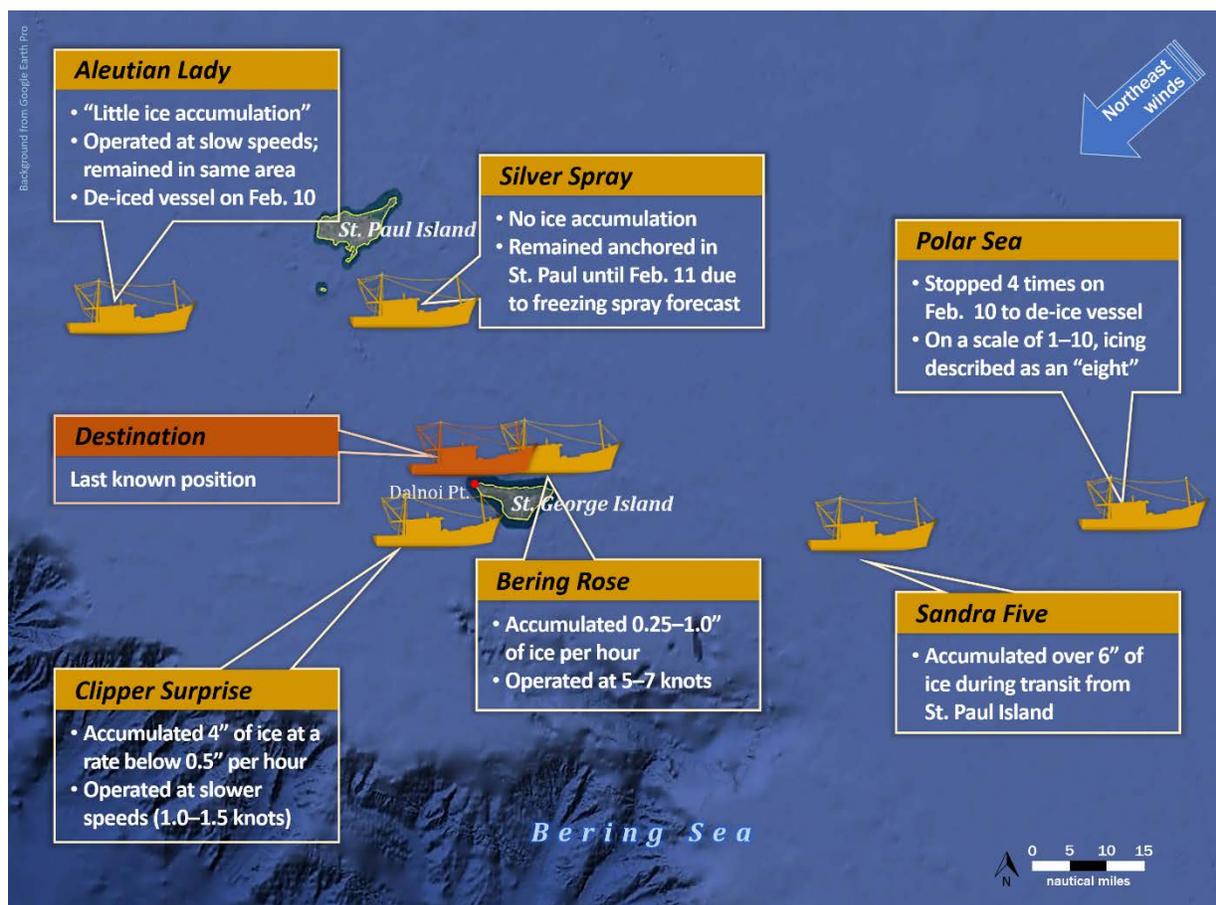
Approximate locations of other fishing vessels near the accident site during the days leading up to February 11.

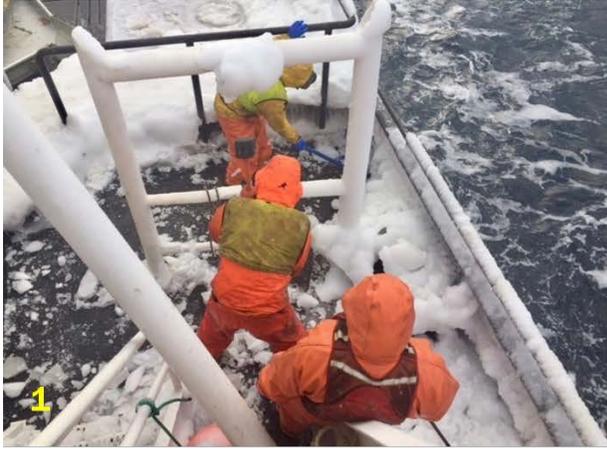
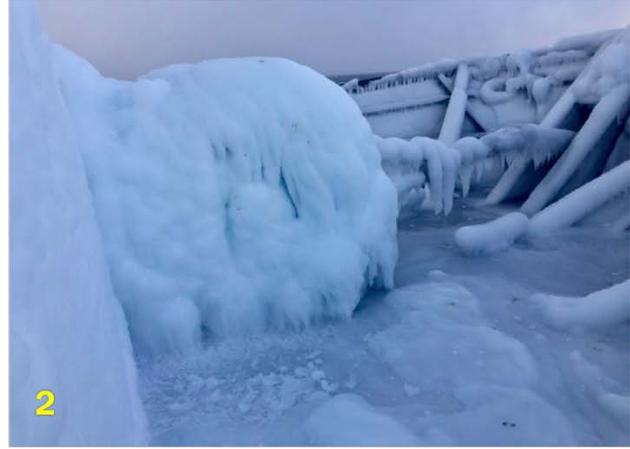
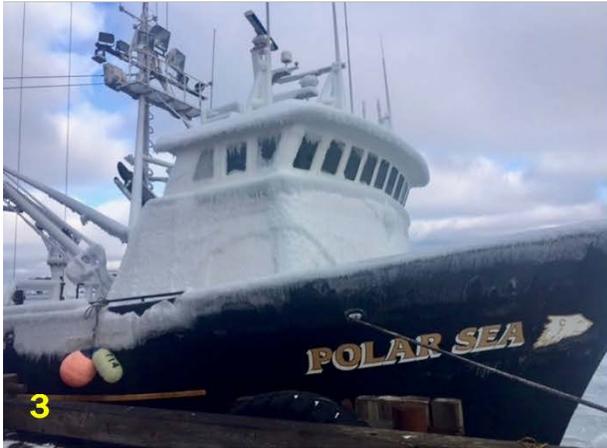
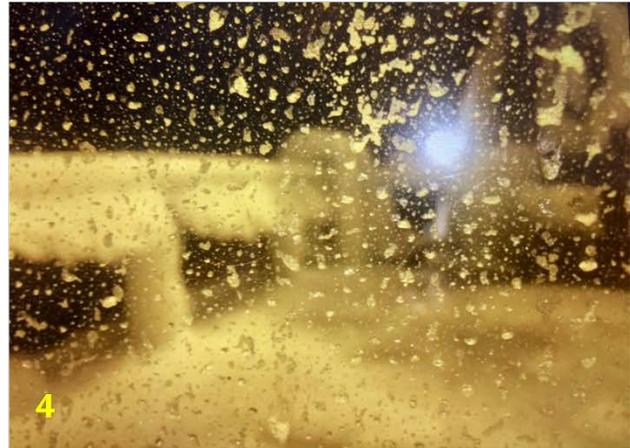
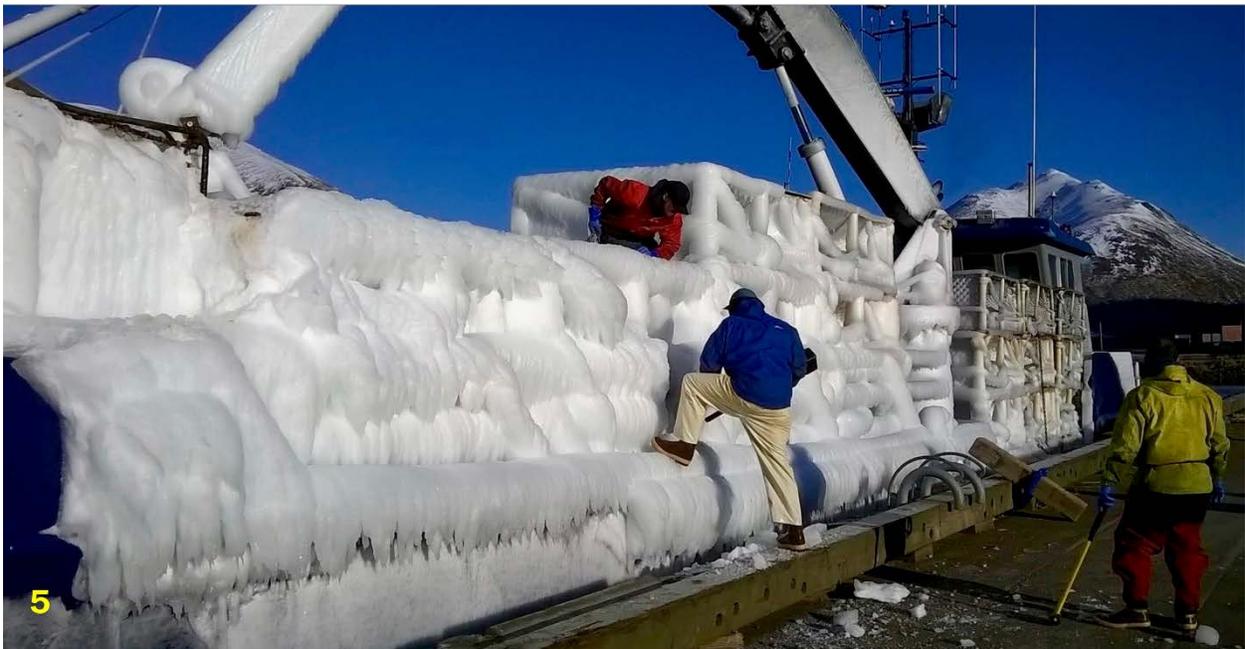
(1, 2, and 3) *Polar Sea*: ice covers the decks and anchor chain during the vessel's transit to St. Paul Island on February 10 and remains on the wheelhouse while it was docked there the following day. (4) *Bering Rose*: accumulation of ice on deck aft of the wheelhouse during the early hours of February 11. (5) *Sandra Five*: while in King Cove on February 12, crewmembers examine the ice that accumulated during their transit from St. Paul Island.

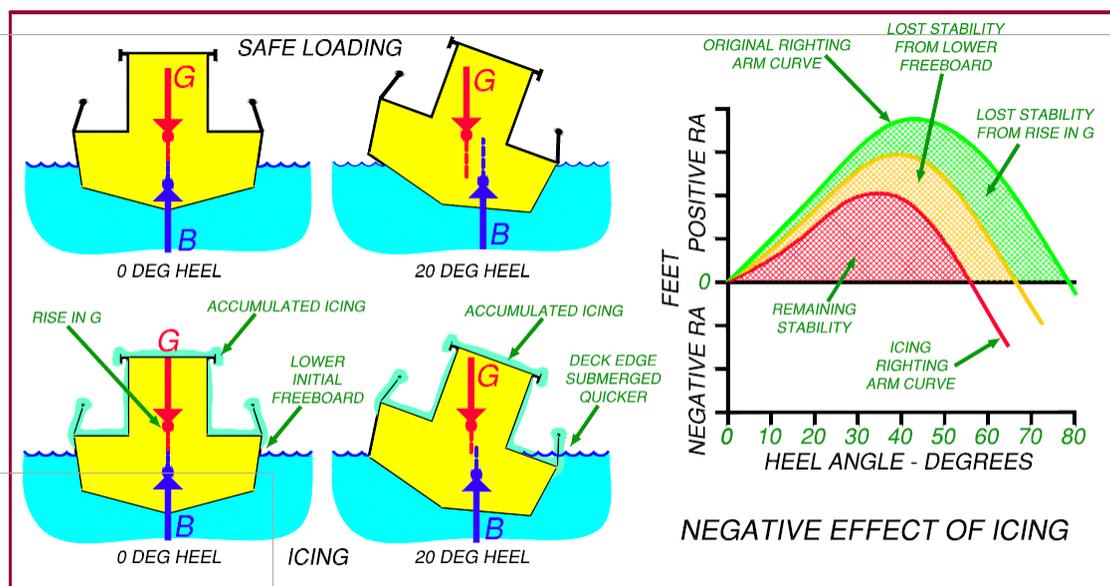
A diagram from the Coast Guard's guide on vessel stability illustrates the negative effect of icing.

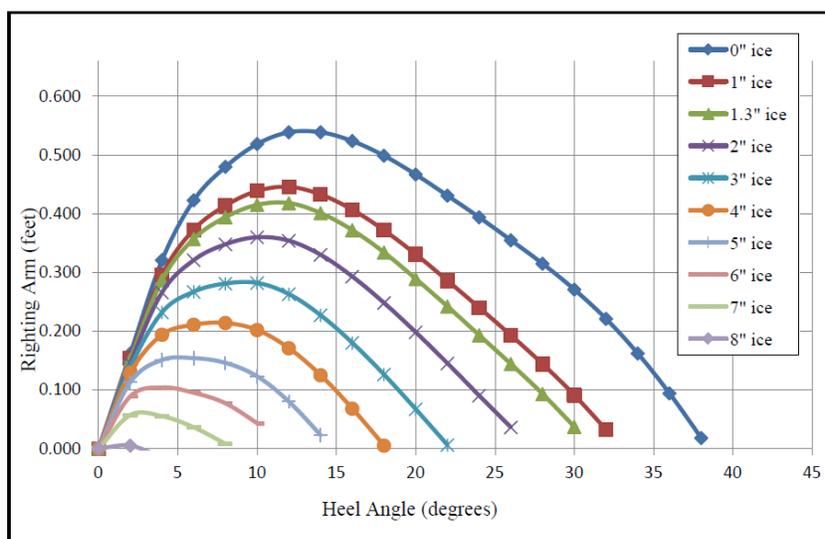
The MSC concluded that the vessel likely capsized in the large seas and winds as it came out of the lee of St. George Island due to prolonged icing conditions adding weight high on the vessel, leaving it with a lower freeboard and a decreased righting arm (lower stability). The AIS position data that indicated a rapid heading change as the vessel left the island’s lee support this capsizing scenario.

Righting arm curves for incremental ice loads calculated by the Coast Guard’s Marine Safety Center for its stability analysis of the *Destination*.
