National Transportation Safety Board

Marine Accident Brief

Grounding and Subsequent Breakup of Dive Vessel *King Neptune*

Accident no.	DCA15LM010
Vessel name	<i>King Neptune</i>
Accident type	Sinking
Location	Avalon Harbor, Catalina Island, California, about 40 nautical miles south-southwest of Los Angeles, California; 33°20.8' N, 118°19.6' W
Date	December 30, 2014
Time	2300 Pacific standard time (coordinated universal time – 8 hours)
Injuries	1 fatality
Property damage	Total loss of vessel, valued at \$1.5 million
Environmental damage	None reported
Weather	Overcast, rain squalls, northeast winds gusting to 39 knots, air temperature 40°F, water temperature about 60°F
Waterway information	Small, shallow bay on southeast Catalina Island

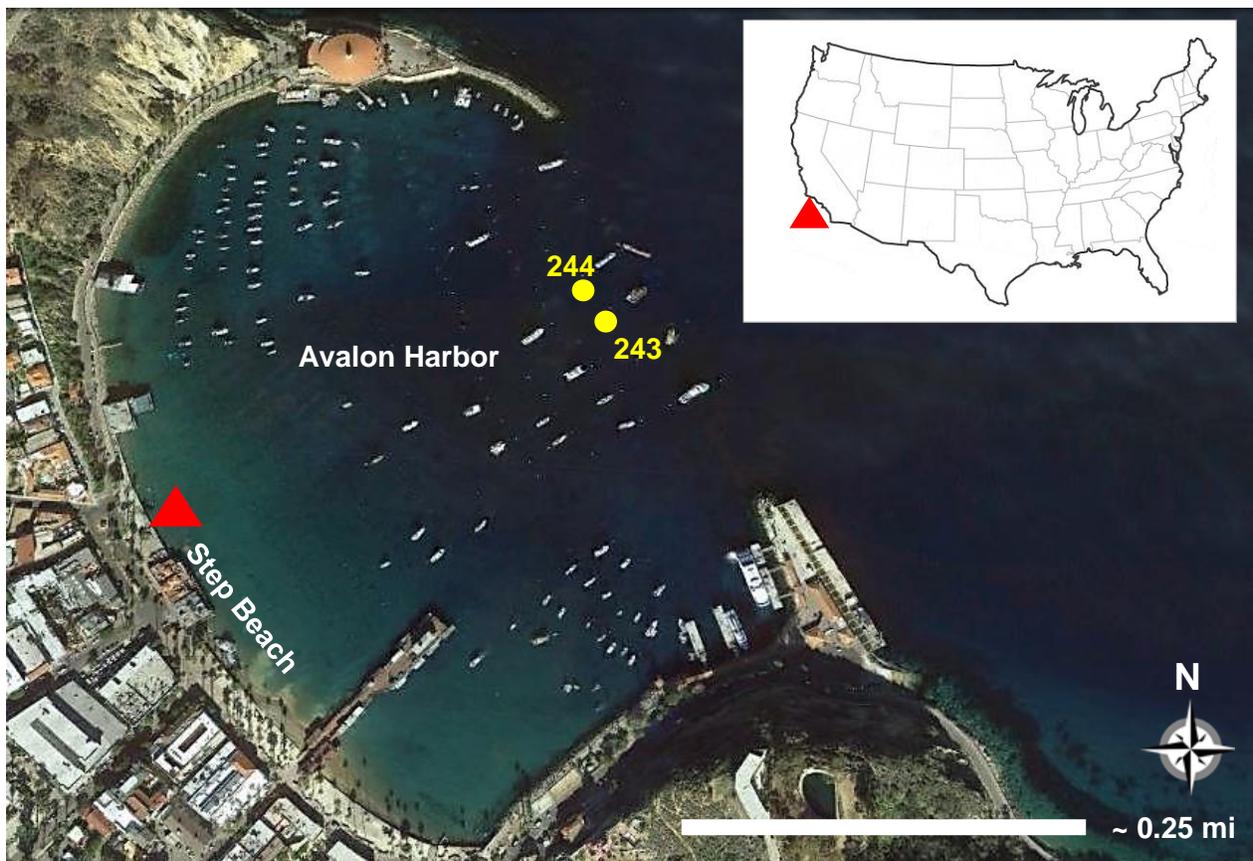
Aerial view of Avalon Harbor. The approximate locations of mooring buoys 243 and 244 are overlaid by yellow dots. The approximate site of the patrol officer's death and the vessel breakup is marked by a red triangle. (Background by Google Earth)

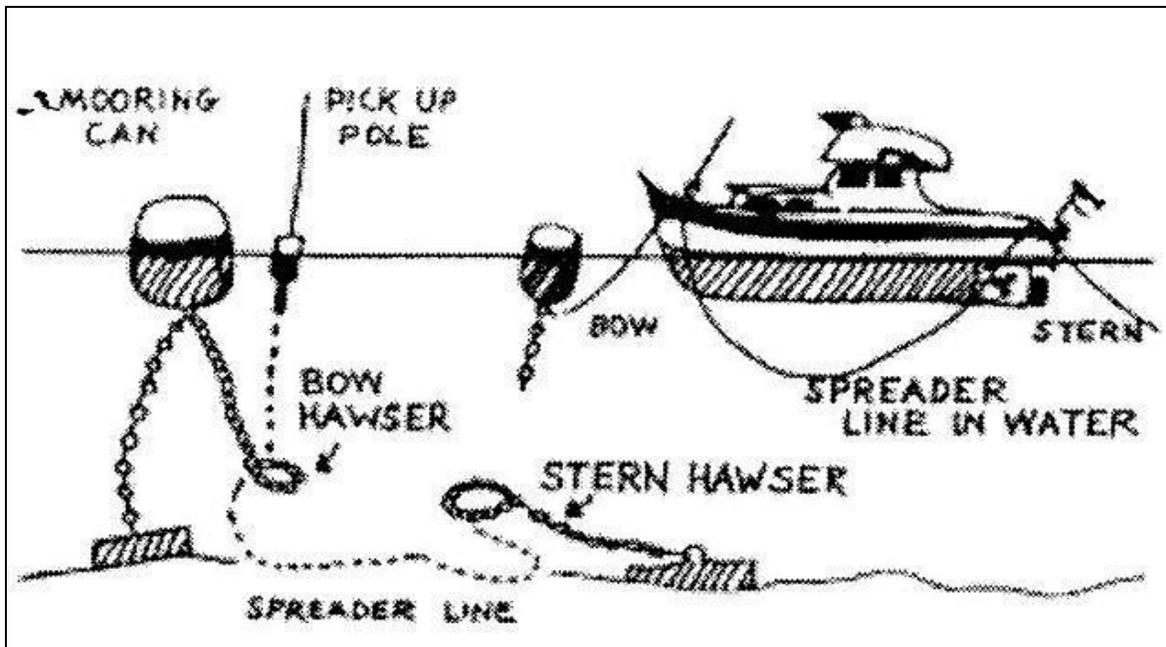
The Avalon Harbor Department recommended that boaters moor their vessels by securing the loop (“eye”) of the harbor-provided 1-inch-diameter mooring line (“hawser”) to the deck of the vessels. According to a *King Neptune* deckhand, the crew varied this method by passing one of the vessel’s dock lines through the eye of the bow hawser (similar to “threading the eye of a needle”) and then securing the end of the dock line back onto the vessel. The stern was secured in a similar manner as the bow; that is, the harbor-recommended method was again varied by securing the vessel’s dock line to the deck of the vessel after the line was first passed through the stern hawser’s eye. Boaters would sometimes use this variation to facilitate releasing from, or letting go of, the moorings on departure.

Mooring arrangement similar to that used by the *King Neptune* on the day of the accident. (Diagram provided by the Avalon Harbor Department)

About 1400, the part-time captain and the deckhand placed an additional bow line and stern line, in the same manner used at mooring buoy 243, to the adjacent hawsers at mooring buoy 244 and notified the owner. According to the deckhand, none of the vessel's dock lines had chafing gear (an expendable cover material placed around lines to prevent friction wear), and the places on the vessel to secure the bow lines were two cleats attached to the closed chocks. Closed chocks are openings in a vessel's side above the waterline that form a complete closed circle, allow the passage of lines, and reduce (but not eliminate) chafing. On the *King Neptune*, the closed chocks were built into the fiberglass hull. (The photo below shows a combination chock/cleat recovered from the *King Neptune* wreckage.)

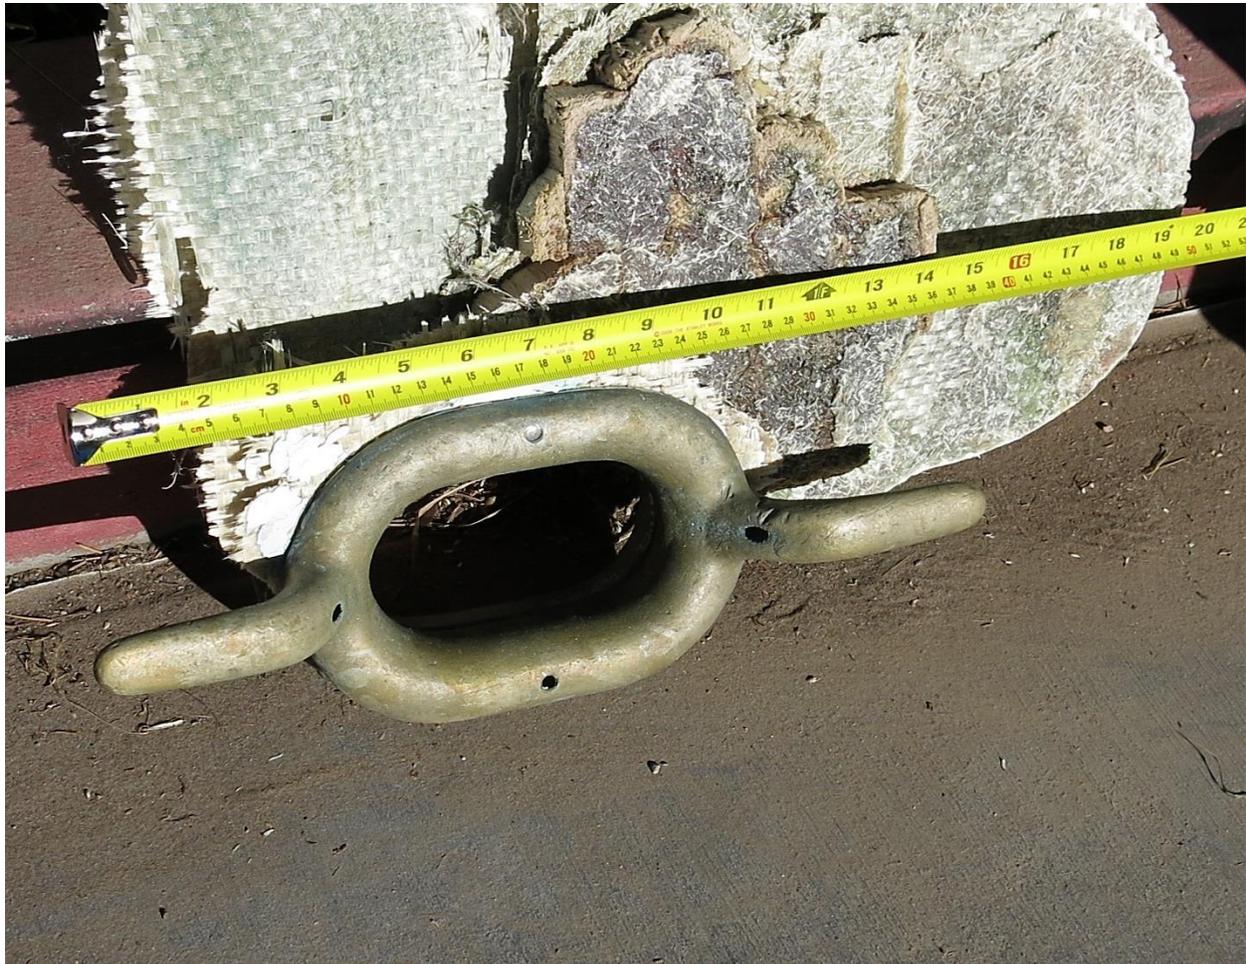
A combination closed chock/cleat arrangement recovered from the bow of the *King Neptune*.

Although vessels in Avalon Harbor had previously broken their moorings during inclement weather, neither the city of Avalon harbor regulations nor the Avalon harbor master had any specific guidance addressing safe mooring in inclement weather or the use of chafing gear on mooring lines. A postaccident inspection of mooring buoys 243 and 244, to which the *King Neptune* was moored, found the hawsers intact and the anchors in position. The *King Neptune* crew modified the recommended mooring arrangement by using the vessel's own dock lines to make fast (attach) to the provided mooring hawsers. The harbor master told investigators he was aware that some people used their own lines to tie up to the moorings so that the vessels could let go easily on departure. However, he also stated that no requirements or specifications existed to ensure that the lines used were of equal or greater strength than the provided mooring hawsers. Although it could not be determined whether the *King Neptune* mooring lines parted or the entire bow ground tackle (plate to which mooring equipment was attached) broke away, the failure occurred somewhere in the vessel's own mooring equipment.

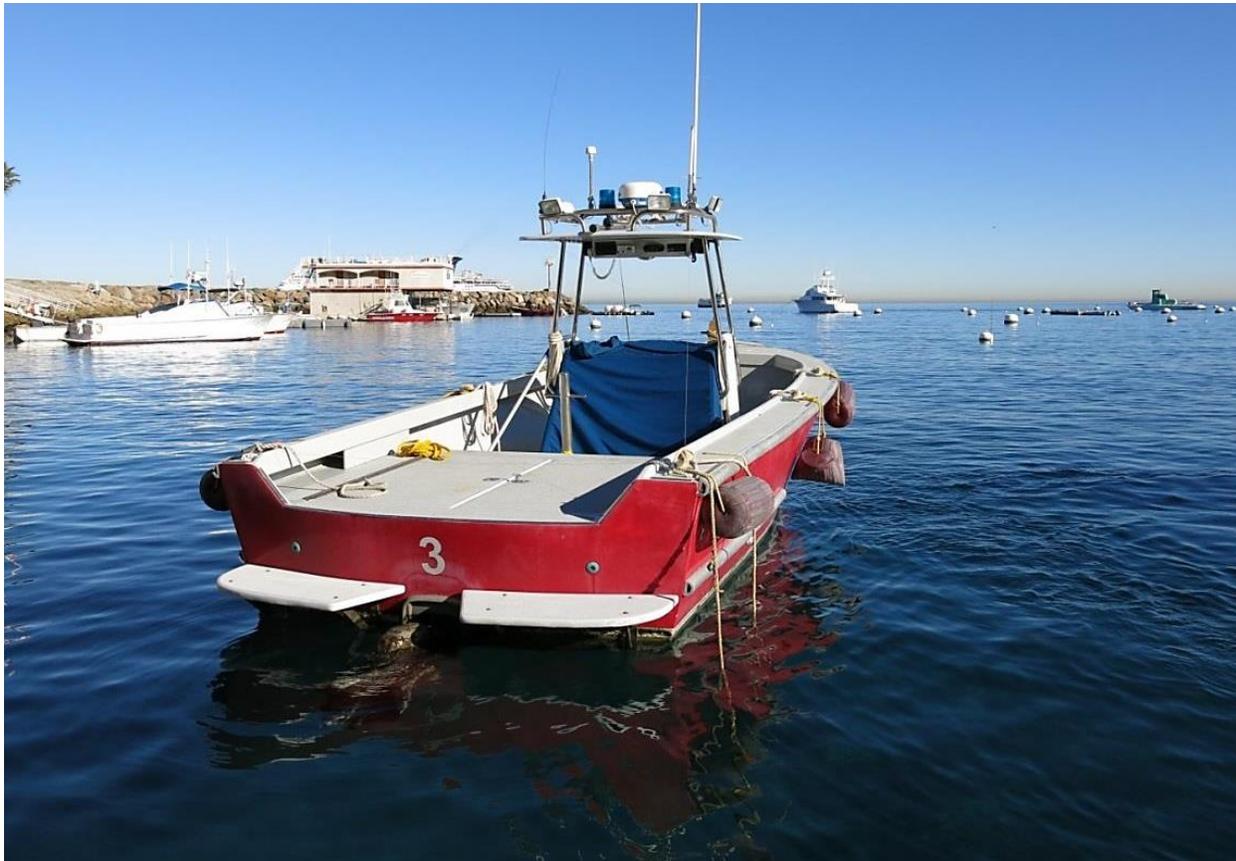
Patrol boat 3 after the storm. Mooring buoys similar to the ones to which the *King Neptune* was secured can be seen in the background.

In addition, the patrol boats responding to the emergency were of inadequate size and power to effectively tow the *King Neptune*. Witness statements questioned the feasibility of a much smaller harbor patrol boat towing a much larger vessel in severe weather conditions; one patrol boat captain believed "having any luck" towing the *King Neptune* was a "fantasy." Nevertheless, attempts were made to tow the *King Neptune* "because towing [other] vessels was what we [patrol boats] were sent to do." Finally, although anchors are often used to slow or arrest a vessel's drift, the *King Neptune* anchor was not deployed during the emergency.

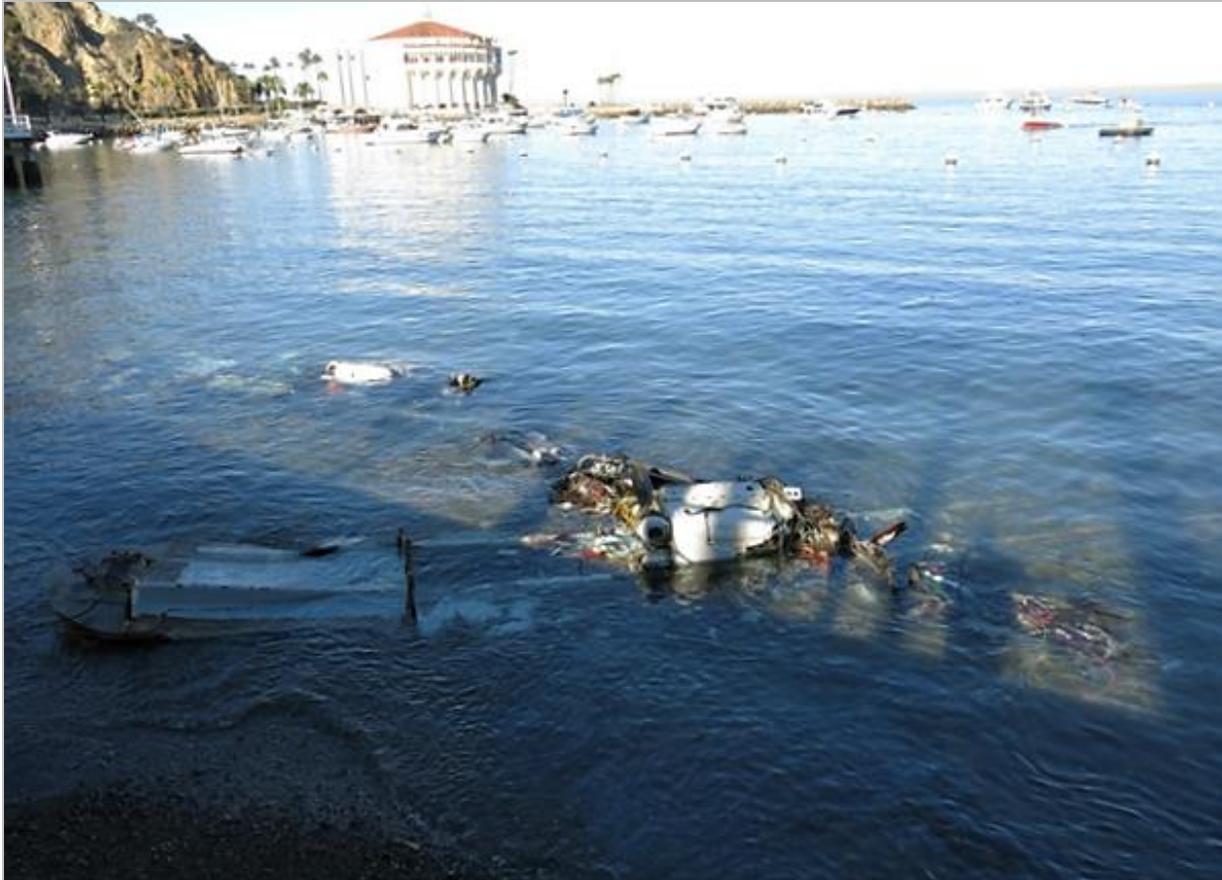
All that remained of the *King Neptune* after a night of constant pounding against the seawall was a partially submerged hull and engines. Vessel debris was strewn about the harbor bottom, shoreline, and road near Step Beach. The vessel was a constructive total loss.

Beached wreckage of the *King Neptune*.
