Marine Accident Report

**Sinking of the Amphibious Passenger
Vehicle *Miss Majestic*, Lake Hamilton,
Near Hot Springs, Arkansas, May 1, 1999**

NTSB/MAR-02/01
PB2002-916401
Notation 7222B
Adopted April 2, 2002

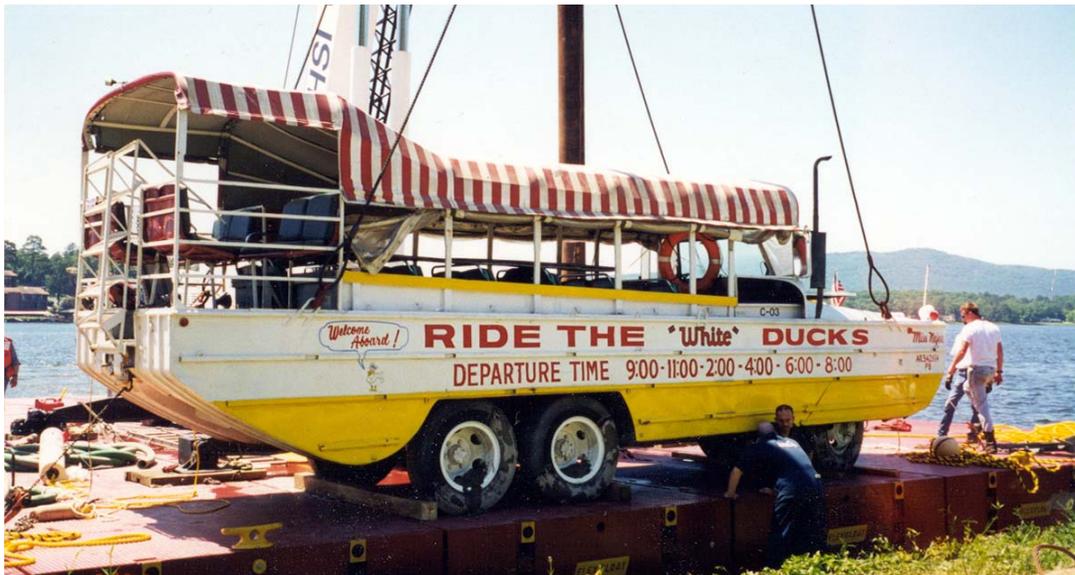
Figure 1. The *Miss Majestic*. When the DUKW was converted for commercial passenger service, a steel frame was installed around and over the passenger compartment. The *Miss Majestic* had a vinyl canopy over the frame to protect passengers from the weather.

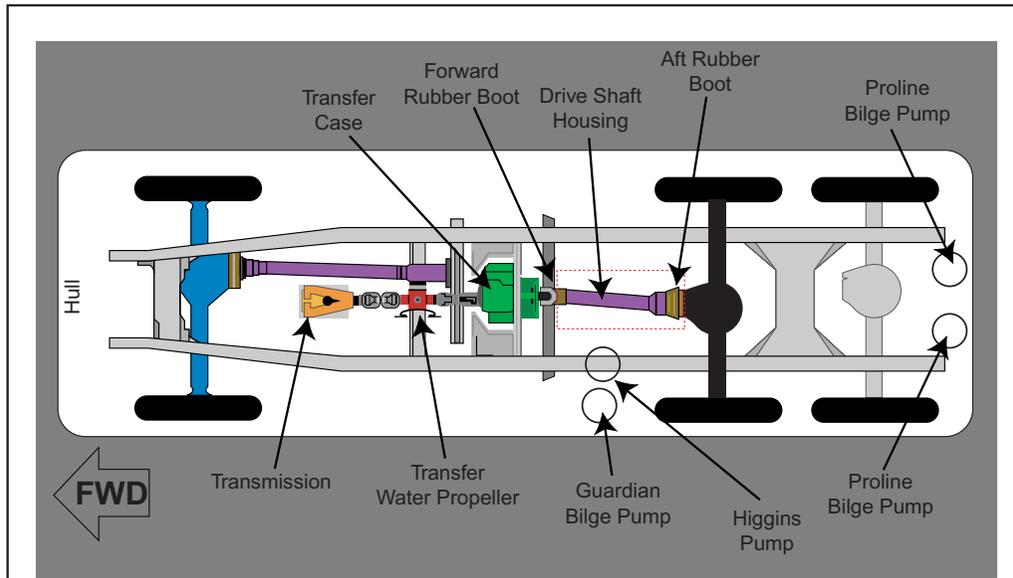
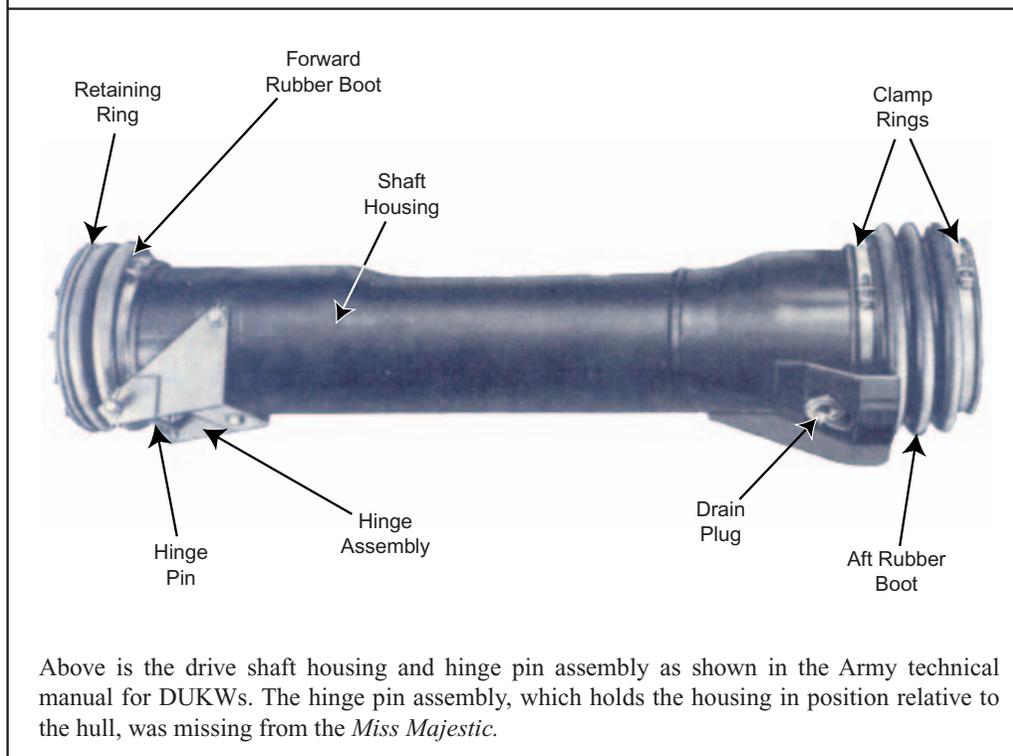
After the mechanic examined the vehicle and determined that the source of the leak was a tear in the forward rubber boot³ on the rear driveshaft housing (figure 2), the operator drove the *Miss Majestic* to Hot Springs, where she completed the land tour and dropped off passengers. She then drove the *Miss Majestic* to the company garage for repairs.

Plan view of the *Miss Majestic's* drive shaft and chassis assembly. The area indicated by a dotted line includes the drive shaft and its rubber boots, which were designed to provide a waterproof seal for the drive shaft's penetration into the hull.

Above is the drive shaft housing and hinge pin assembly as shown in the Army technical manual for DUKWs. The hinge pin assembly, which holds the housing in position relative to the hull, was missing from the *Miss Majestic*.

Figure 2. Top illustration shows the *Miss Majestic's* assembly and the approximate locations of the Higgins pump and the three electric bilge pumps. Bottom illustration shows a side view of the driveshaft housing and components as designed by the Army.

On April 30, at the garage, the maintenance mechanic began work after 1200⁴ on the *Miss Majestic* after conducting daily checks on three other DUKWs that were being used for tours that day. To repair the leak, he replaced the forward boot with a rubber boot that had been obtained from sources such as Army surplus. In the course of making the repair, he discovered a small tear in the aft boot for the rear driveshaft housing; however, he did not have time to replace the aft boot before the end of his workday. The next morning, the day of the accident, the mechanic replaced the aft boot with a previously used boot. The *Miss Majestic* was then returned to service.

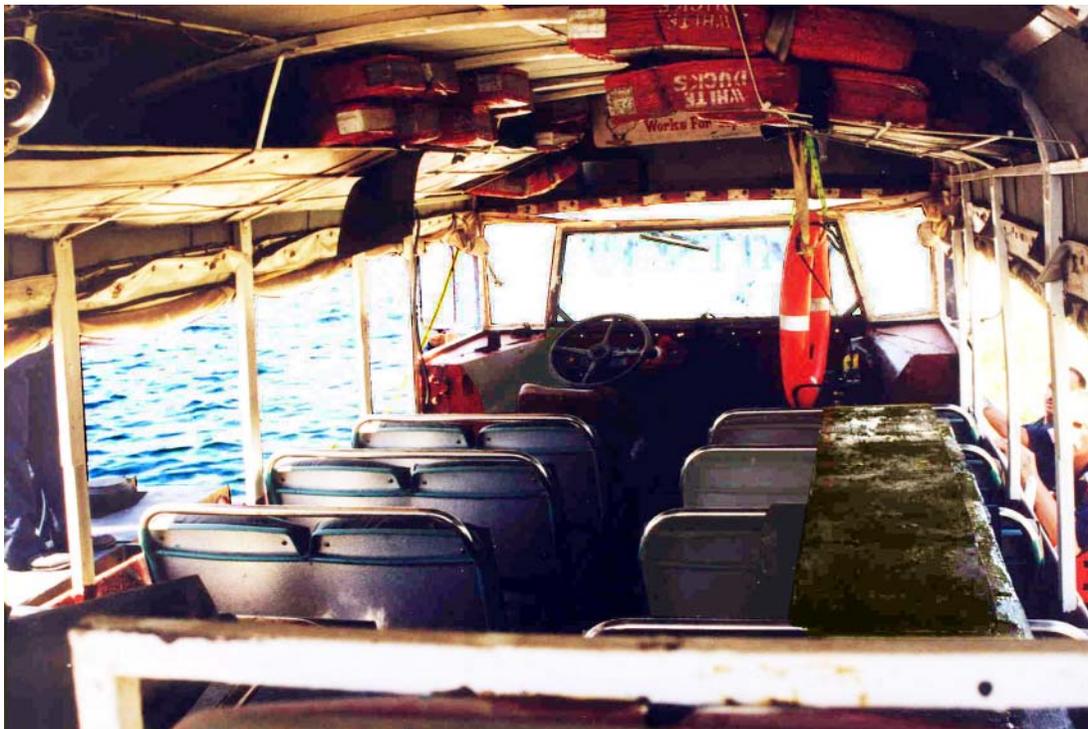
While briefing the passengers about the lifejackets, the operator tried to pull one out of the storage rack (see figure 3) to demonstrate how to don it. When she could not pull a lifejacket free, the operator gave up trying.⁶ According to passengers, as the operator retook her seat at the forward part of the vehicle, she pointed to the lifejackets and said, “They’re up there.” The passengers said that the operator neither offered lifejackets to anyone nor explained how to get off the vehicle in case of an emergency on the water.

Figure 3. Postaccident view of the *Miss Majestic*'s main passenger compartment looking forward from the aft seating area. The lifejackets were stored in open racks above the passengers' seats.

⁶ Safety Board investigators examined other DUKWs belonging to the company and found the lifejackets jammed tightly into the storage racks.

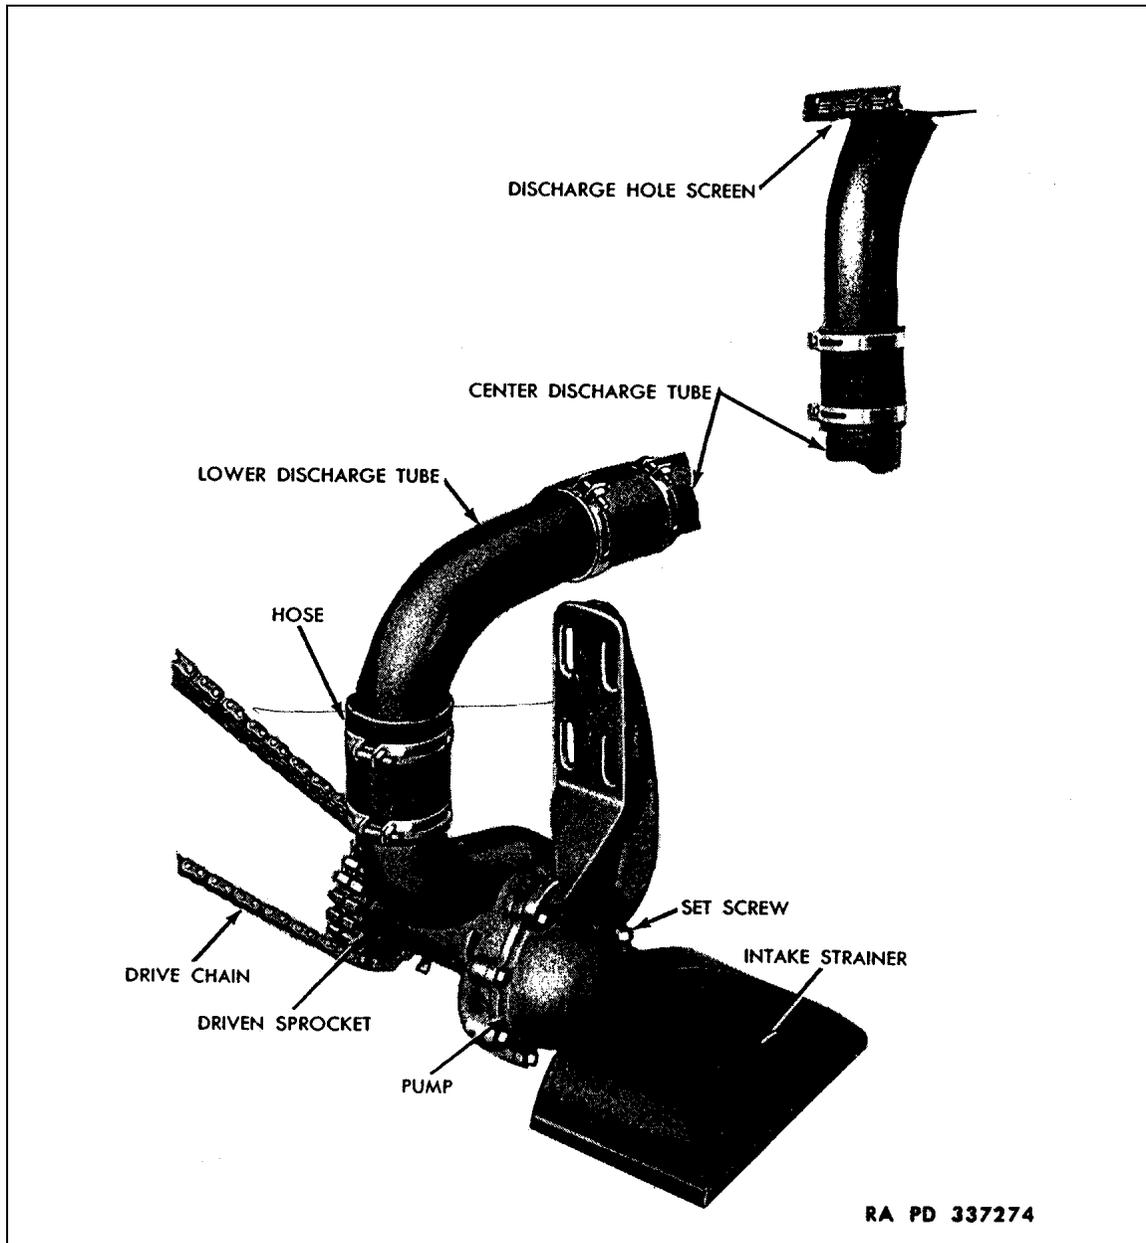
propeller driveshaft through a keyed sprocket on the pump shaft and operated whenever the propeller's driveshaft was engaged. (See figure 5.) The Higgins pump discharged straight upward and overboard through an opening on the port side gunwale, near the second row of seats.

Figure 5. The Higgins pump arrangement. The centrifugal-type, bronze pump had a 4-bolt mounting bracket, which, in the case of the Miss Majestic, attached the pump onto the port longitudinal girder (channel) under the passenger compartment. The face of the pump's intake (suction) strainer was about 1 1/2 inches above the bottom of the vehicle. The 2 1/2-inch-diameter discharge pipe extending upward from the pump had three sections: a lower discharge tube, a center discharge tube, and an upper discharge tube. A short section of hose with clamps connected the lower discharge tube to the pump discharge.

Higgins Pump. Safety Board investigators found that the key attaching the pump shaft to its drive chain sprocket was missing. The sprocket appeared old and had excess play on the pump shaft. Investigators noted that the play in the sprocket allowed the drive chain to rub against the hull frame; they also observed several abrasion marks on the frame. The pump impeller turned freely at the time of the examination. Investigators found that a 1 ½-inch portion of an impeller blade's leading edge was sheared off.

Higgins Pump: The pump suction strainer is attached to the intake flange of the pump's housing by a setscrew. The intake flange of the housing for mounting the suction strainer showed two sets of setscrew marks, about 90 degrees apart. Each set of marks contained multiple circular impressions from multiple contacts with the setscrew. The strainer body showed a brazed repair around the square headed setscrew.

The pump's driving sprocket is attached to the pump shaft by 2 screws: one that screws down on a key between the sprocket and shaft and another that screws down on the shaft. The socket screw heads were cracked or rounded from over tightening.

The driving sprocket was found to be installed with the sprocket hub facing toward the pump. The Army Maintenance Manual TM-9-803 shows that the sprocket should have been installed with its hub facing away from the pump. One side of the sprocket teeth was discolored compared to the other, suggesting that one side was kept clean by the chain due to misalignment of the sprocket.

A section of an impeller blade was found missing, and the tips of the two remaining ones were damaged. The roots of the blades were cracked. The inside of the impeller housing showed discolored rub markings.

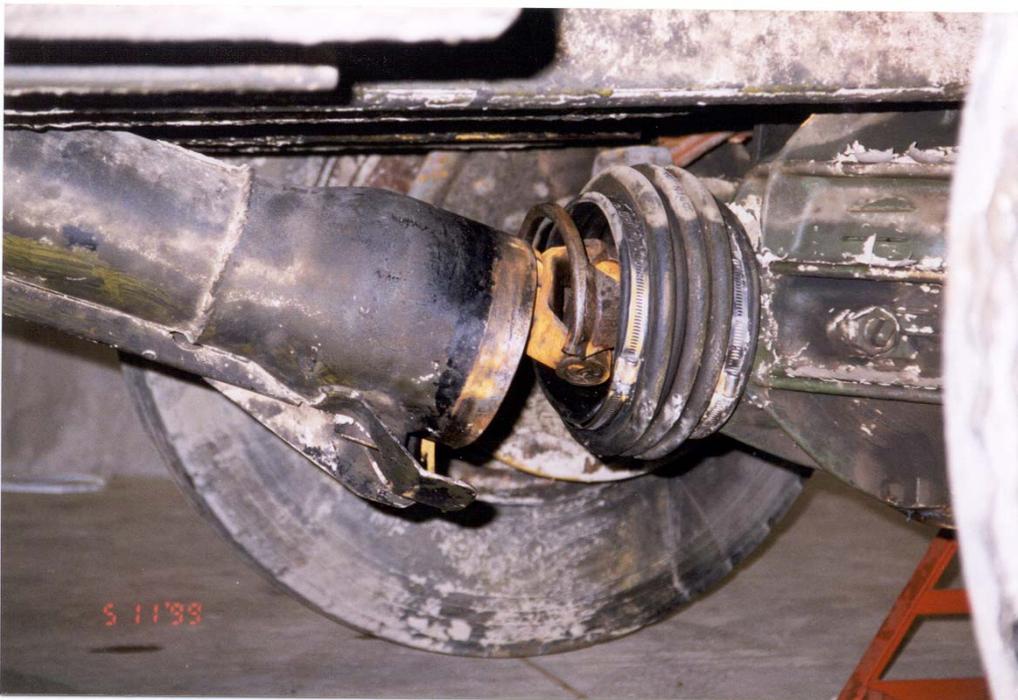
Driveshaft Boots. Shortly after the *Miss Majestic* was salvaged from Lake Hamilton, Safety Board investigators found that the aft rubber boot had separated from the rear shaft housing. (See figure 6.) Upon attempting to replace the boot on the housing, investigators found that the hose clamp holding the rubber boot onto the aft shaft housing was sufficiently loose to enable them to turn the boot by hand. Investigators were able to reclamp the boot onto the housing by tightening the hose clamp screw with two to two and a half turns of a screwdriver. The hose clamp securing the boot on to the differential was tight.

Figure 6. Postaccident view of the rear driveshaft boot.

Investigators found that the hinge pin assembly bracket at the forward end of the shaft housing had been removed.

He said that the leaking forward rubber boot that he replaced before the accident had dry-rotted and cracked. While replacing it, he noticed that the aft boot was also torn, so he replaced that as well. He stated that, during his current and previous period of work

with Land and Lakes, he had replaced numerous boots. He had found that most boot leaks and failures had resulted from dry rot and cracking from age.

Rubber Boots. The Safety Board also examined the rubber boots and observed that the rear boot that slipped off the housing had patches of dull green paint with a pattern of cracks. Multiple circumferential lines adjacent to the clamp suggest numerous installations of a hose clamp on this seal. The forward seal for the housing also showed imprints of numerous previous installations of a hose clamp.

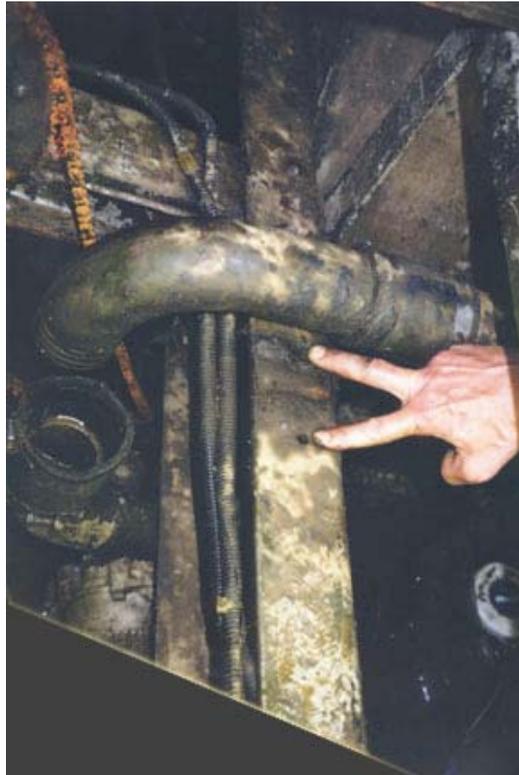
The overboard discharge pipe had separated from the hose connecting it to the pump discharge. The hose was rotted. The U-clamp that secured the discharge pipe to the chassis girder was missing. (See figure 7.)

Figure 7. The discharge hose of the Higgins pump was broken and missing the U-clamp that connected the pump to a chassis girder of the vehicle.
