National Transportation Safety Board

Marine Accident Brief

Capsizing and Sinking of Towing Vessel *Ricky Robinson*

Accident type	Capsizing/Listing	No. DCA18FM007
Vessel name	<i>Ricky Robinson</i>	
Location	Lower Mississippi River, mile 732.8, near Memphis, Tennessee 35°07.11' N, 090°06.50' W	
Date	December 8, 2017	
Time	1126 central standard time (coordinated universal time – 6 hours)	
Injuries	2 fatalities	
Property damage	\$1.5 million est.	
Environmental damage	Approximately 200 gallons of fuel oil released into water	
Weather	Clear skies, visibility 10 miles, winds northeast 5–10 knots, air temperature 36°F, water temperature 52°F	
Waterway information	The river stage of the Lower Mississippi River near the accident site was approximately 2 feet and falling, and the current was approximately 3–4 mph.

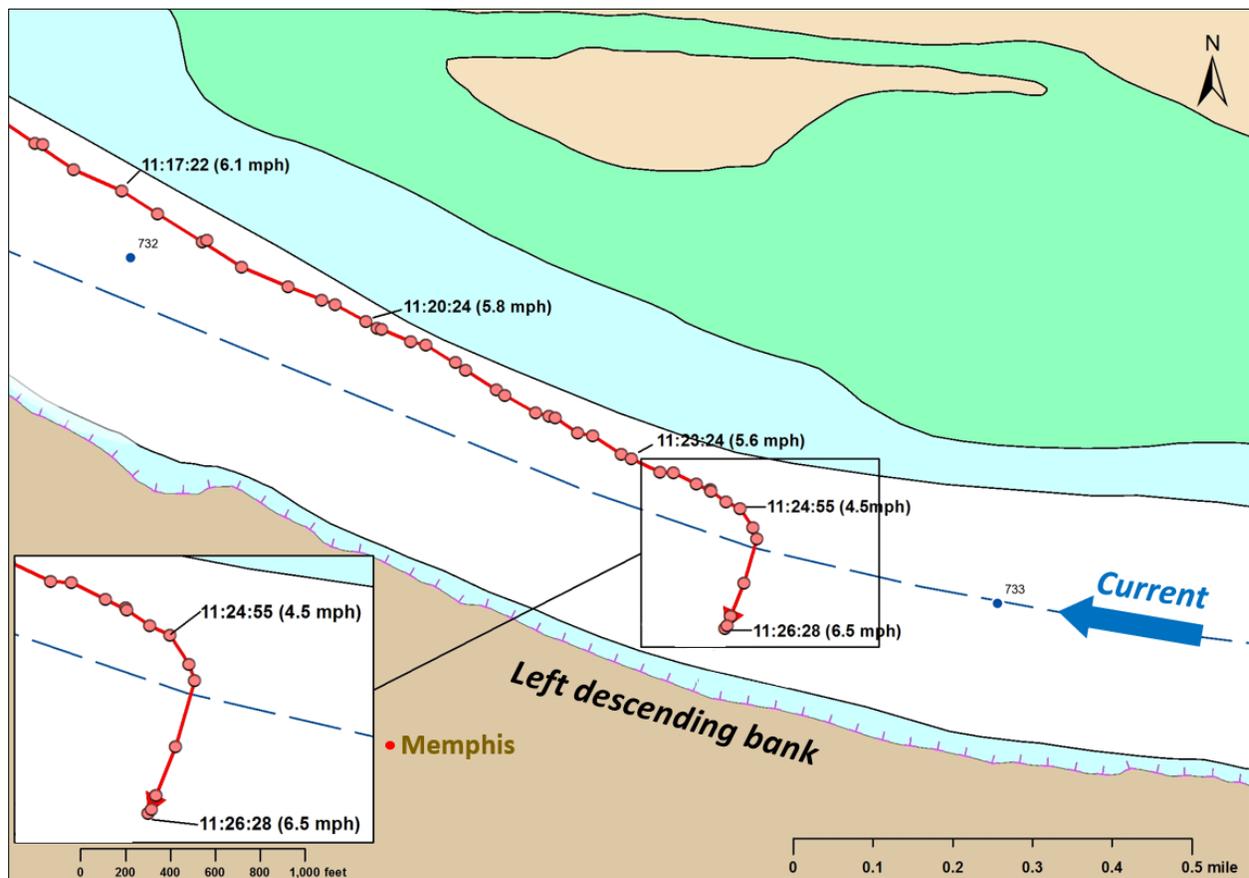
Trackline of *Ricky Robinson*, illustrated with red line, over its last 10 minutes reveals towing vessel's sudden turn to left descending bank just before sinking. (Background from Google Earth)

About 2 minutes before the last position was transmitted from the *Ricky Robinson*, there was an abrupt turn to starboard and a decrease in speed to approximately 4.4 mph. As the current changed from ahead to the port beam, the vessel's speed exceeded 7 mph. The sudden turn was likely the pilot's attempt to beach the flooding vessel, as suggested by his two distress calls stating that he was taking on water, most likely due to water entering the aft voids through the open or unsecured hatch covers.

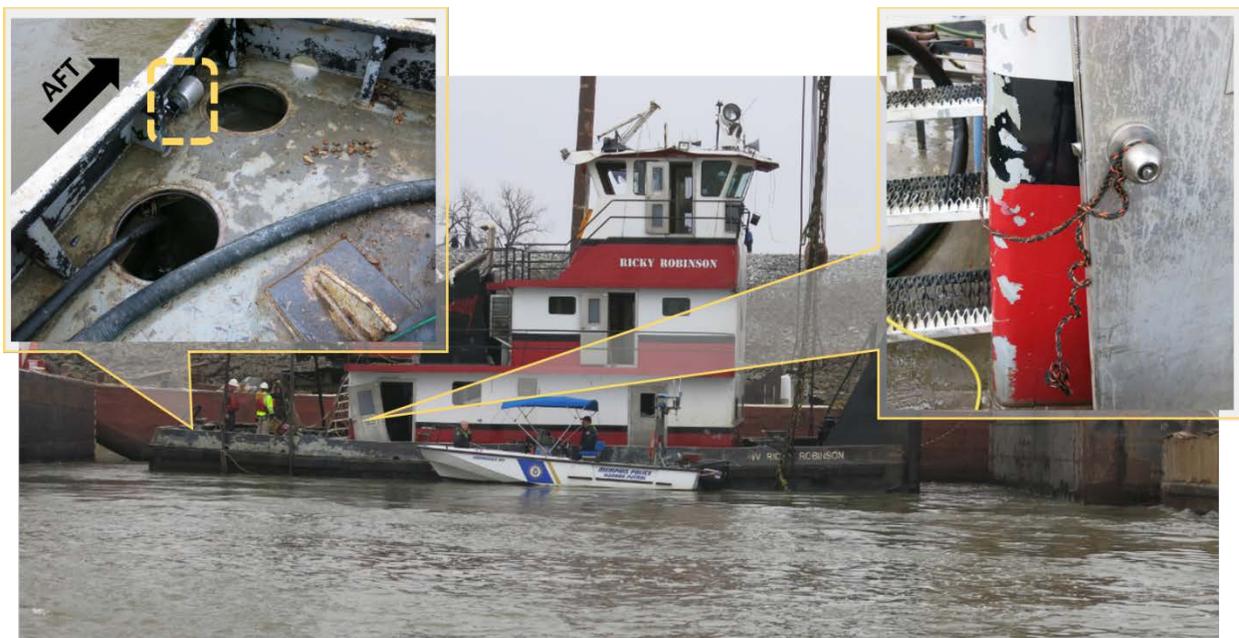
***Ricky Robinson* post-salvage. Two inset photos show, at left, both aft voids missing hatch covers, with a yellow square highlighting where submersible pump was found, and, at right, open starboard engine room door tied off to stairs.**

Although the witness who last saw the *Ricky Robinson* reported seeing both engine room doors open, only the starboard-side door was found open; it had been tied back with a rope to the stairs. All other main deck doors were found closed. The port- and starboard-side hatches for the aftermost and forward stern voids were open and all missing their covers (four covers total). There was no evidence of impact or mechanical damage around the coamings. All other hatches for fuel and water tanks were closed. While the vessel was floating, there were no leakages observed from the hull, the propeller shaft seals, or the engine cooling water system on both sides of the vessel. There was an electric submersible pump found on the starboard aft deck next to the bulwark with both cable and hoses severed.

One probable source of internal water ingress into the forward stern void was the potential leakage from a steering rudder tube that passed through the void or from a corroded, missing, or broken weld for the tube. Externally, the water could have entered either through the rudder post top seals on the aft main deck, over the bow while the vessel was traveling against the current, or onto the deck when it submerged. There were no indications of damage to the hatch covers or evidence of them being forced out during sinking, nor were they removed by the salvors. Therefore, it is likely that the four hatch covers for the two aft voids were either left open or not

properly secured at the time of the sinking. Water on deck would have entered the stern voids if the covers were not properly secured.

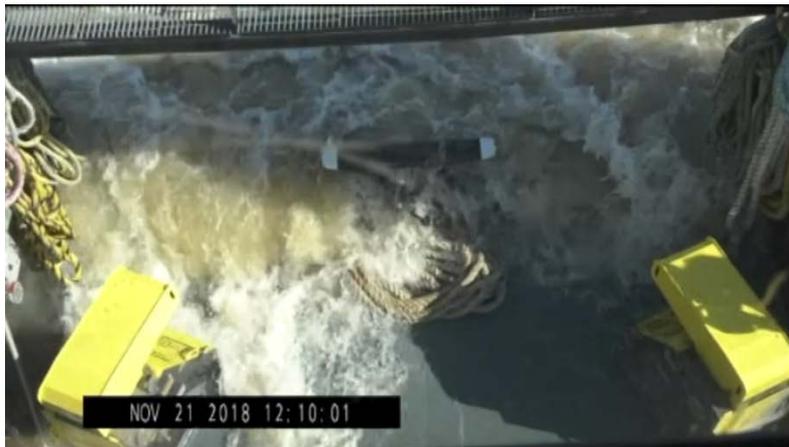
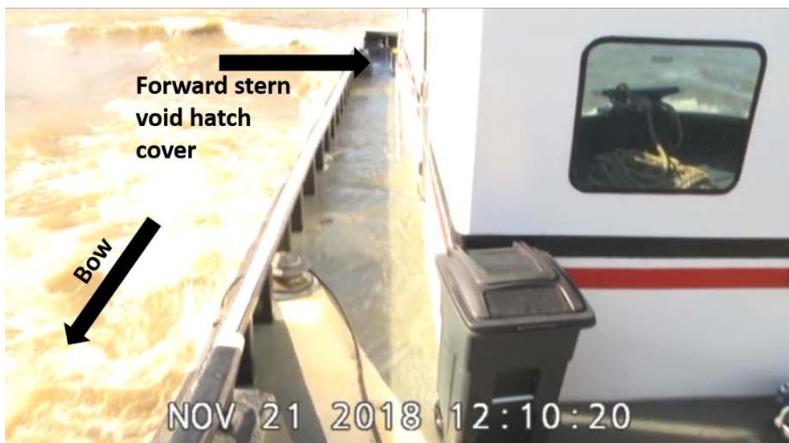
Screenshots from Wepfer Marine video of *Ricky Robinson* in a lightboat condition while heading into two different current speeds. In each instance, when vessel speed increases, the amount of water coming over bow increases.

Based on the company video and interview statements, the *Ricky Robinson* operating in a lightboat condition was at risk of taking water over the bow and thereby introducing water onto the main deck. Water then could travel as far back as the stern, where it could downflood into the tanks and voids through any open or unsecured hatches. At the time of the sinking, the towboat had almost full fuel and water tanks and the aft void was likely flooded, resulting in a lower freeboard. Thus, while the *Ricky Robinson* traveled into a current of 3 to 4 mph at a speed of approximately 6 mph, or nearly 10 mph through the water, as demonstrated in the video, the vessel likely took water over the bow onto the main deck, where it would have flowed aft toward the open stern void hatches.

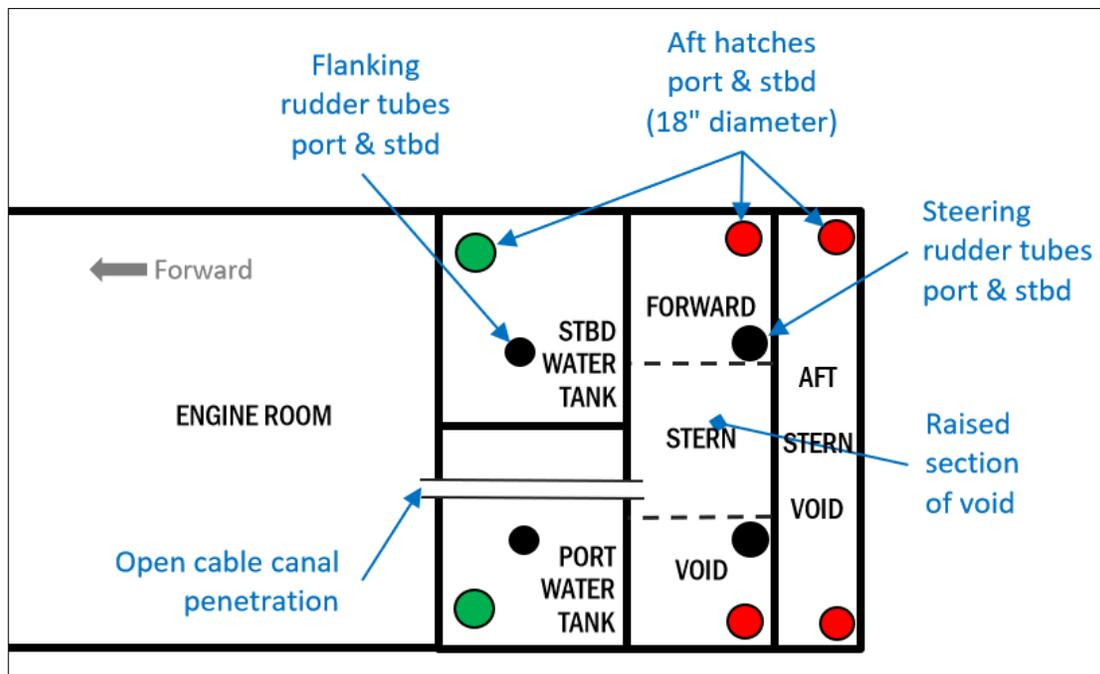
Investigators found two items of concern inside the forward stern void. First, despite efforts to pump out the void completely, there remained a pool of water between the two longitudinal frames that investigators estimated was approximately one-quarter of the void’s full capacity. Because no drainage or bilge suction existed in the area, pumping out the remaining water would require someone to enter the space and use a portable pump. Second, when the forward stern void was filled to a water level approximately 7 inches below the top of the void, investigators found a flow of water into the engine room through a cable canal between the forward stern void and the engine room. There was no evidence of the cable canal having any packing or penetration seals.

Plan view of *Ricky Robinson* (not drawn to scale). Circles colored red indicate access to void tanks found open with no covers when vessel was salvaged; green indicates hatches for potable water tanks, which had covers in place when vessel was salvaged; and black indicates steering and flanking rudder tubes that passed through voids.

After the accident, the *Ricky Robinson* was rebuilt and returned to service at Wepfer Marine. Modifications were made to the forward and aft voids to include a 6-inch raised coaming and four “dog” hatches.
