# National Transportation Safety Board

## Marine Accident Brief

**Accident No.:** DCA-10-FM-003  
**Vessel No. 1:** *Thriller 09*  
**Vessel No. 2:** *CG 25689*  
**Accident Type:** Collision  
**Location:** Charleston Harbor, South Carolina  
**Date:** December 5, 2009  
**Time:** 2028 eastern standard time<sup>1</sup>  
**Owner/Operator:** *Thriller 09:* Foxrose, LLC  
*CG 25689:* U.S. Coast Guard  
**Property Damage:** *Thriller 09:* \$94,300  
*CG 25689:* \$1,380  
**Injuries:** *Thriller 09:* 6  
*CG 25689:* 0  
**Complement:** *Thriller 09:* 2 crew and 22 passengers  
*CG 25689:* 3 crew

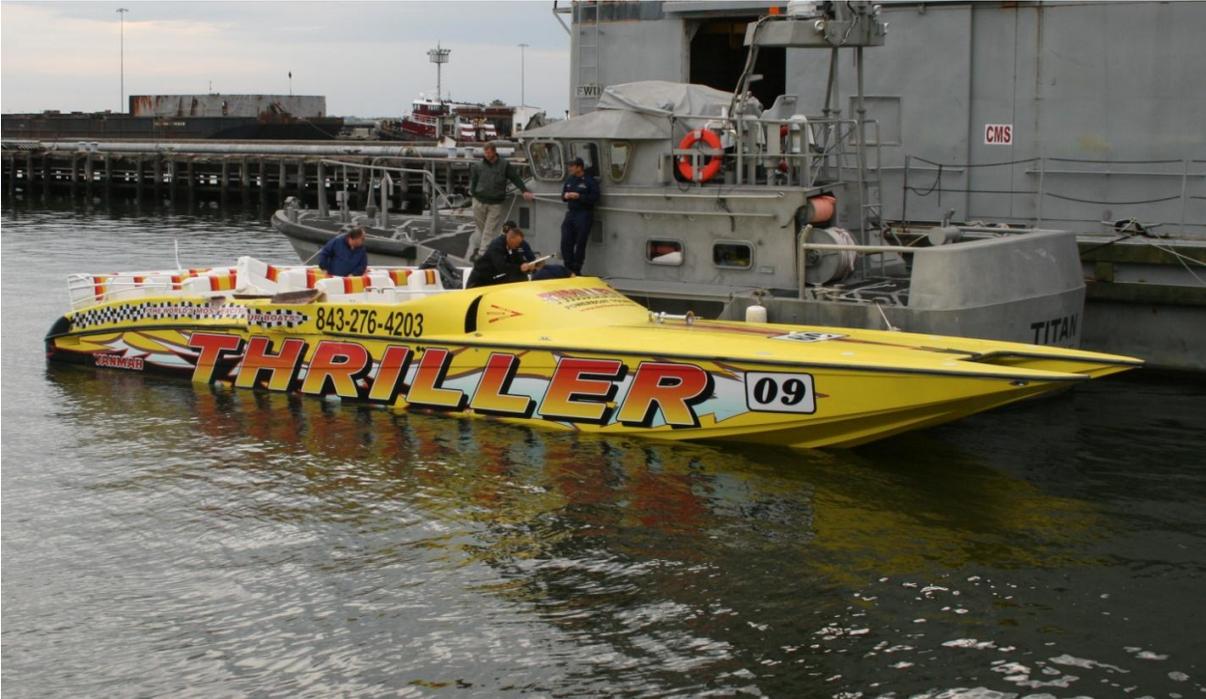
Figure 2. Profile view of *Thriller 09* postaccident.

their injuries, the master quickly determined that the *Thriller 09* was not taking on water. However, he found that a section of metal hand railing had broken off the starboard gunwale and that the vessel's hull was damaged above the waterline. In addition, the third bench seat on the starboard side had broken loose from the deck mounting near the outboard side where the impact had occurred, and the outboard portion of the seat had been displaced upward, about 1 foot in height.

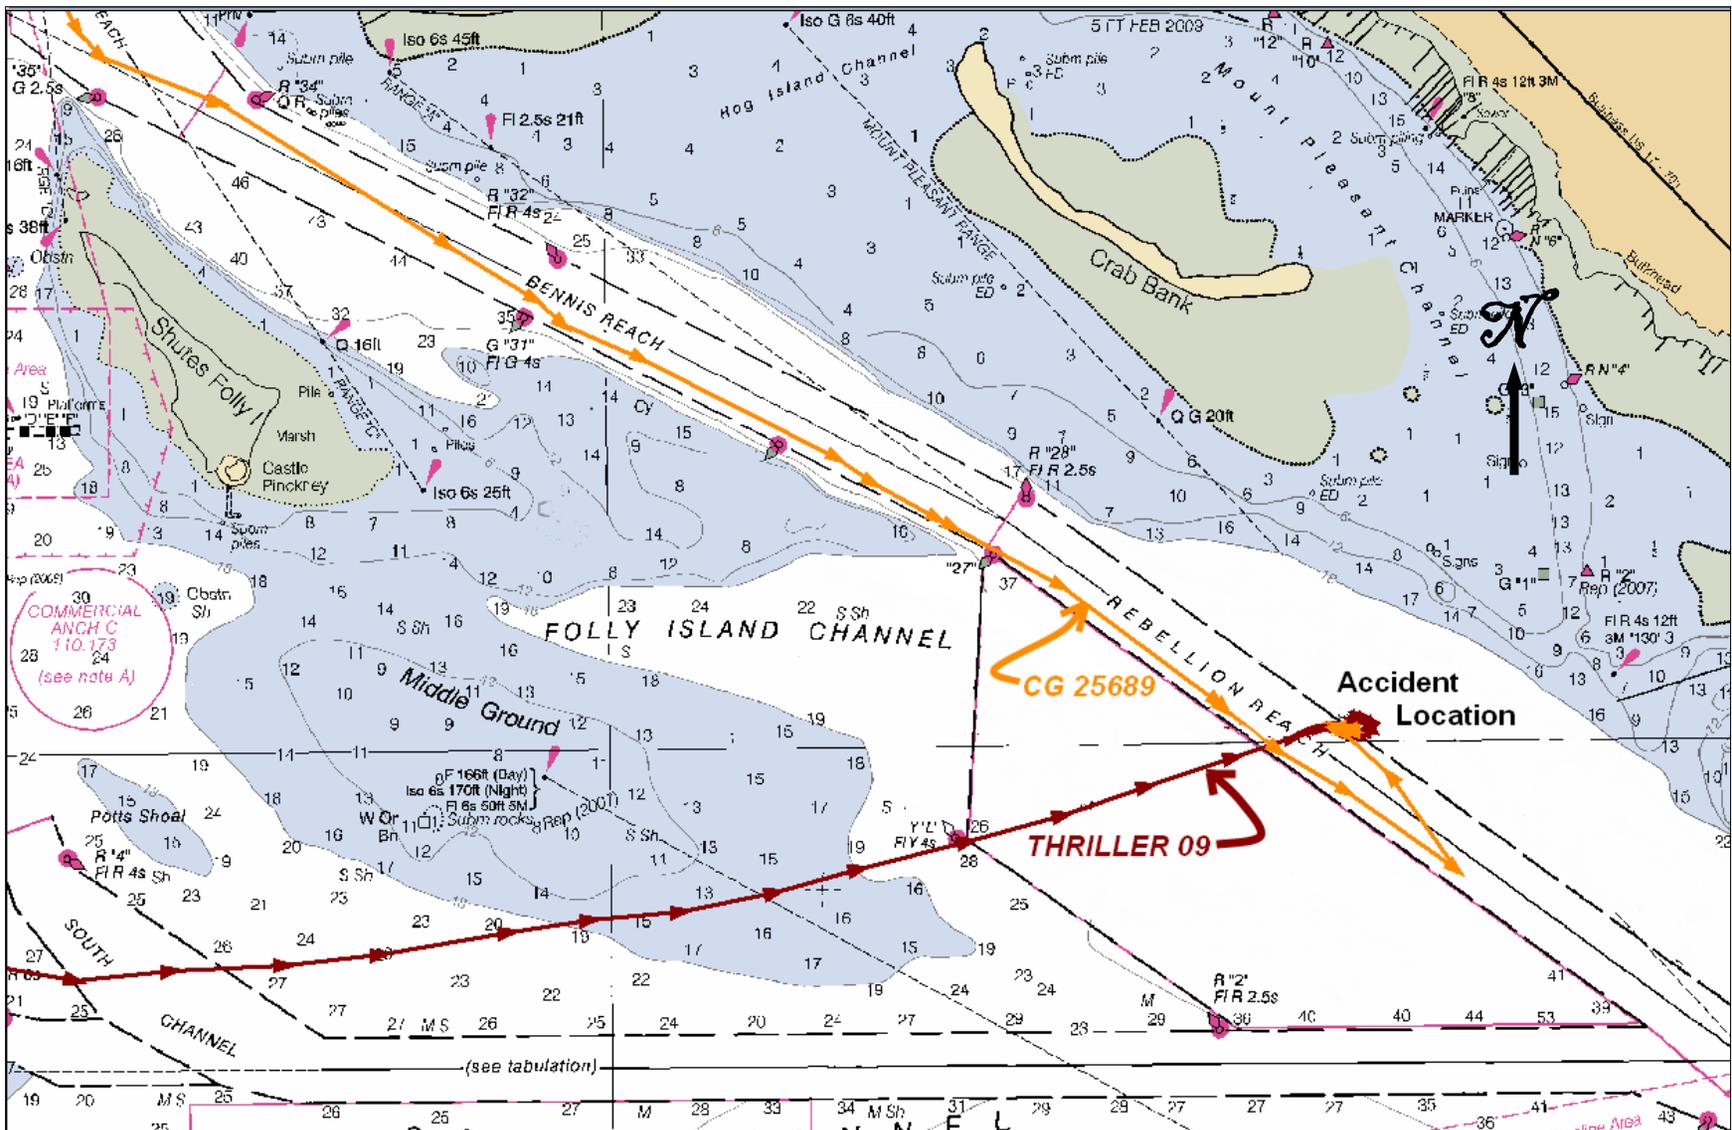
The track of the *CG 25689* was captured by the vessel's automatic identification system (AIS).<sup>8</sup> The trackline appears in figures 3 and 4, as does the trackline of the *Thriller 09* as captured by its global positioning system (GPS). Evidence indicates that in the minutes before the accident, the *Thriller 09* and the *CG 25689* were approaching each other at an approximately constant bearing rate, as shown by the nearly parallel bearing lines in figure 4.

Figure 3. Tracklines of the CG 25689 (orange) and the Thriller 09 (red).

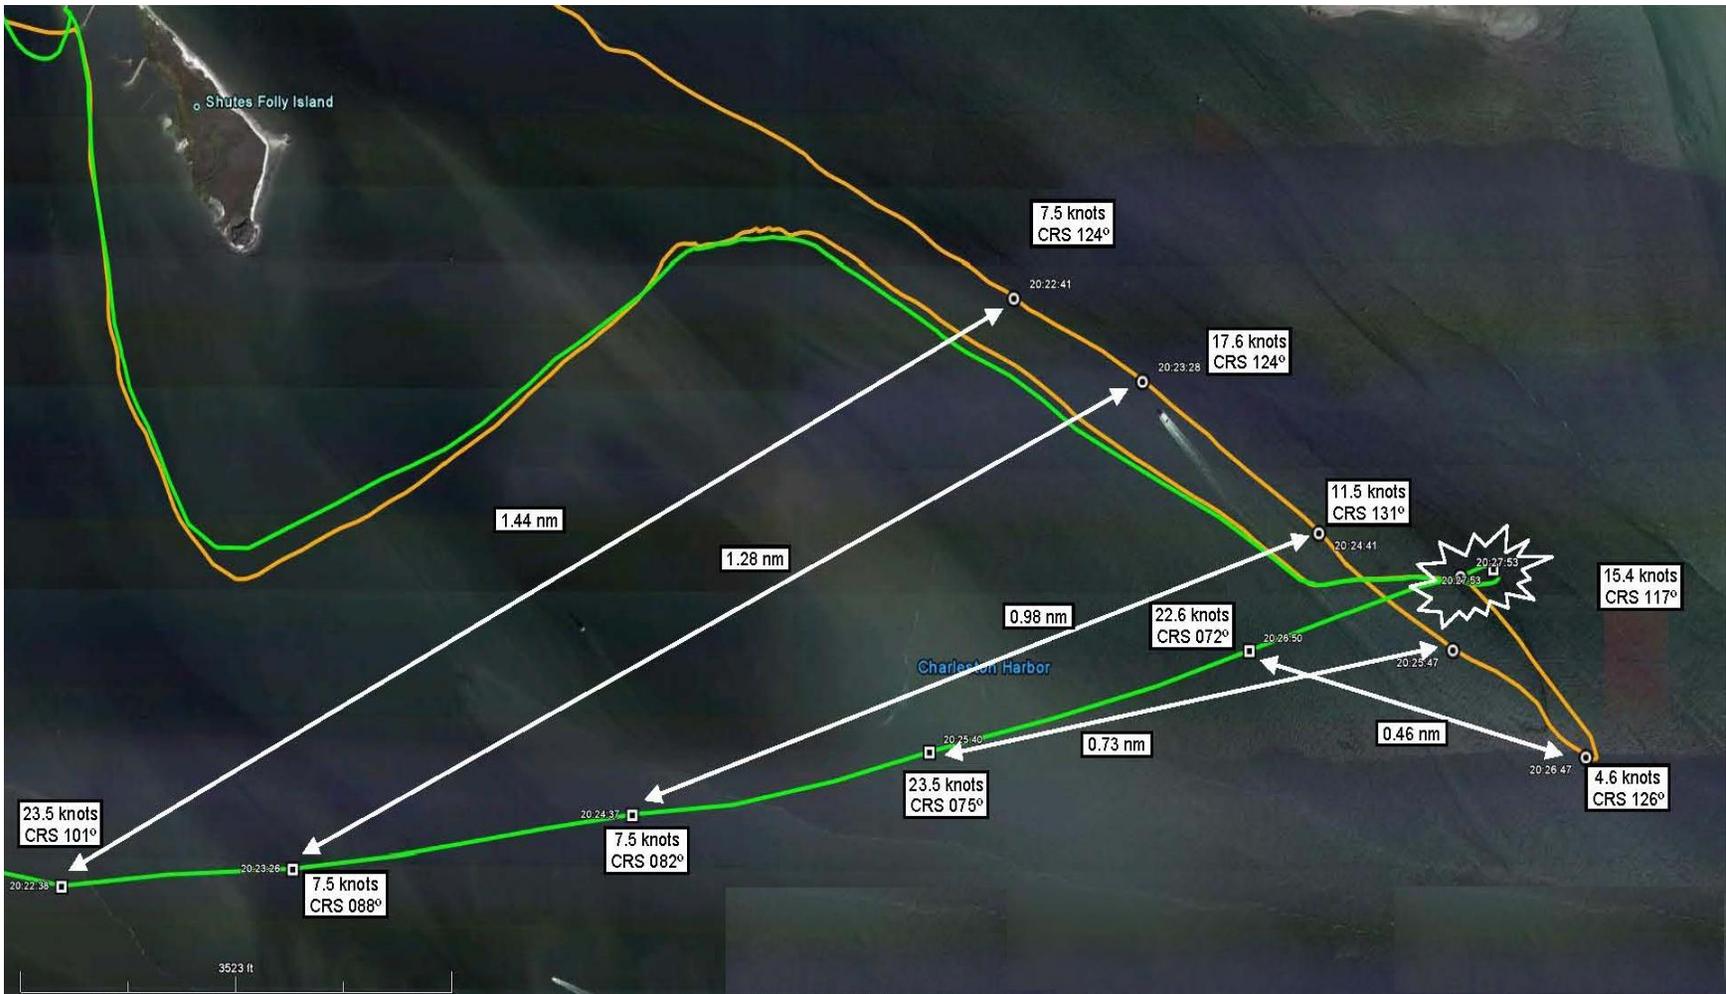
**Figure 4.** Graphic shows the tracklines of the CG 25689 (orange) and the *Thriller 09* (green). The white lines indicate the relative bearings between the vessels at various times. The star shape outlined in white indicates the approximate location of the collision. Background by Google Earth.

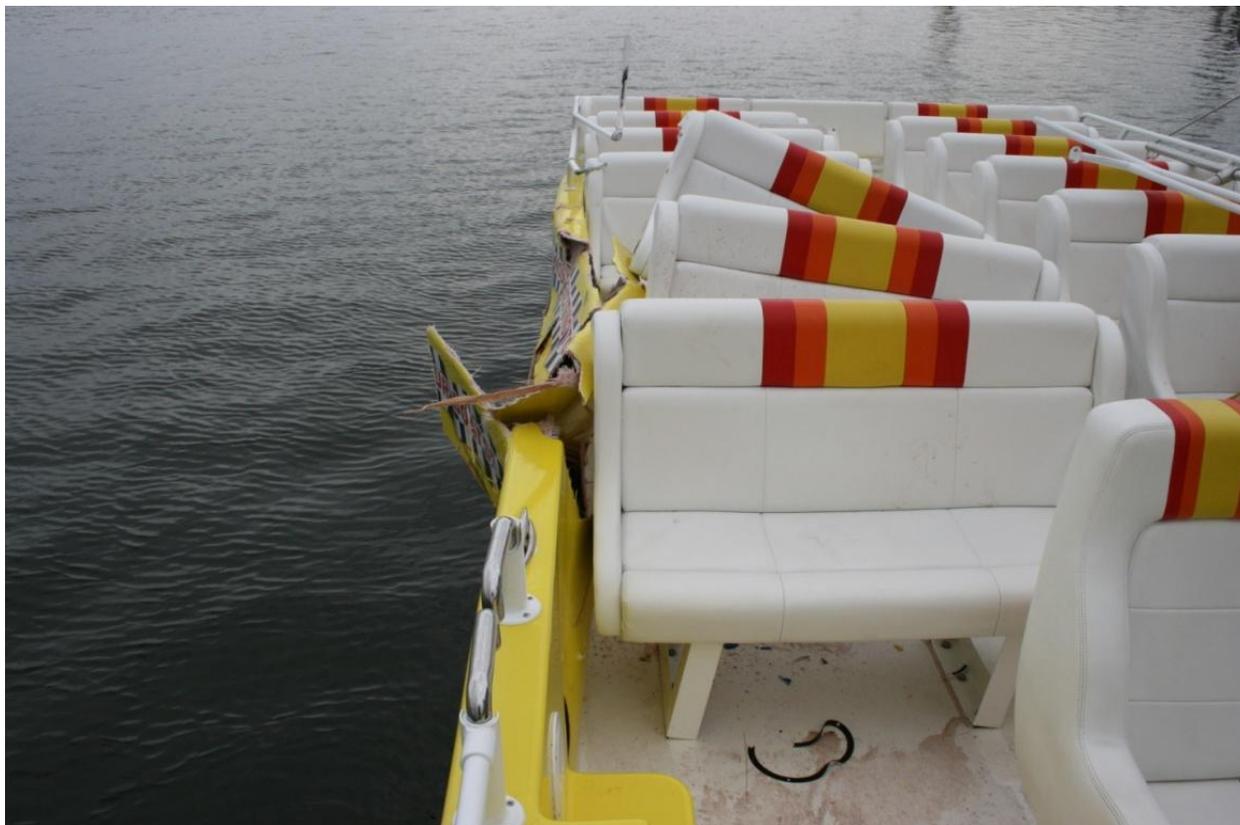
**Damage.** The *Thriller 09* sustained damage primarily to the starboard-side hull, above the waterline (figure 5). The damage in the impact area consisted of scratched, cracked, broken, and detached portions of the fiberglass hull shell, as well as fracturing of the interior hull framing and deck in this area. As a result of the collision, the starboard passenger bench seats at rows 2 and 3 were lifted and partially detached from the deck. The damage began 29 feet 7 inches from the bow and extended aft 12 feet 9 inches. According to the attorney for the boat owner/operator, the damage repair cost totaled \$94,300, excluding transportation and storage costs associated with shipping the boat to a Florida repair facility.

**Figure 5.** Damage to *Thriller 09* starboard side, looking aft from the bridge.

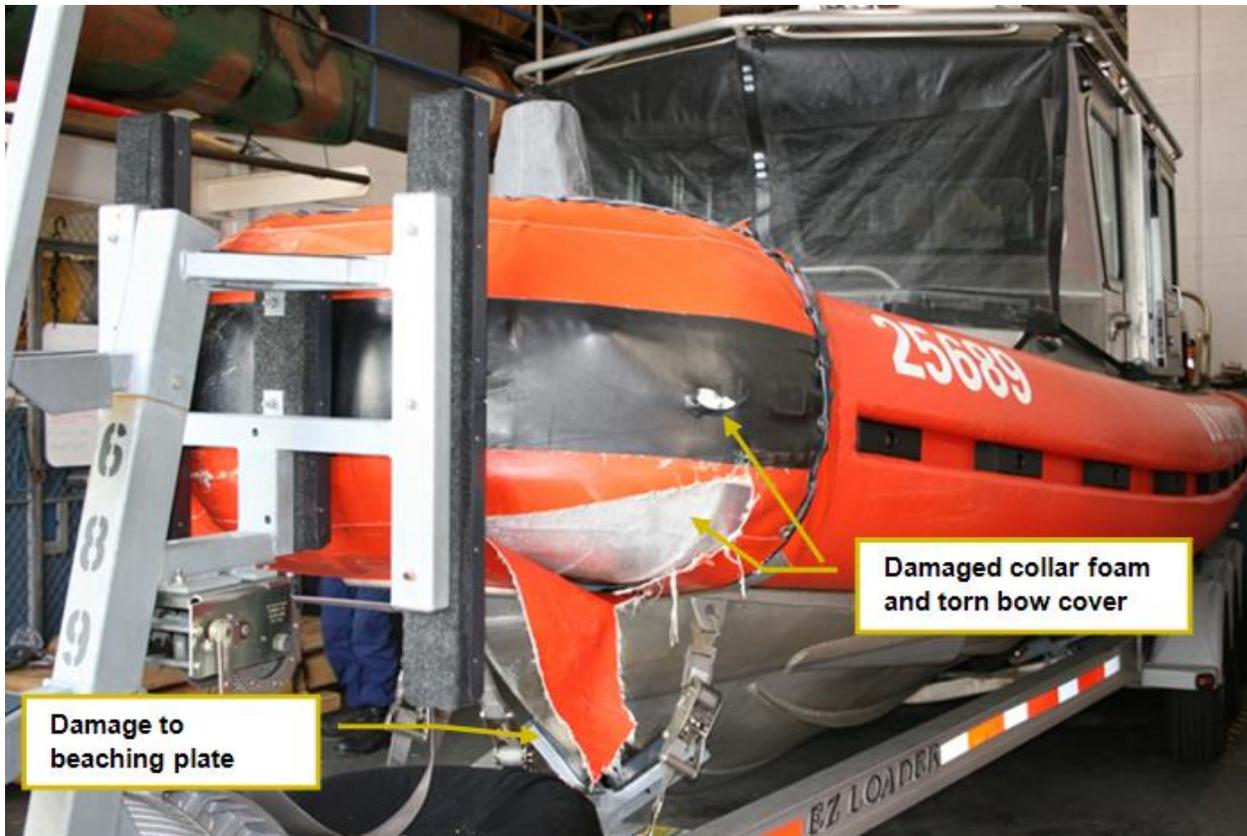
**Damage.** Damage to the *CG 25689* was limited to the bow area and consisted of one large (19- by 16- by 20-inch) tear in the bow fabric cover and several small tears, scuffs, scrapes, and similar damage to the cover (figure 6). In addition, the beaching (doubler) plate on the bow stem showed scuffing and impact damage but no apparent indentation or fracturing of the hull. The Coast Guard estimated the damage cost to total \$1,380, including the bow cover replacement, materials, and some hull welding.

**Figure 6.** Damage to the CG 25689's bow collar foam, bow cover, and beaching plate.

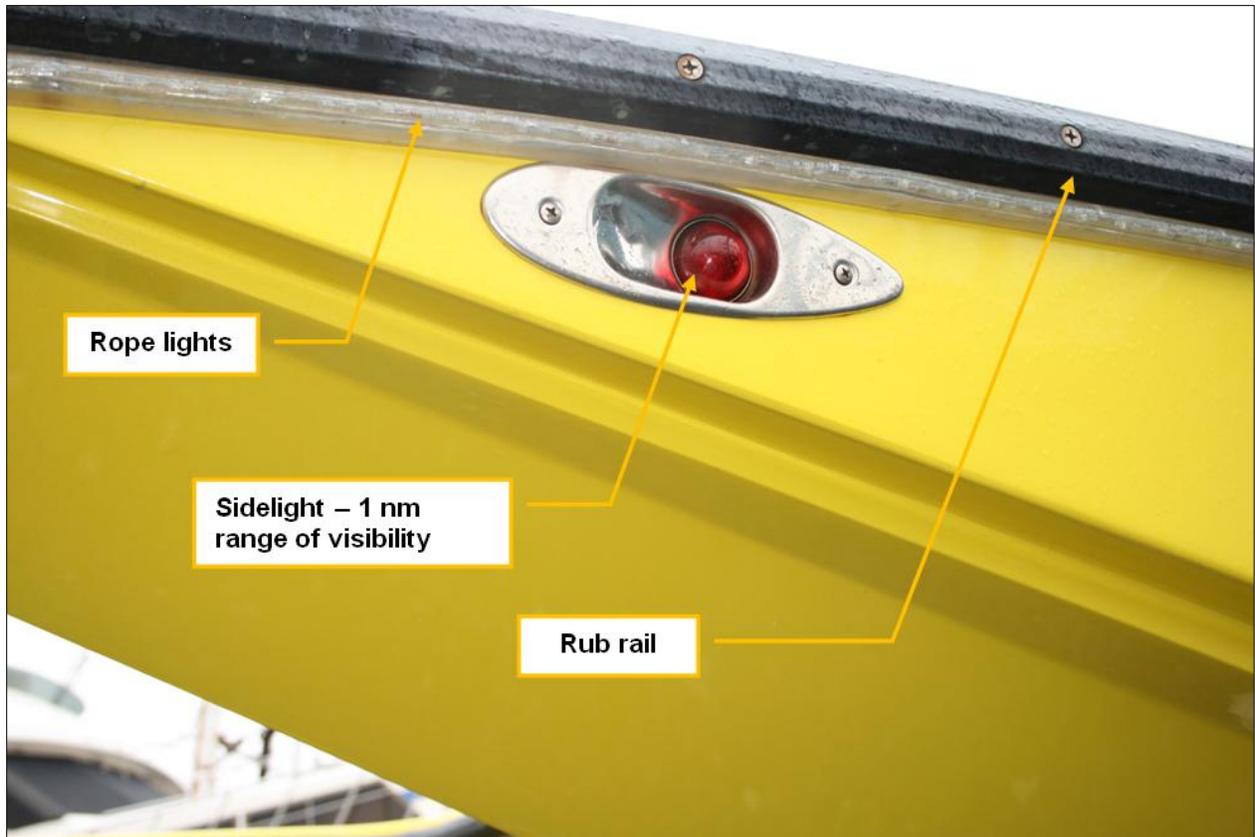
Both vessels were fitted with the required navigation lights for use during restricted visibility and nighttime operations. Crewmembers of both vessels and passengers of the *Thriller 09* reported that both vessels' lights were illuminated at the time of the accident. Investigators later verified that all required lights were operational. However, investigators identified two anomalies with the navigation lighting system of the *Thriller 09*. First, its port and starboard navigation sidelights, fitted at the outboard sides of each of the catamaran's bows, had range of visibility ratings of 1 nm rather than 2 nm as required by the navigation rules. In addition, the boat had decorative rope lights installed around the perimeters of its hulls, just below the rub rail (figure 7). According to the rope light manufacturer's specifications, the LEDs in the rope lights had a luminous intensity rating that exceeded the rating of the navigation sidelights.<sup>14</sup>

**Figure 7.** View of portside navigation sidelight and rope lights at the *Thriller 09*'s bow.

**Thriller Boats.** After the accident, the Coast Guard required the owner/operator of the *Thriller 09* to modify the navigation sidelight installation to meet the 2-nm range of visibility requirements of navigation rule 22, Visibility of Lights (within part C of the inland navigation rules, Lights and Shapes).<sup>15</sup> The owner was permitted to keep the rope lights installed on the boat but was prohibited from illuminating them when the vessel was under way.
