Collision of Tugboat/Barge *Caribbean Sea/The Resource*
with Amphibious Passenger Vehicle *DUKW 34*
Philadelphia, Pennsylvania
July 7, 2010

Accident Report

NTSB/MAR-11/02
PB2011-916402

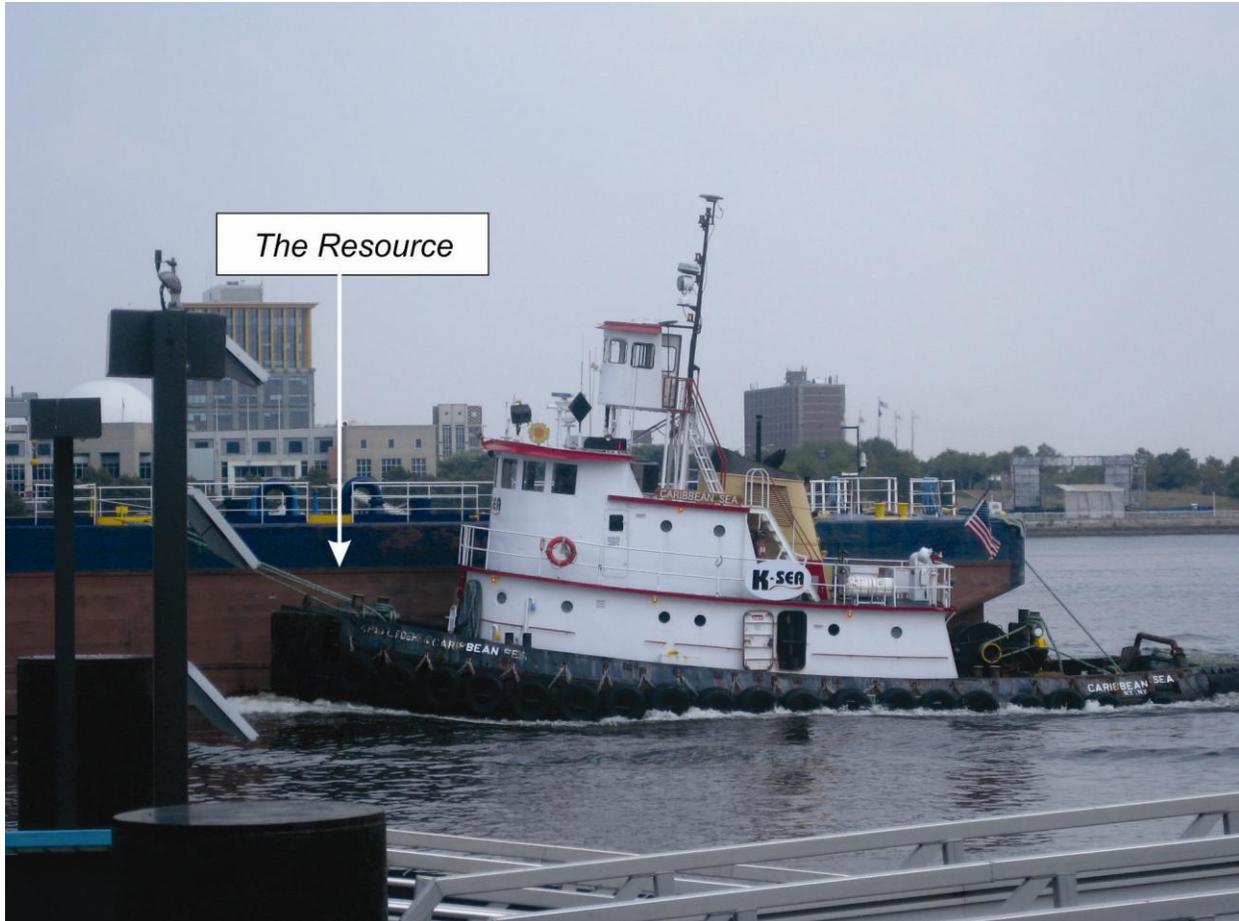
Figure 3. Tugboat *Caribbean Sea* with tank barge *The Resource* in a starboard hip tow as seen about 45 seconds before the accident. (Photo by Megan Scharpf)

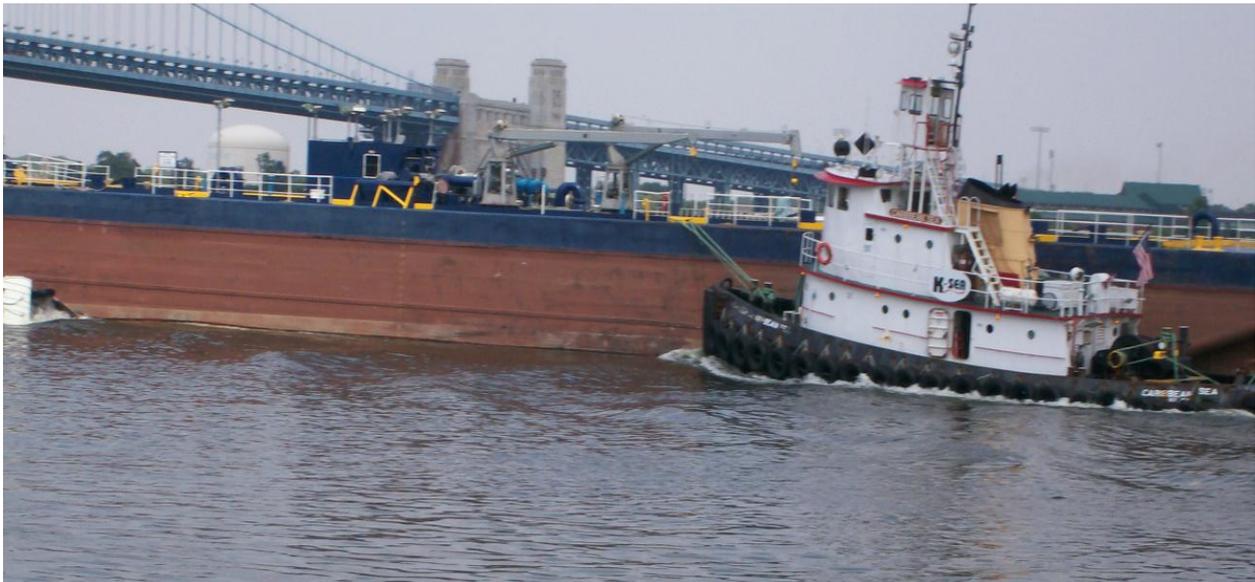
A video security camera on the New Jersey side of the river captured the accident sequence. According to the time correlation study¹¹ on the video, the barge made contact with the stern of *DUKW 34* at 14:37:23. Ten seconds later, at 14:37:33, the APV, having been turned to port, rolled over onto its starboard side and was pushed completely under the water (figure 4). Based on AIS data, in the minutes before the accident, the *Caribbean Sea* was near the center of the river's navigation channel and traveling at about 6 knots.

Figure 4. Tugboat *Caribbean Sea* and barge *The Resource* seconds after the bow of the barge made contact with *DUKW 34*, a portion of which is visible at far left. (Photo by Brian E. Stover)

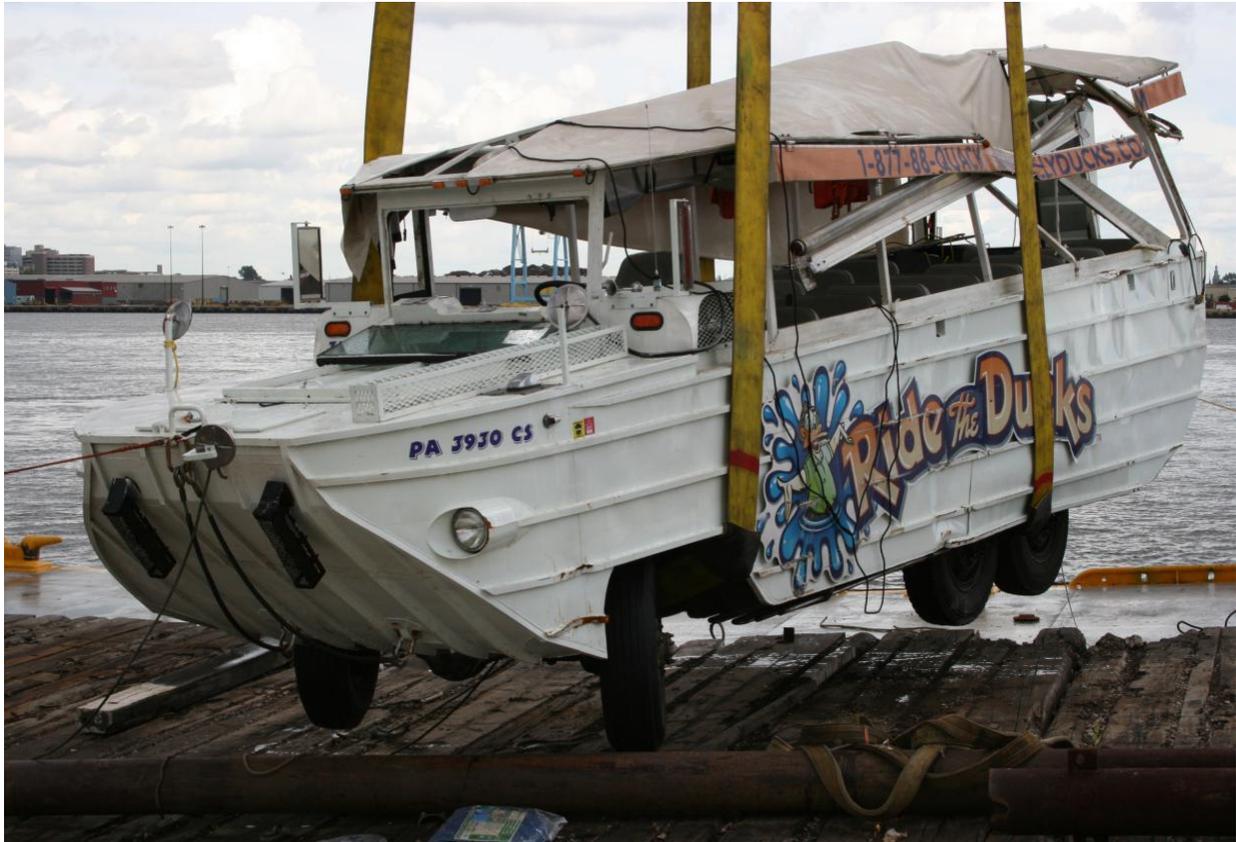
DUKW 34 was raised from the river on July 9, 2010. Damage to the APV was principally to the port side of the hull and the aft portion of the port side of the canopy. The hull damage consisted of scrapes and indentations along the hull's external support members and hull shell, and to the "Ride The Ducks" sign attached to the side of the hull. The scrapes to the Ride The Ducks indicated the relative movement between the APV and the barge during their period of contact (figure 6).

Figure 6. *DUKW 34* after being raised from the river bottom.

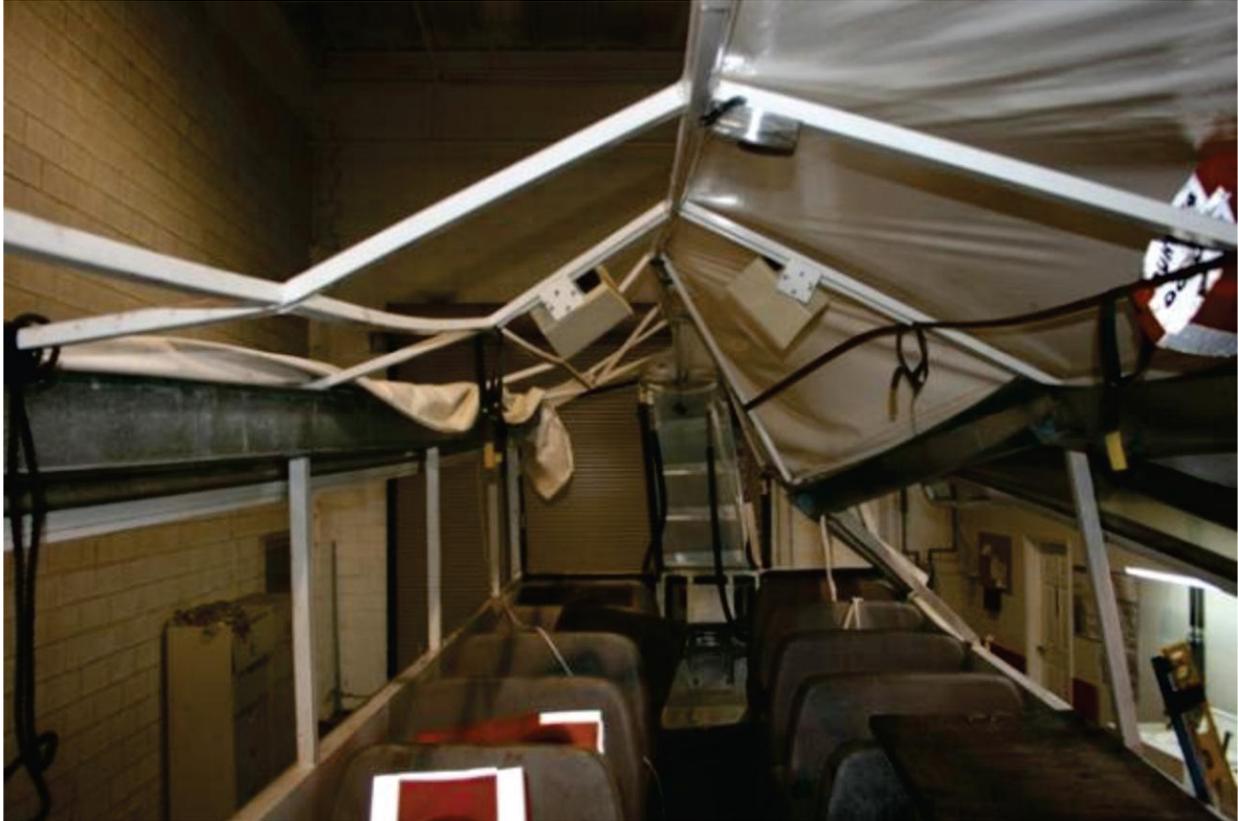
Damage to the canopy framing system (figure 7) consisted of bending and buckling of the square and rectangular steel tubing and some tearing of the canopy awning, principally at the aft portion. The two aftermost port side vertical frames of the canopy were bent over about 45°, and other support members were similarly damaged. The port-side roller curtain was damaged and detached from its mountings, and the passenger loading ladder indicated distortion and impact damage. The left front wheel was slightly displaced from its axis of rotation, and a subsequent tear-down examination showed that its drive axle was slightly bent.

Figure 7. View of *DUKW 34*'s damaged canopy, looking aft.

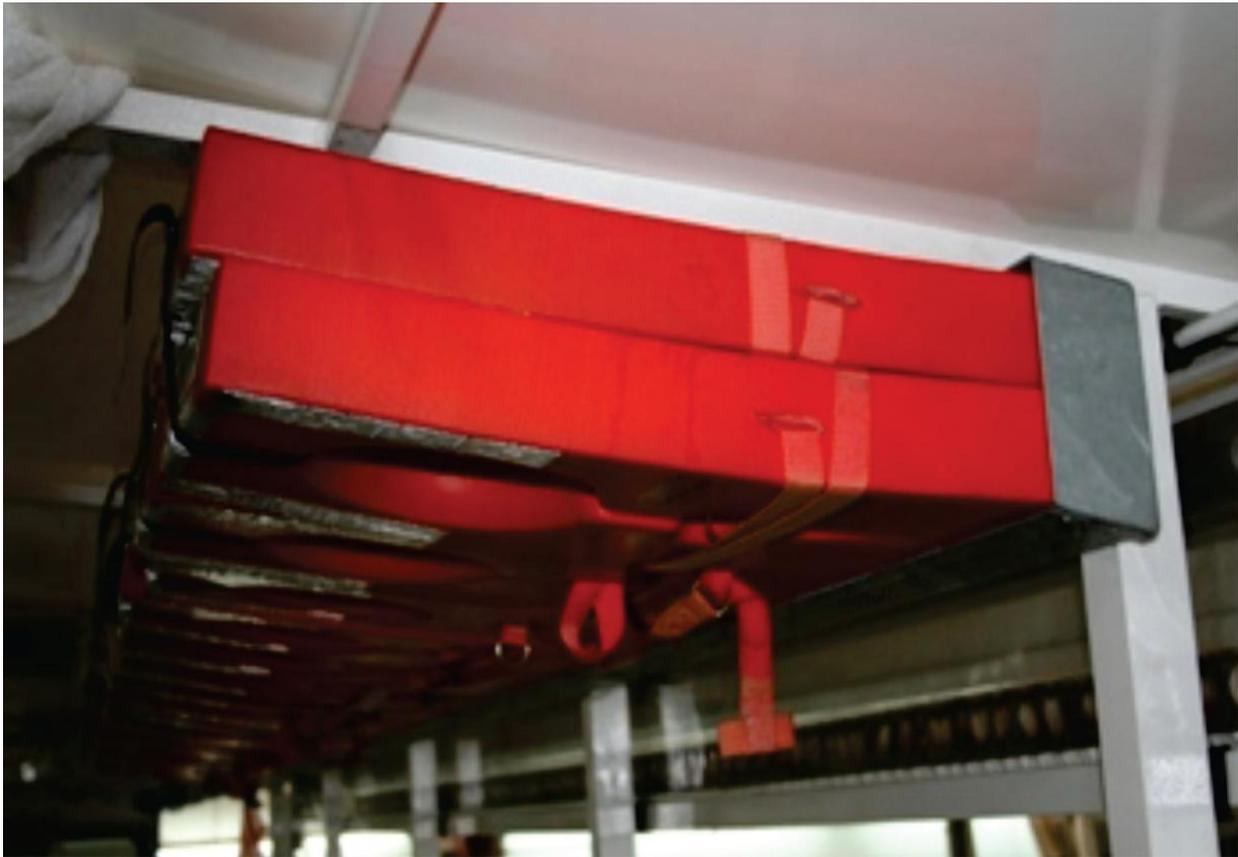
Lifejackets were stowed in the overhead on both sides of the vessel. Adult lifejackets were stowed in stacks of two on the starboard side above all but the last row of seats. Child-size lifejackets were stowed similarly on the port side and were above all but the last 3 rows of seats. The bottom end of each lifejacket was resting in a metal channel just below the canopy on each side (figure 8).

Figure 8. Lifejackets on Ride the Ducks APVs were stowed in stacks of two above each row of passenger seats. Adult jackets were on the starboard side; child jackets were on the port side.

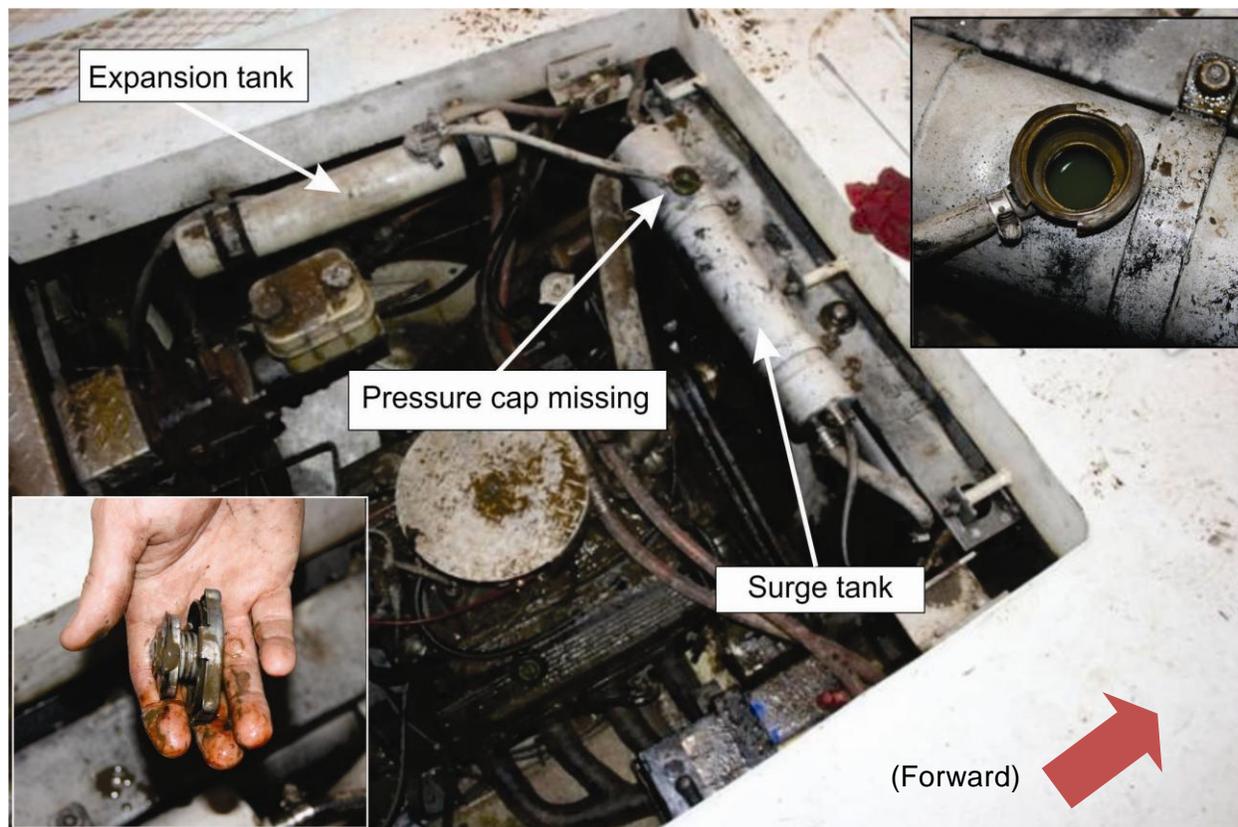
Radiator. Examination of the vessel's engine compartment revealed that the pressure cap normally fitted to the radiator surge tank was missing (figure 9). The pressure cap was subsequently found undamaged in the lower part of the engine compartment. The pressure cap was tested and was shown to open at 11 to 13 psi. The pressure cap was rated for 13 psi.

Figure 9. Engine compartment of the salvaged *DUKW 34*, with the surge tank pressure cap missing. The upper inset photo is a close-up of the uncapped tank; the lower inset photo shows the pressure cap recovered from the bottom of the engine bay.

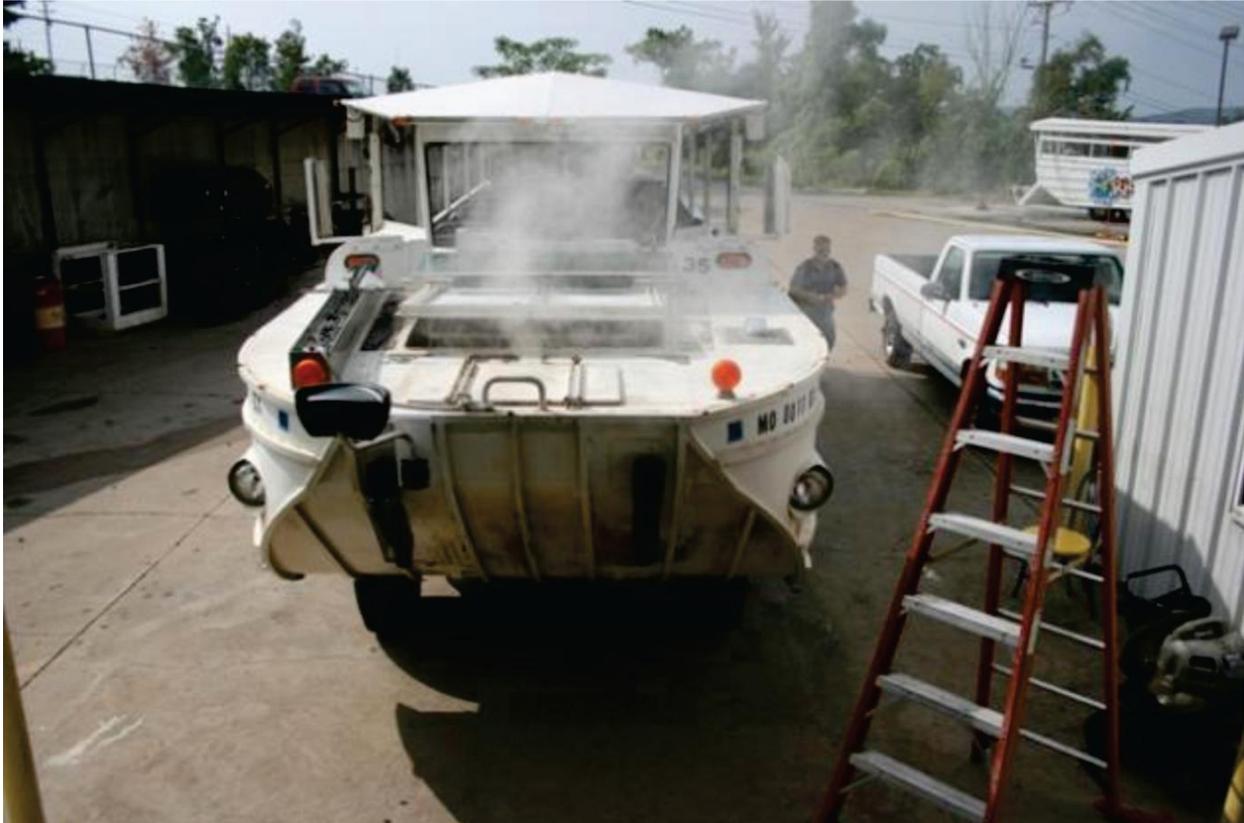
The test run consisted of on-road travel only,⁴⁸ and no attempt was made to match the test load to the passenger load on *DUKW 34* at the time of the accident. At the time of the test, the ambient air temperature was about 72° F. After about 10 minutes of on-road travel, the engine coolant temperature increased to about 220° F, at which time steam from the boiling coolant could be seen escaping from the vessel hood and began entering the passenger cabin from the starboard engine compartment vent (figure 10).

Figure 10. Steam from the engine compartment of a test APV, with cooling water temperature of about 220° F.

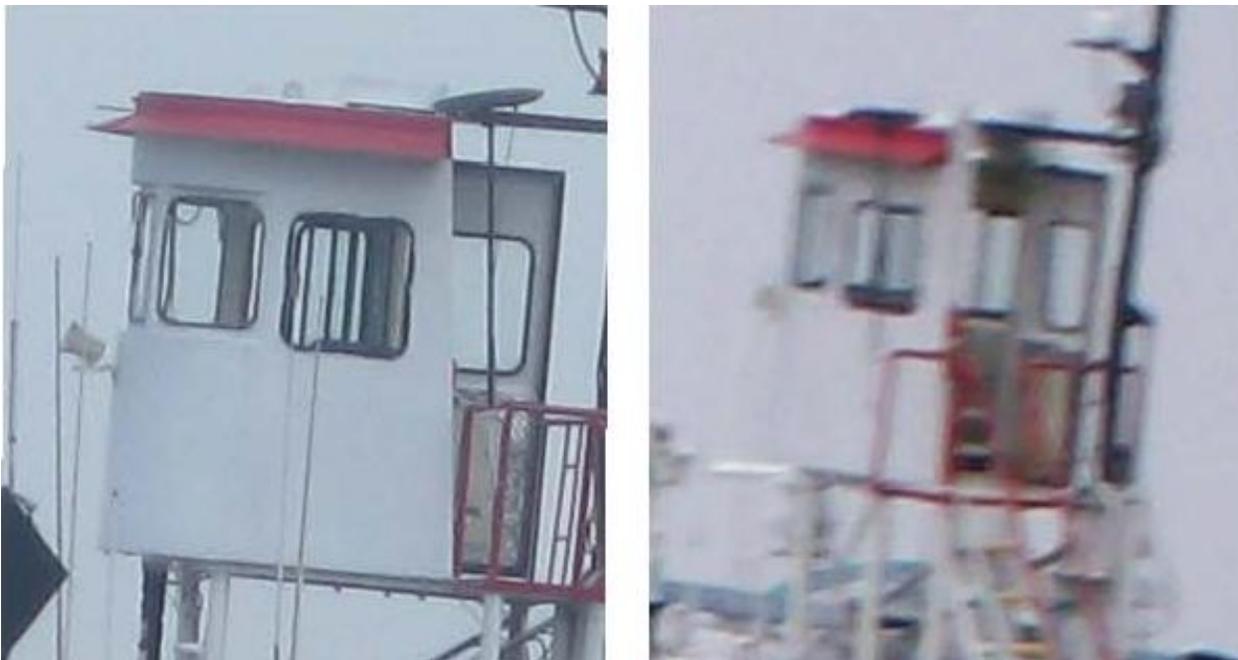
At least two of the still photographs (included as figures 3 and 4 in this report) provide fairly clear images of the upper wheelhouse of the *Caribbean Sea* just before and just as the barge struck the APV. Figure 11 shows enlargements from figures 3 and 4 that provide close-up views of the upper wheelhouse just before and after the accident. The enlargement from figure 3 shows the upper wheelhouse in a profile view. The door is open, and the wheelhouse appears to be empty. Anyone at the helm would have been visible through the un-tinted windows. The enlargement from figure 4, taken just after the bow of the barge *The Resource* struck the APV, shows the upper wheelhouse from almost a rear 3/4 view. A portion of the interior of the wheelhouse is visible through the open door. In this image, too, the upper wheelhouse appears to be empty.

Figure 11. (Left) Enlargement from figure 3, showing the *Caribbean Sea*'s upper wheelhouse about 45 seconds before the collision. (Right) Enlargement from figure 4, showing the *Caribbean Sea*'s upper wheelhouse just as the bow of the barge strikes *DUKW 34*.
