# National Transportation Safety Board

## Marine Accident Brief

**Accident No.:** DCA-09-MM-013

**Accident Type:** Allision

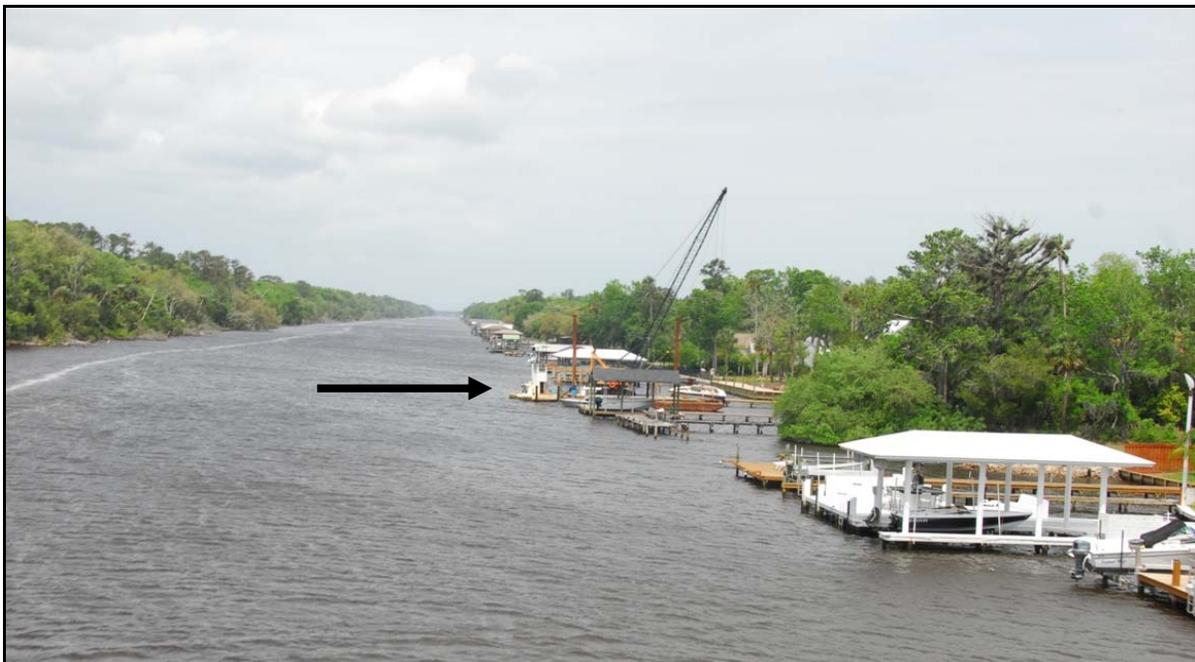
**Figure 4.** Photo of ICW looking north, showing residences with docks extending into east side of waterway. Arrow points to accident site and to push boat struck by recreational boat. At low tide, mudflats form along both shorelines. Two miles south of accident site, low tide was at 1909 on April 12.

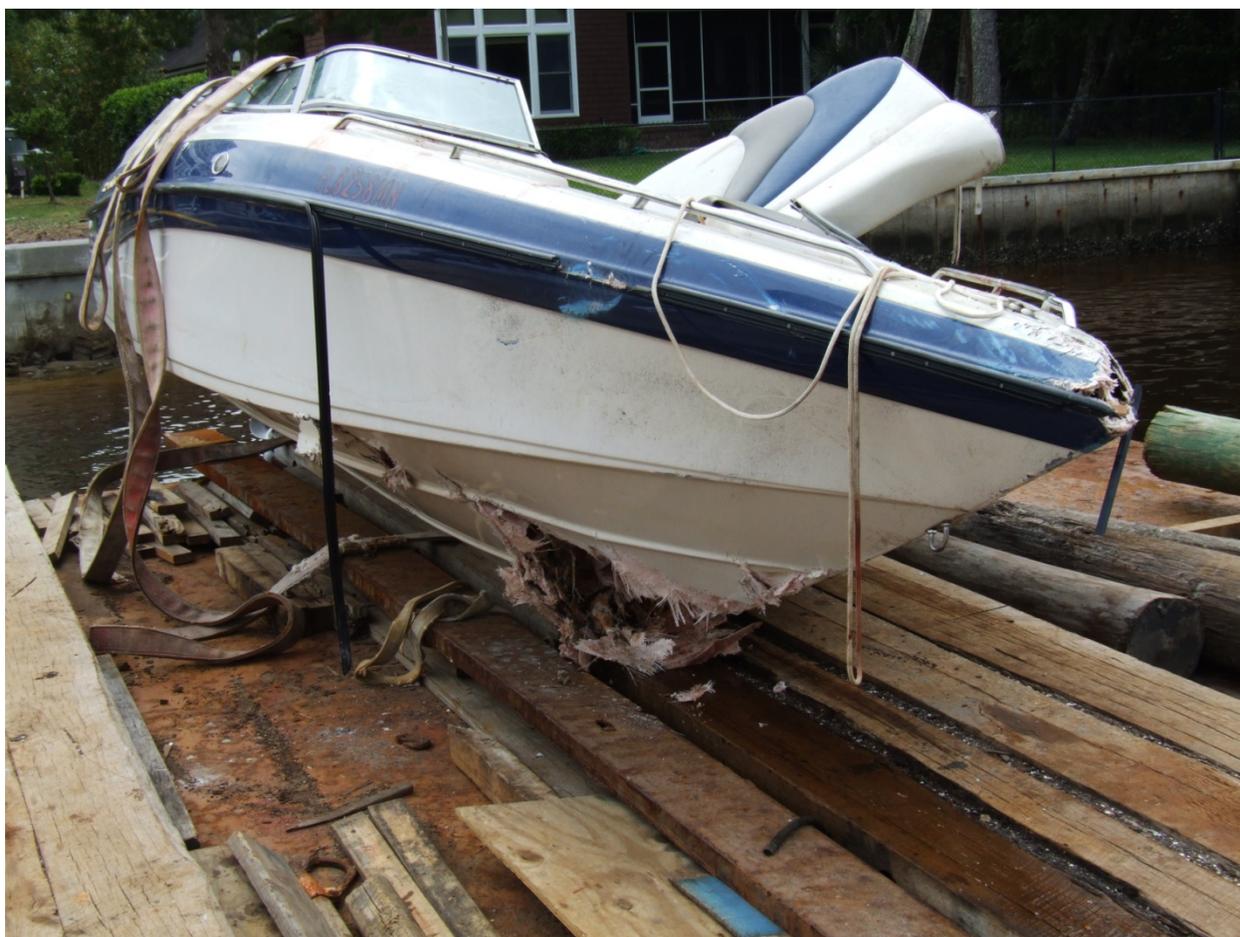
**Damage.** The recreational boat came to rest with its bow out of the water and extending about 3 feet into the starboard side of the push boat's deckhouse (see next section). The boat sustained major structural damage to the stem of its bow just below the waterline and about 6 feet aft of the nose (figure 6). The damage extended to the wooden stringer system. Other hull damage consisted of scrapes and chips in the bow area.

**Figure 6.** Photo of recreational boat after accident, showing structural damage to bow area.

Damage to the boat's interior consisted of detached operator's and passenger's chairs, impact damage to the passenger side of the console, damage to and detachment of the wind-screens, damage to the portside grab rail in the bow seating area, and damage to the steering wheel and console. According to the FWC, the throttle was found in the full or nearly full position after the accident. The electrical system's 12-volt battery was found on the boat's deck about 6 feet forward of its mounting on the starboard side.

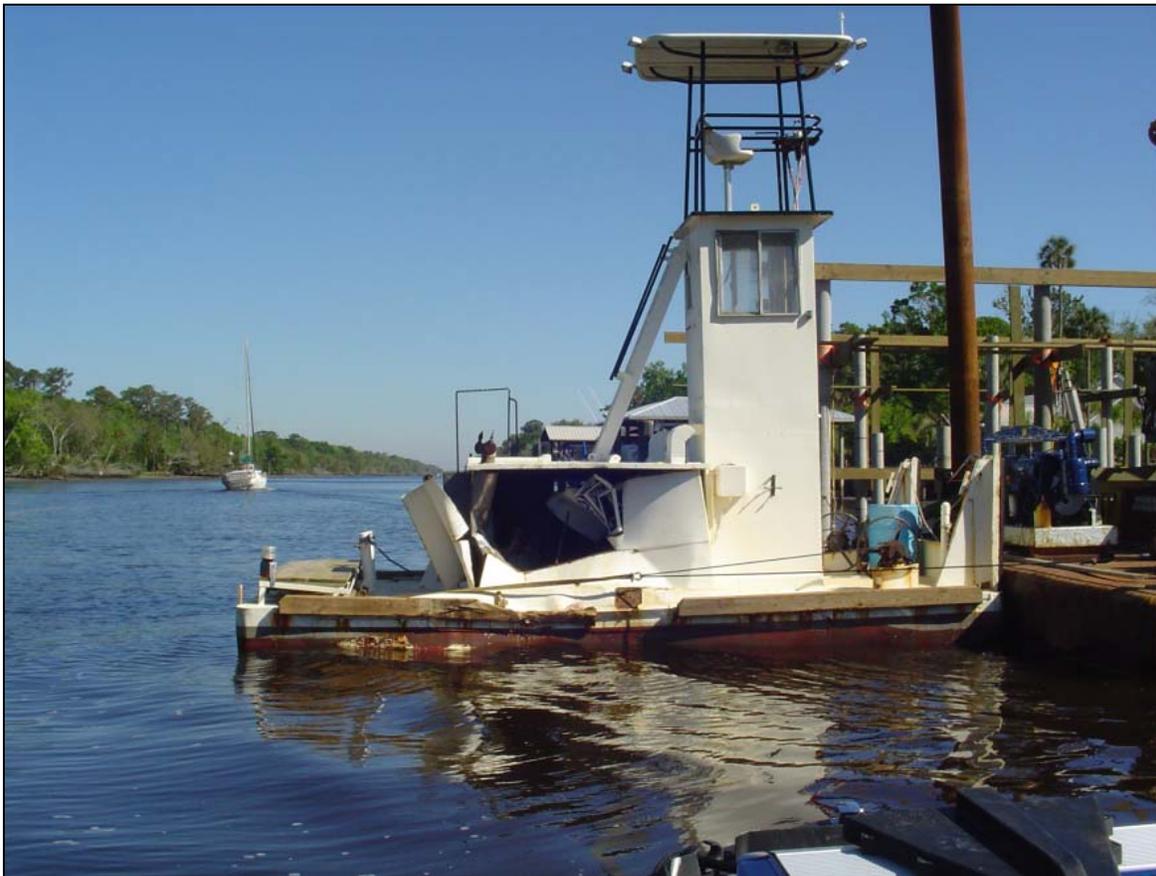
**Damage.** The *Little Man II* sustained damage to the starboard side of the hull and the enclosure for the engine space (figure 7). The initial point of impact by the recreational boat was about 15 feet aft of the push boat's bow. The damaged area on the starboard side of the push boat began about 10 feet aft of the bow and extended for about 15 feet. The hull sideshell was set in a maximum of about 10 inches over the length of the damaged area, and the deck in the area of the damaged sideshell was buckled upward. The 1/4-inch steel plating at the starboard side bulkhead of the deckhouse was buckled inward and torn loose where the bow of the recreational boat had entered the engine space, and several welded areas of vertical and horizontal joints of the plating were fractured. The vertical section of the exhaust pipe from the starboard propulsion engine was crushed and pushed aft several inches.

**Figure 7.** Photo of *Little Man II* after accident, showing damage to hull and deckhouse.
