Collision Between U.S. Coast Guard Vessel *CG 33118* and
Sea Ray Recreational Vessel *CF 2607 PZ*
San Diego Bay, California
December 20, 2009

NTSB/MAR-11/03
PB2011-916403

Marine Accident Report

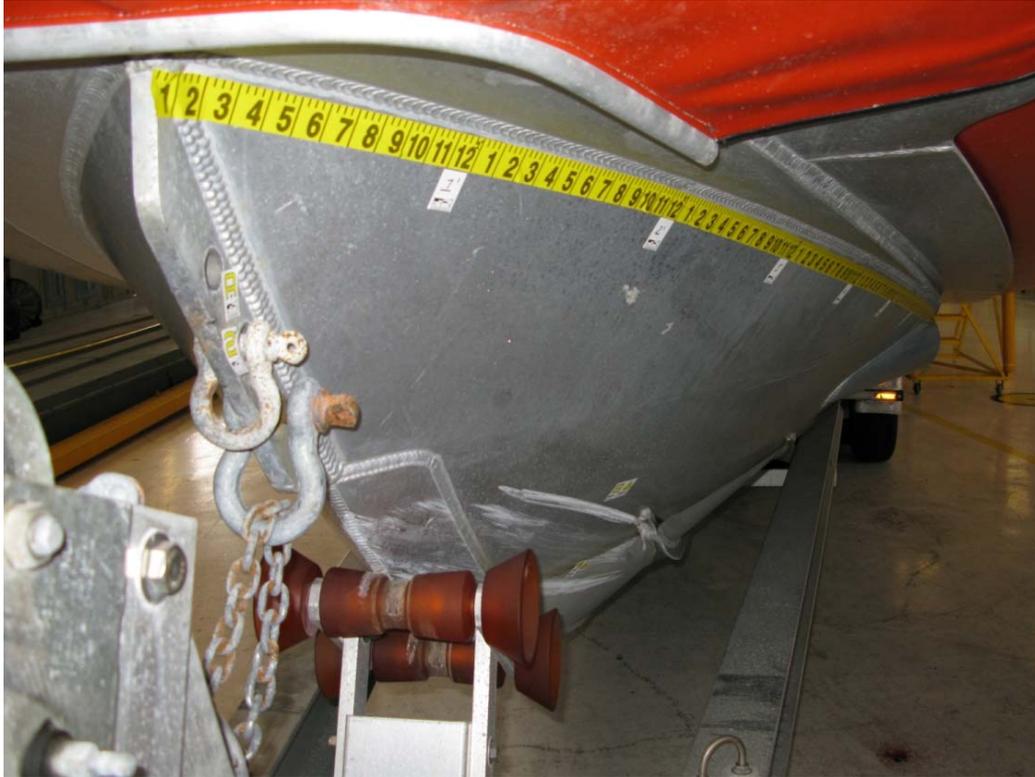
The *CG 33118* sustained surface scratches and paint transfer starting at the beaching plate³³ at the stem and continuing aft along the keel for about three-quarters of the length of the hull (**figure 6**). The crewmembers indicated that they did not notice any major postaccident problems with the vessel's performance on the way to impoundment at Coast Guard San Diego's helicopter hanger.

Figure 6. Damage to the CG 33118.

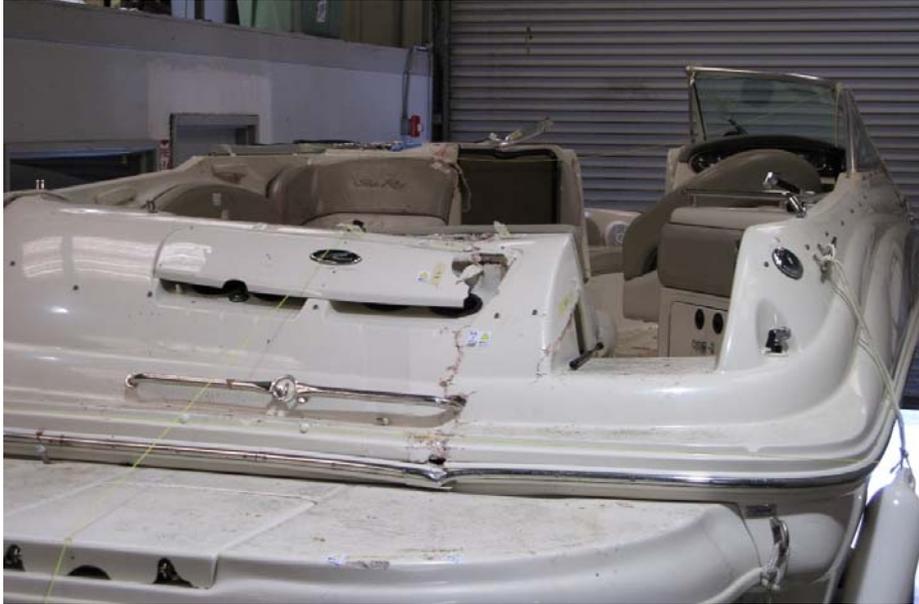
Most of the Sea Ray's damage was located above its water line, from the starboard side of the transom and extending forward of the port windshield (**figures 7 and 8**). The port window was torn off and the remaining frame bent outward. The fiberglass at the sheer below the missing port window had failed and cracked down the length of the remaining window frame. The door to the head,³⁴ located just below the port window, was knocked off and pushed inward. The swim platform in the stern had a sharp gouge on the starboard side. The structural fiberglass damage to the Sea Ray rendered the vessel beyond repair.

Figure 7. Damage to the Sea Ray.

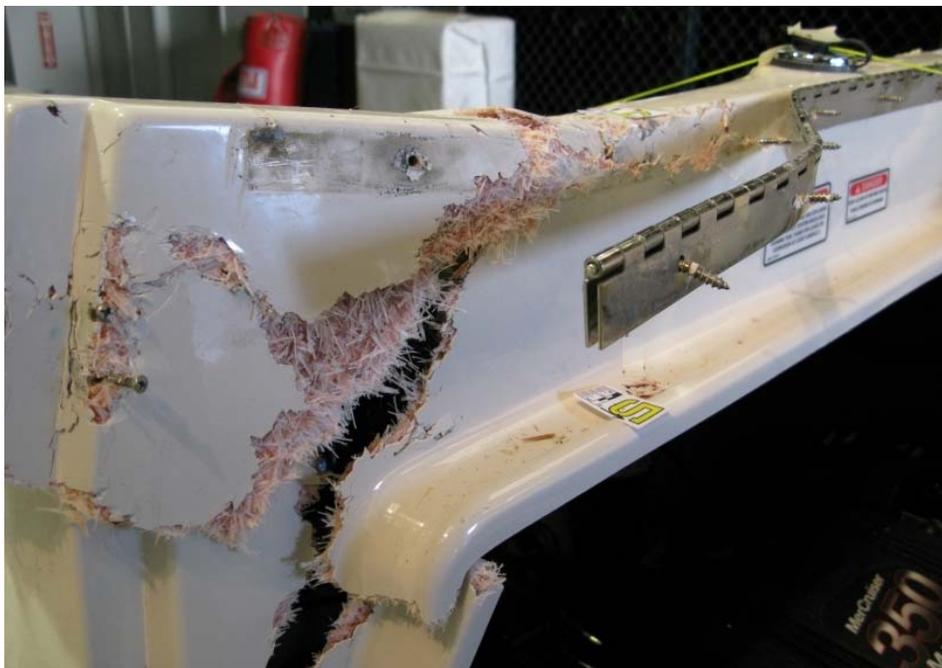
Figure 8. Fractured fiberglass on the Sea Ray, viewed looking aft and port from inside the boat's cockpit.

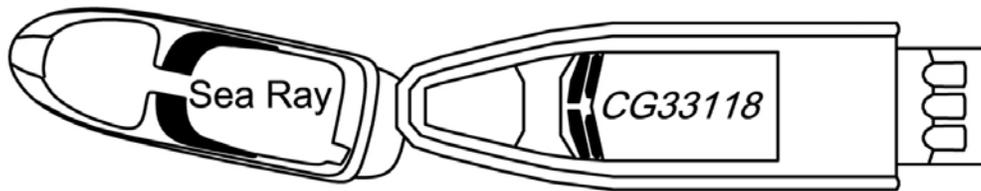
NTSB investigators calculated the strike angle by taking location measurements of the damage to both vessels. The strike angle to the Sea Ray was estimated to be about 11 degrees to starboard (**figure 9**).

Figure 9. Depiction of the CG 33118 colliding with the Sea Ray at an angle of about 11 degrees.

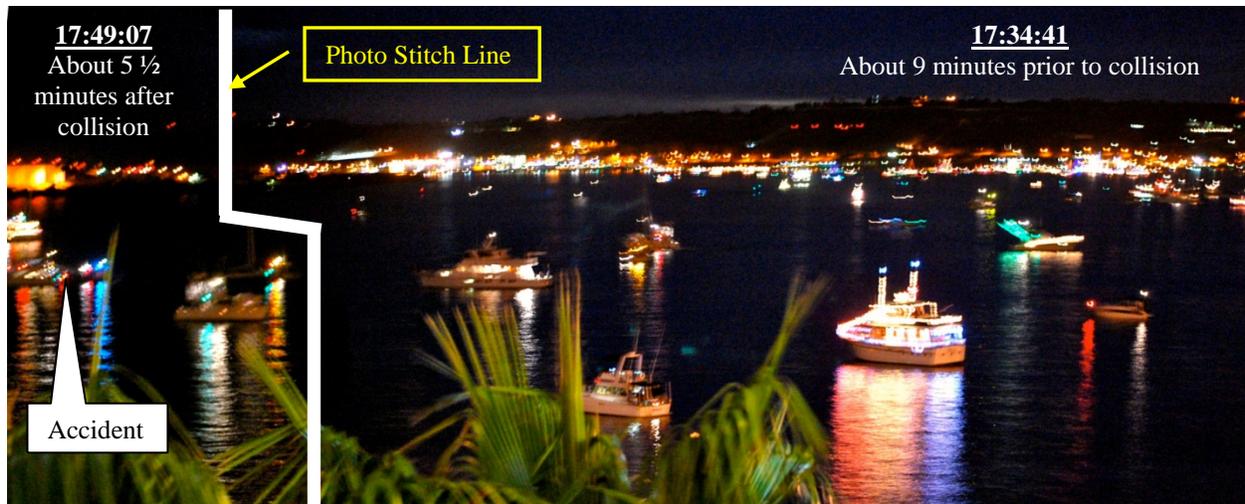
Vessel density in San Diego Bay was considered heavy at the time of the accident. SDHP officers stated that on the night of December 20, 2009, the bay was congested with hundreds of boaters because of the Parade of Lights. One officer characterized the Parade of Lights as bringing “one of the highest amounts of boat traffic on any given date in San Diego Bay.” In its accident report, SDHP noted that its vessel therefore responded to the collision “at a slow rate of speed due to the very heavy vessel traffic.” Witnesses also characterized heavy traffic density from the north end of Shelter Island to the Hilton Hotel on Harbor Island, along the parade route. As noted earlier, the Sea Ray operator estimated that about 20 vessels were within 50 yards of his boat at the time of the accident. Many spectator vessels were located near the West Basin inlet. As the parade moved northeast along Shelter Island and turned east to parallel Harbor Island, spectator vessels located near the West Basin inlet would have been primarily to the left of the parade route. Other than the spectator vessels near the West Basin inlet, vessels were also located along the shore of Harbor Island. **Figure 10** shows conditions near the accident site.

Figure 10. View of San Diego Bay looking southwest from the sixth floor of the Hilton Hotel near the western end of Harbor Island before and after the collision. The two combined photos illustrate the waterway traffic before the accident (right) and the location of the accident site (left). The CG 33118's approximate path to the West Basin would have been from the left to the right through the combined photos. (These two photos were the best available, and were taken as close as possible to the time of the accident.) Photo courtesy of T. Beckman.

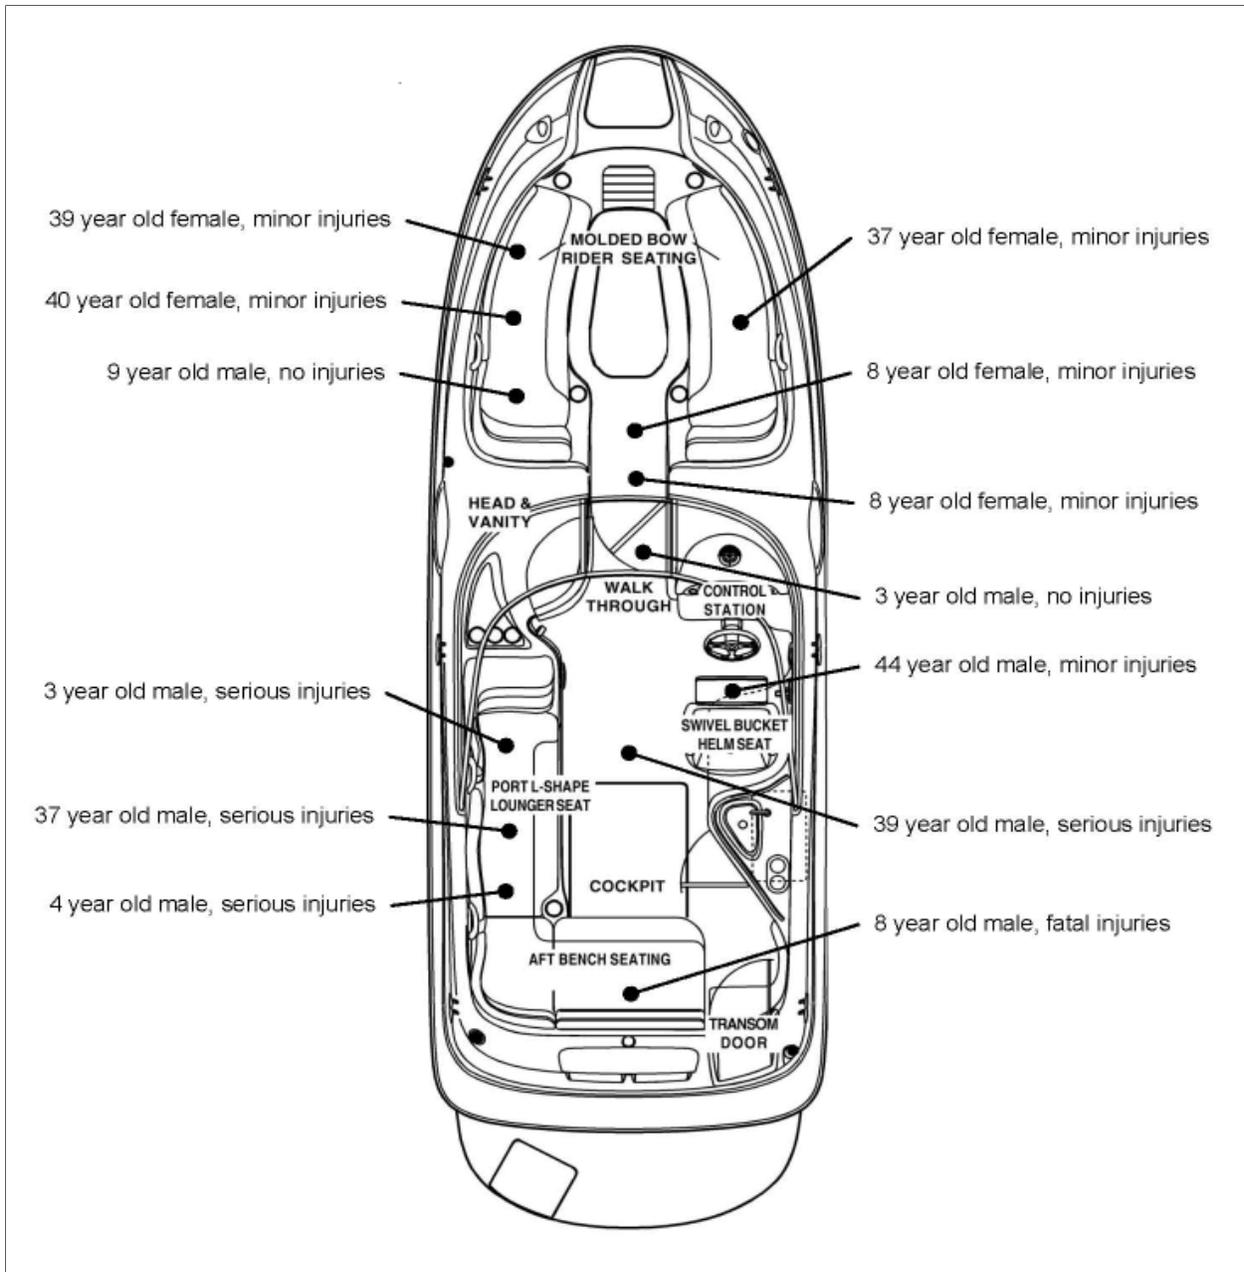
Figure 11 details the approximate location of each passenger on board the Sea Ray at the time of the accident and the severity of their injuries, based on medical records and interviews with surviving passengers. The four seriously injured passengers and the fatally injured boy were all seated in the rear half of the vessel. Those sitting or standing forward of the operating station received either minor injuries or none at all.

Figure 11. Layout of the Sea Ray and locations and injuries of the 13 people on board.
