# National Transportation Safety Board

## Marine Accident Brief

### Capsizing of Towing Vessel *Megan McB*

<b>Accident no.</b>	DCA13LM027
<b>Vessel name</b>	<i>Megan McB</i>
<b>Accident type</b>	Capsizing
<b>Location</b>	Lock and Dam 7, Mississippi River mile marker 702.5, near La Crescent, Minnesota
<b>Date</b>	July 3, 2013
<b>Time</b>	0558 central daylight time (coordinated universal time – 5 hours)
<b>Injuries</b>	One fatality
<b>Damage</b>	\$500,000
<b>Environmental damage</b>	50 gallons of diesel fuel discharged into the water
<b>Weather</b>	Winds at 3 knots from the south, air temperature 86°F, water temperature 81°F
<b>Waterway information</b>	Mississippi River, Lock and Dam 7, water flow rate of 88,900 cubic feet/second

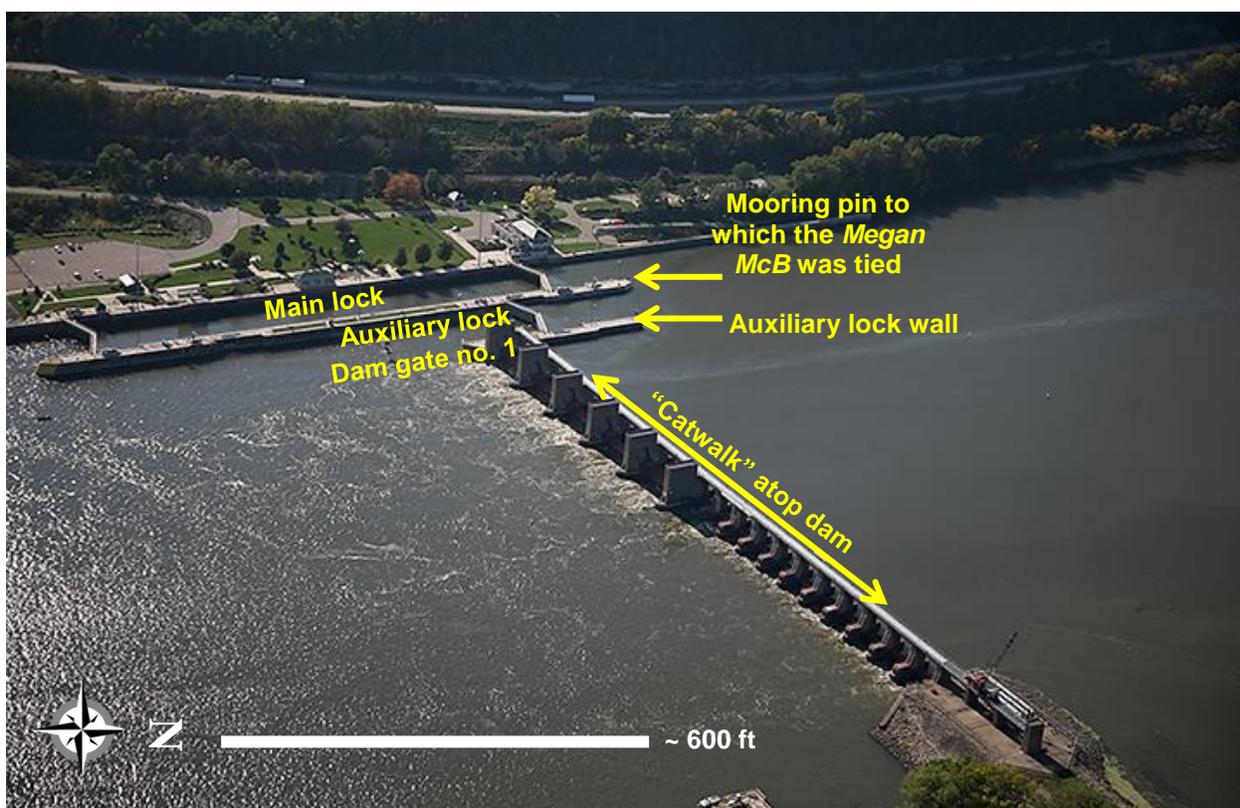
Aerial view of Lock and Dam 7, looking west across the river. (Photo by the Coast Guard)

The river current swept the *Megan McB* into gate no. 1 of the dam. The top of the vessel's starboard-side superstructure made contact with the catwalk atop the dam, causing the vessel's hull to be pushed out from underneath the superstructure, while the superstructure remained pinned against the catwalk. As a result, the *Megan McB* capsized onto its port side and came to rest just south of gate no. 1, where concrete baffle blocks held the vessel in place. The pilot and first mate were able to escape through the wheelhouse windows, which the strong current had broken, but the deckhand was missing. The pilot on board the *Bill Berry* notified the assistant lock operator, who launched a rescue boat onto which the pilot and the first mate were retrieved about 8 minutes later. The search continued for the missing deckhand. About 1300 that afternoon, divers located the deckhand's body on the second deck of the *Megan McB*'s superstructure.
