Allision of Crane Barge, Pushed by Towing Vessel  
*Cory Michael*, with the Florida Avenue Bridge  
New Orleans, Louisiana  
August 13, 2014

**Marine Accident Report**  
NTSB/MAR-15/02  
PB2015-105662

**National  
Transportation  
Safety Board**

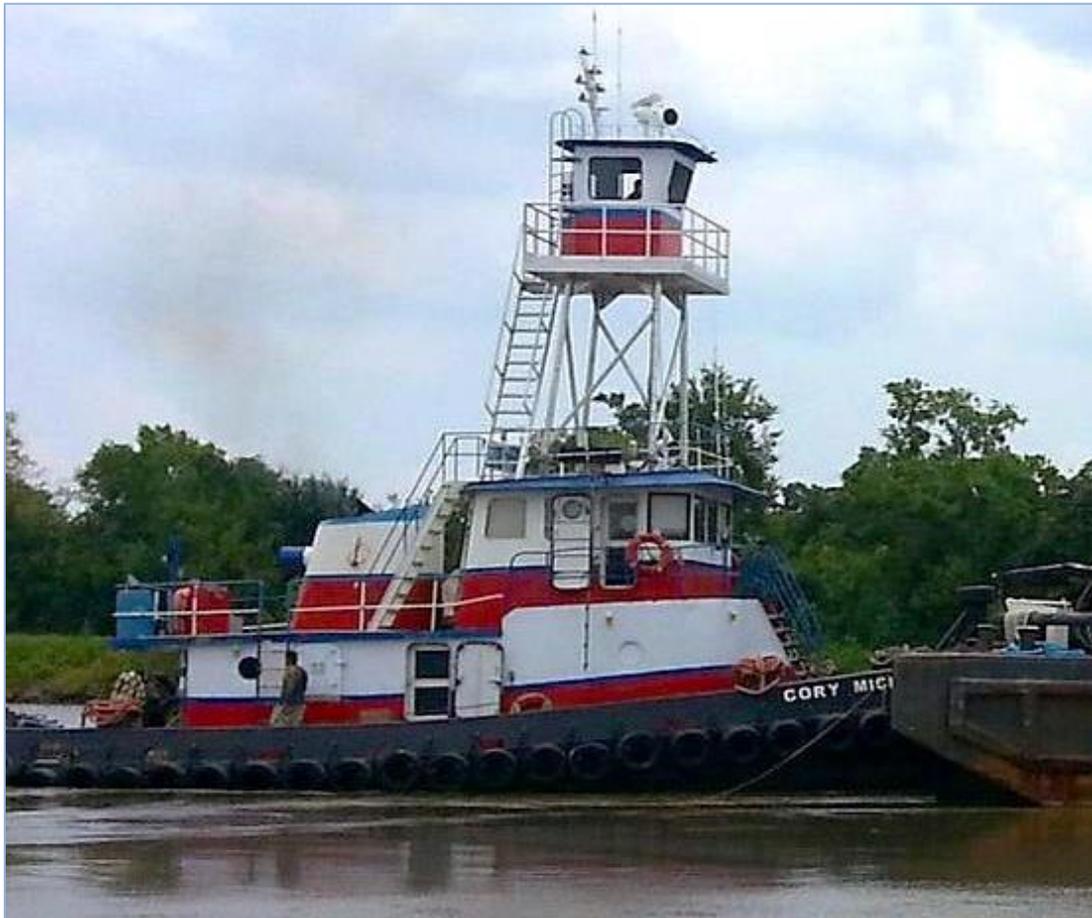
**Figure 1.** Towing vessel *Cory Michael*. (Photo by ABC Marine Towing)

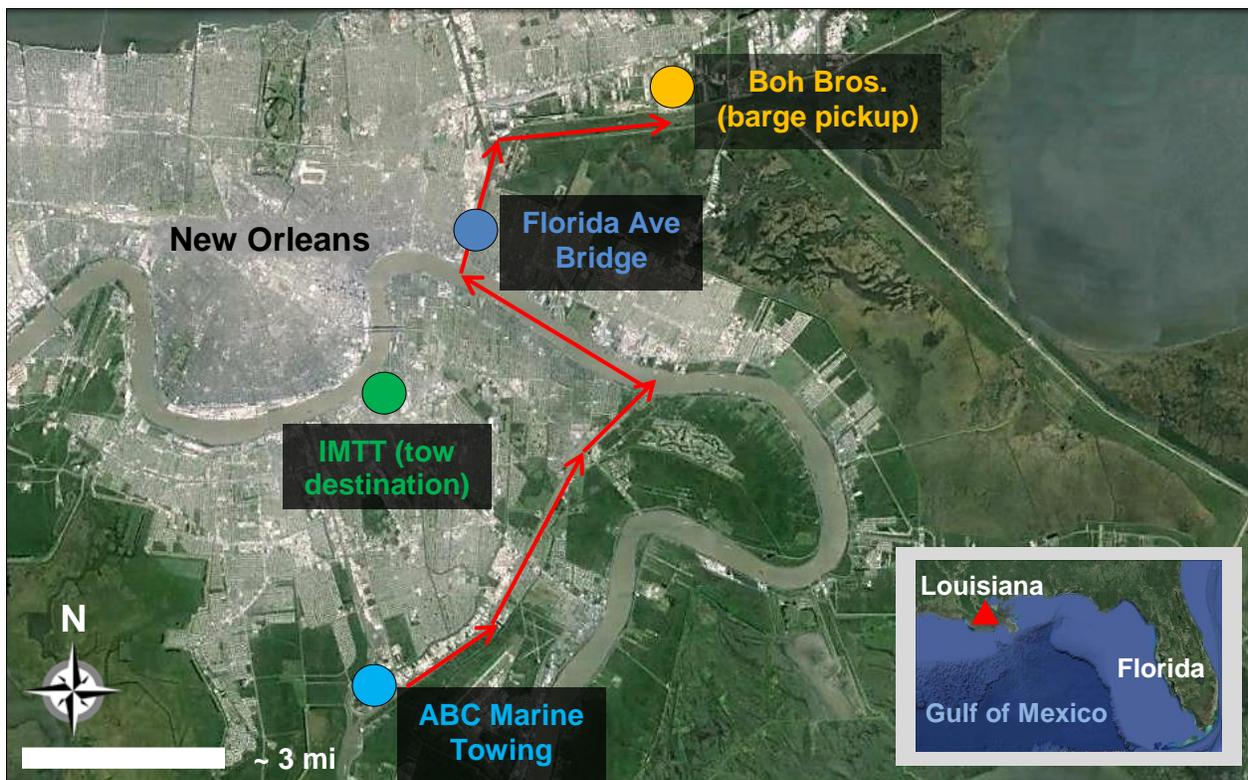
**Figure 2.** Satellite image, overlaid with various locations on the *Cory Michael's* transit. The vessel's trackline is overlaid in red arrows. The allision with the Florida Avenue Bridge occurred on the vessel's return from Boh Bros. after picking up the crane barge.
