National Transportation Safety Board

Marine Accident Brief

Capsizing and Sinking of Fishing Vessel *Destination*

Accident no.	DCA17FM006
Vessel name	<i>Destination</i>
Accident type	Capsizing and sinking
Location	Bering Sea, 2.6 miles northwest of St. George Island, Alaska 56°39' N, 169°49.8' W
Date	February 11, 2017
Time	0610 Alaska standard time (coordinated universal time – 9 hours)
Injuries	6 fatalities
Property damage	\$2.5 million est.
Environmental damage	Oil sheen
Weather	Visibility 9 miles, light snow, cloudy skies, winds northeast at 23 knots with gusts up to 34 knots, seas northeast at 13 feet, surface current south at 0.78 knots, air temperature 18°F, water temperature 37°F, morning twilight 0915, sunrise 0955
Waterway information	The Bering Sea covers 885,000 square miles in the north Pacific Ocean, bordered by the following areas: Russia (Siberia), Bering Strait, mainland Alaska, Alaska Peninsula, and Aleutian Islands. The average depth of the sea is approximately 5,000 feet. The area around St. George and St. Paul Islands (Pribilof Islands) is much shallower, measuring 180–300 feet deep.

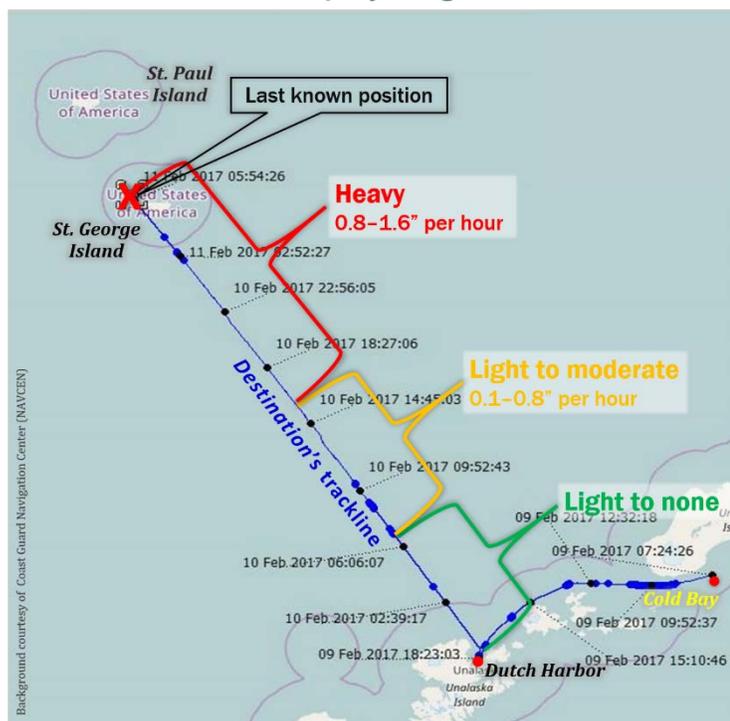
Accumulation of Sea Spray Icing

However, given that the Overland method was developed nearly 30 years ago, investigators sought a more current method for estimating sea spray icing. Memorial University conducted simulations on the icing conditions that the *Destination* encountered, factoring in many more variables than did the Overland algorithm calculations. The university's icing simulations used data from the Navy Global Hybrid Coordinate Ocean Model (HYCOM), the vessel's AIS track, an NTSB weather research and forecasting model, and a computer model of the *Destination* based on its loading configuration during the accident voyage. With ice accumulation calculated in tonnes per 15 minutes, the results revealed that the highest rate of accumulation—2.7 tonnes (5,951 pounds) per 15 minutes—occurred at 1700 on February 10.¹⁷ Between 92.4 and 154.0 tonnes (203,650 and 339,416 pounds) of ice would have accumulated and been distributed across the entire vessel's surface by the accident time.
