Collision of Tugboat/Barge *Caribbean Sea/The Resource*
with Amphibious Passenger Vehicle *DUKW 34*
Philadelphia, Pennsylvania
July 7, 2010

Accident Report

NTSB/MAR-11/02
PB2011-916402

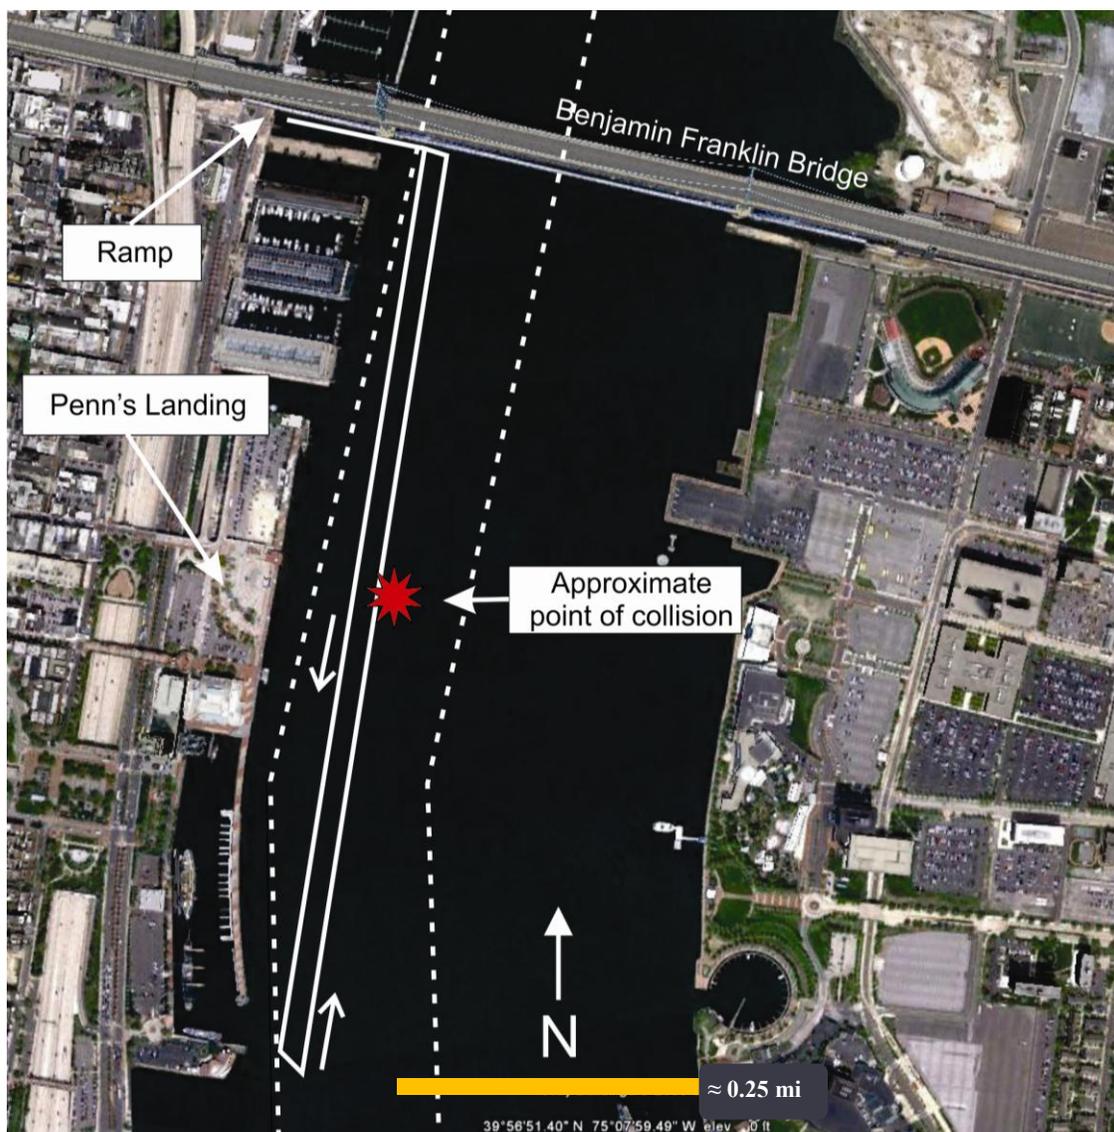
Figure 2. View of the Delaware River at the accident site. The solid white lines indicate the approximate route of Ride The Ducks APVs. The dotted white lines indicate the approximate boundaries of the navigational channel. (Background by Google Earth)

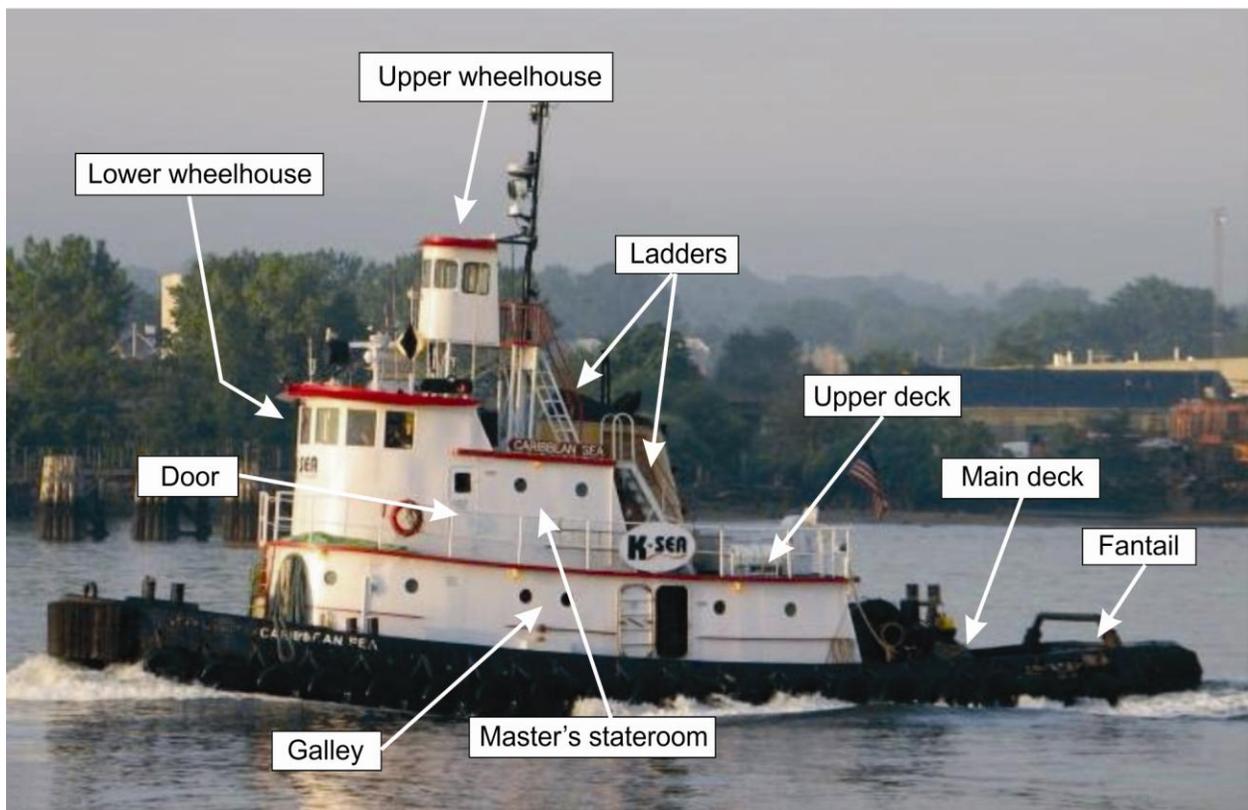
Figure 5. *Caribbean Sea*. (Photo by Joe Becker)

According to interviews of the *Caribbean Sea* crew, at the time of the collision, deckhand No. 1 and the engineer were seated at the table on the port side of the galley (figure 5). They said that they noticed a reduction in the rpm of the vessel's engines and thought that it had arrived at the destination. The deckhand said that he looked out a galley porthole and noticed what appeared to be people in the water off the vessel's port side. Both crewmembers said they then left the galley and proceeded to the aft main deck area (fantail). From there, they said they saw several persons and some debris passing down the port side of their vessel.

The engineer said he then went forward to alert the master of the situation. He said he climbed the ladder on the aftermost bulkhead to the upper deck (refer to figure 5) and then proceeded forward along the port side of the vessel to the exterior door that leads into a passageway between the master's stateroom and the lower wheelhouse. He said that when he opened the door, he saw the mate standing in front of the master's stateroom door. He said this was the first time he had seen the mate after the collision.
